XRMI Image Log Summary Report

**Lebsack Oil Production Inc.
Bensch #4
Rice County, KS
Sect. 33 Twp. 20S Rge. 10W
API: 15-159-22830**

Date: 11-May-2016
Prepared by: Morgan Unrast
morgan.unrast@halliburton.com
Location: Oklahoma Formation and Reservoir Solution
Oklahoma City, Oklahoma, U.S.A
Phone: 1-405-552-1771 (office)
1-405-213-4822 (work cell)

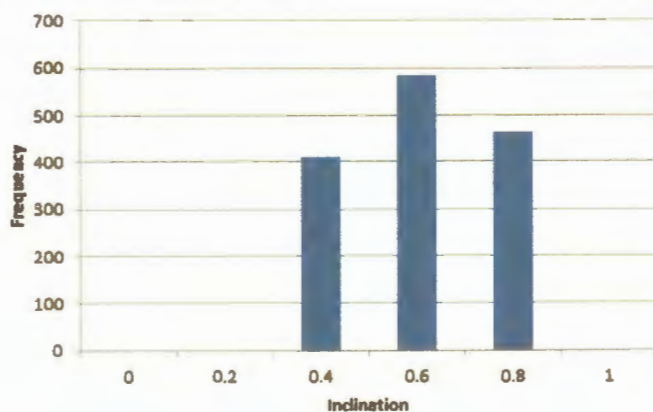
Inclination Statistics

Top Depth:	2,832 ft
Bottom Depth:	3,190 ft
Depth Range:	358 ft
Mean Value:	0.50
Standard Deviation:	0.18
Median Value:	0.49
Minimum Value:	0.205
at depth:	2,963 ft
Maximum Value:	0.791
at depth:	3,116 ft

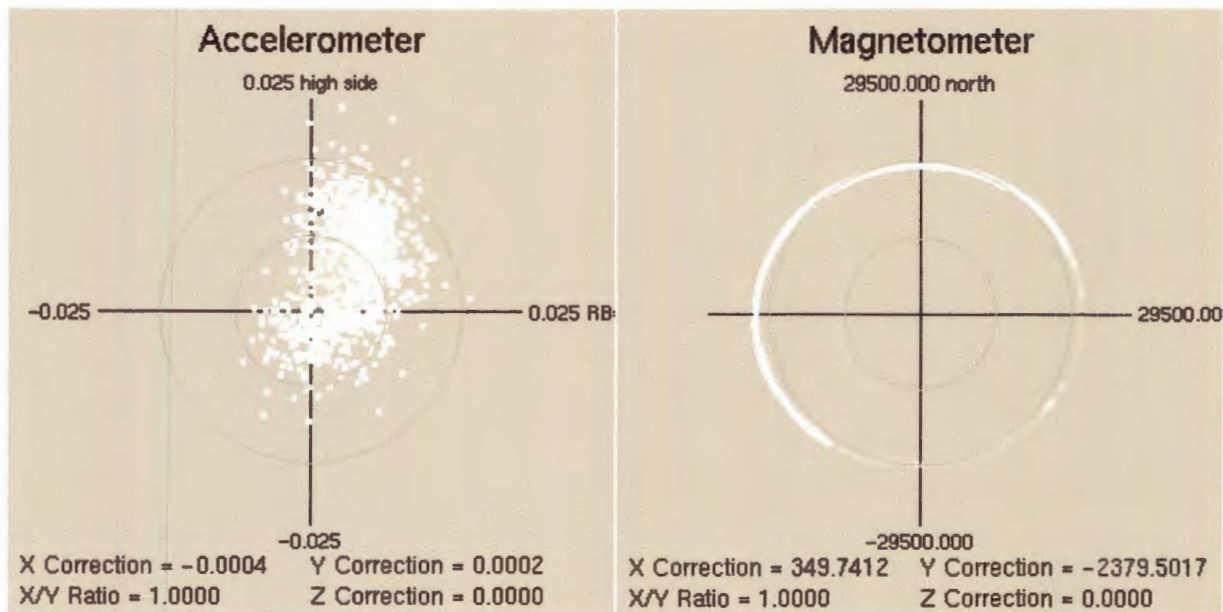
Raw XRFI Data QC

The cross-plots of the X- and Y-axes of the accelerometer and magnetometer sensors were well centered indicating that the magnetometer readings were correct and required little post-processing corrections.

The AZI1 and RB are tracking each other parallel also indicating that the tool's orientation unit is functioning properly for the main run.

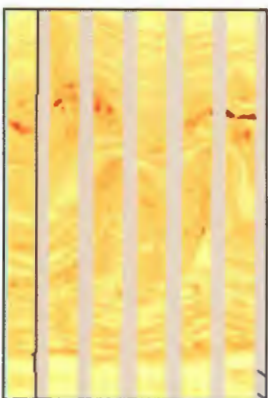
Faults occur when there is displacement along a fracture plane. On image logs, faults can be distinguished where bedding planes are terminated by the fault plane. Often a change in dip azimuth occurs above a fault zone. **Microfaults** are faults that display minor displacement in bedding along the fracture plane. These micro faults can occur above and below a fault zone. The examples to the left show faults.

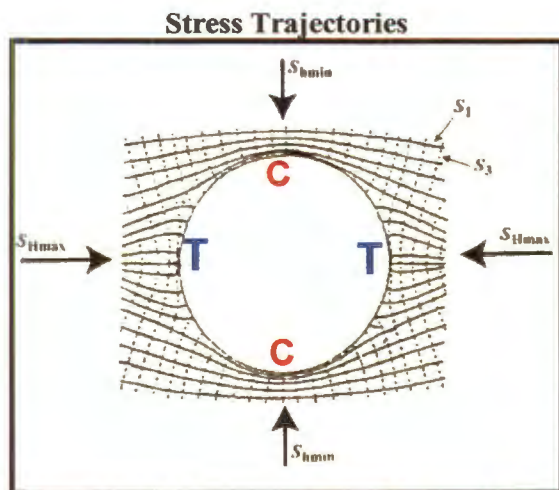
FRACTURE/STRESS REVIEW

T = Tensile quadrants

C = Compressive quadrants

Principal stress (S_v) occurs along a vector pointing into the page

The creation of a cylindrical opening (like a wellbore) causes the stress trajectories to bend in such a way as to be parallel and perpendicular to the wellbore wall. The wellbore stress field reacts in this manner because it is a free surface that cannot sustain shear traction. As the material is removed, it is no longer available to support far field stresses, which can result in stress concentration around the well. The way in which a formation responds to the stress concentration is a function of both the stress field and rock strength. The stress concentration around a vertical well drilled parallel to the principal stress (S_v) reveals information about the present day *in situ* stress when borehole failure occurs (induced fractures and/or breakout).

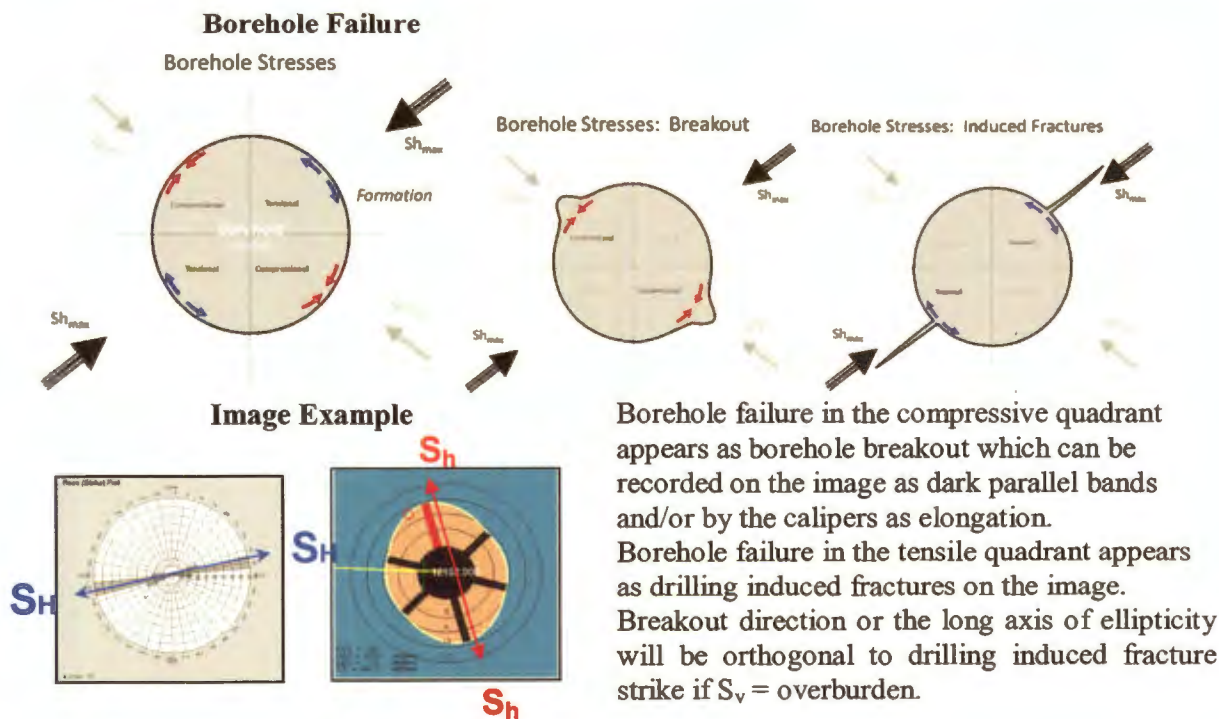
The bunching up of stresses at the azimuth of S_{hmin} , indicates strongly amplified compressive stress, and spreading out of stress trajectories at S_{Hmax} indicates a decrease in compressive stress.

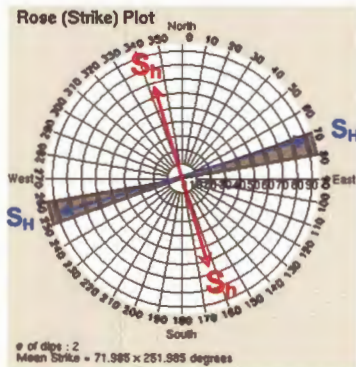
DRILLING INDUCED FRACTURES

(n = 2)

Average strike: 72° / 252°

The Rose Plot diagram to the left shows the overall strike orientation of **drilling induced fractures** that were observed/interpreted in the logged interval. The induced fractures provide evidence to estimate the orientation of the maximum horizontal stress direction or S_H . The orientation of the S_h (minimum horizontal stress) on the polar plot is from the orientation above and is orthogonal to the strike of the drilling induced fractures.

Borehole breakout was not seen in the image. A couple of drilling induced fractures were observed in the ENE-WSW strike direction.

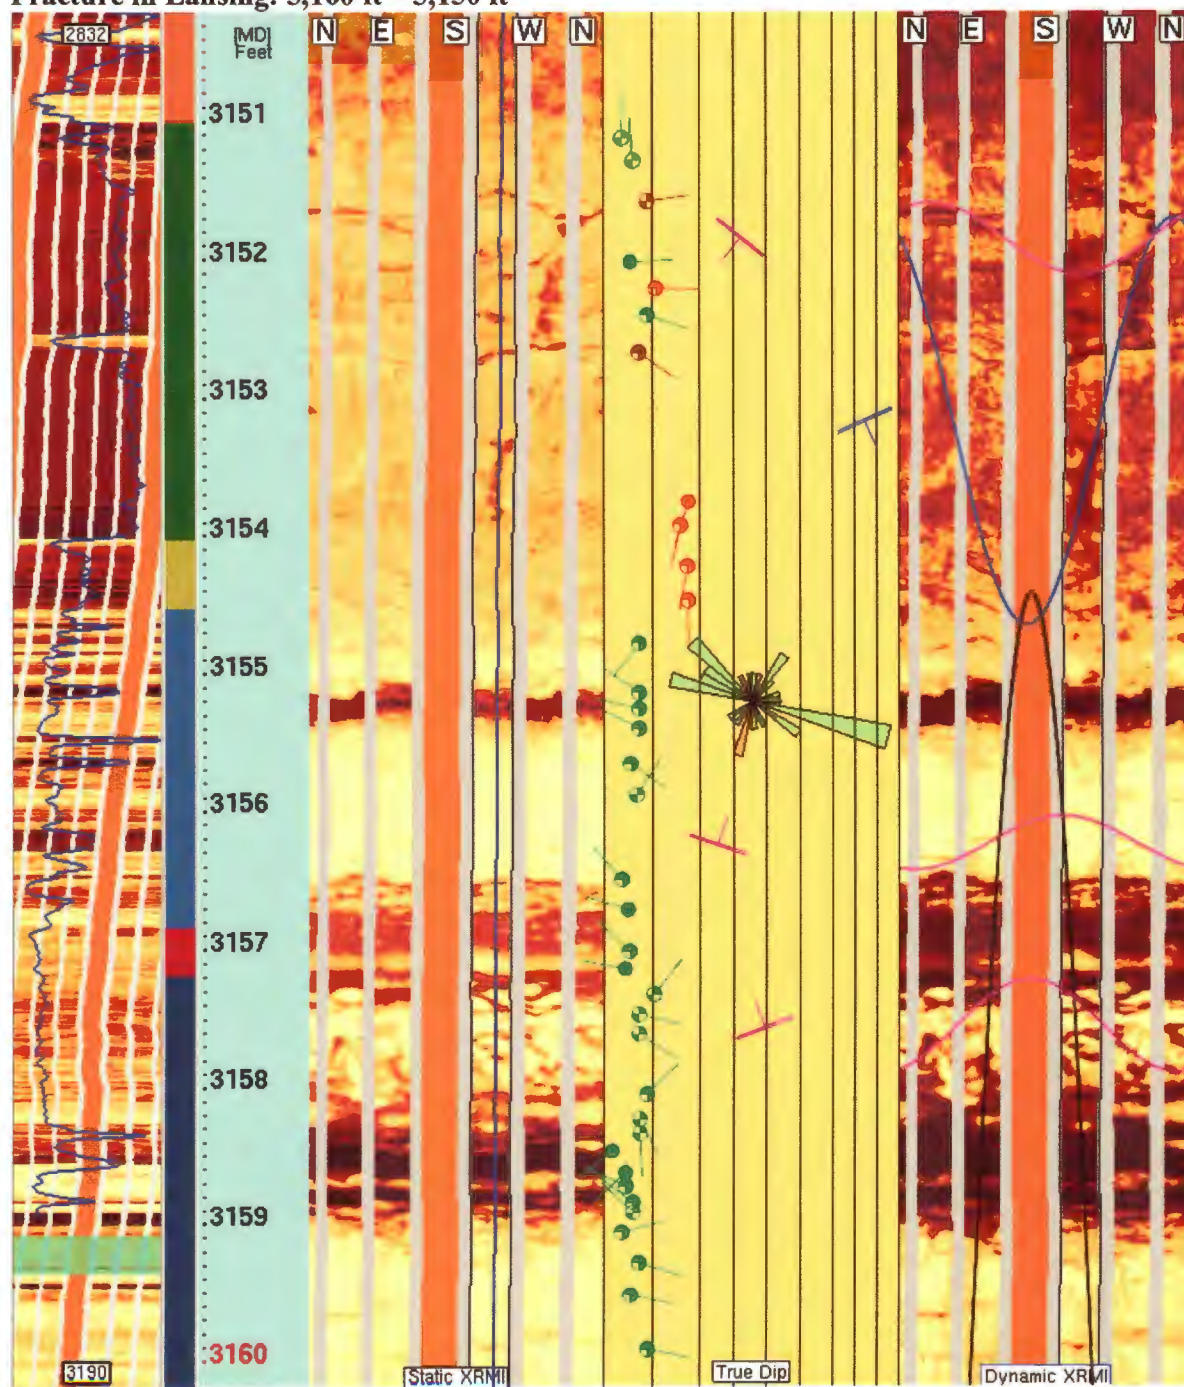
Fracture in Lansing: 3,160 ft – 3,150 ft

Above figure is a closeup of the static and dynamic image in the Lansing. A few low-quality fractures were observed. Identifying natural open and closed fractures was difficult. Partial fractures appear in three pads or less and shown with pick tadpoles. Mostly natural fractures were found in the Lansing Formation.

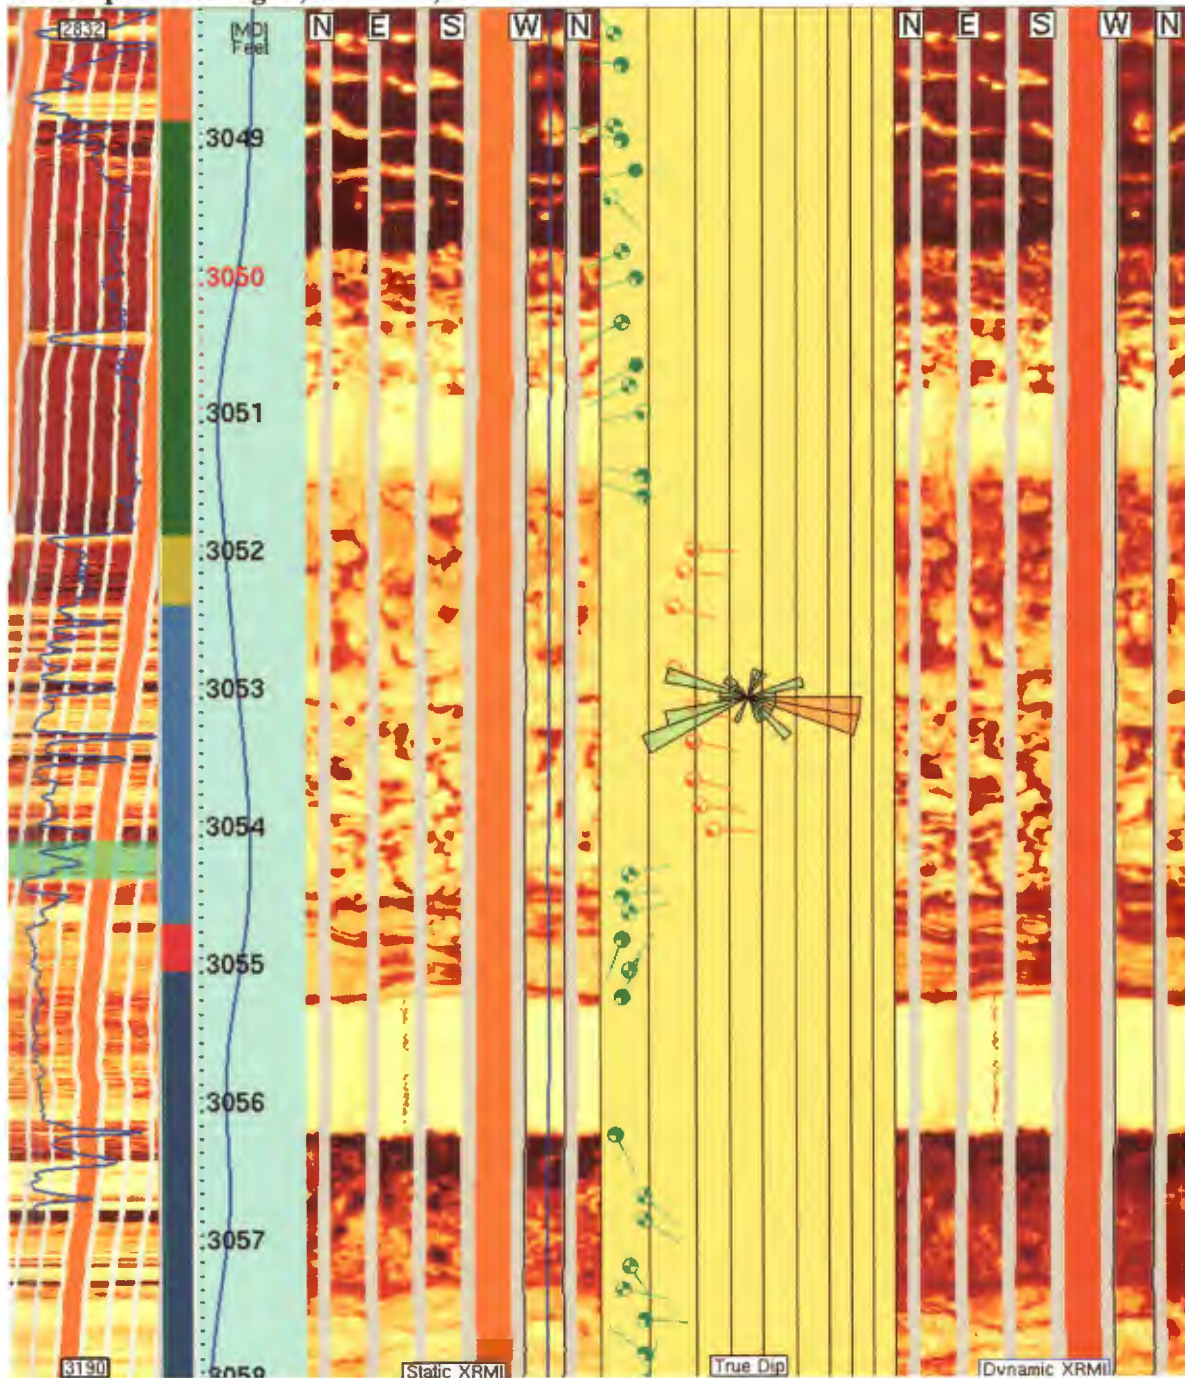
Close-up of Lansing: 3,057 ft. – 3,047 ft

Above figure is a closeup of the static and dynamic image in the Lansing. The limestone around 3055.8 ft and 3,051.2 ft appears to fossiliferous limestone whereas the unit between 3,054.5 ft to 3,051.4 ft was observed as limestone with moldic porosity. At 3,055 ft is a dissolution feature.

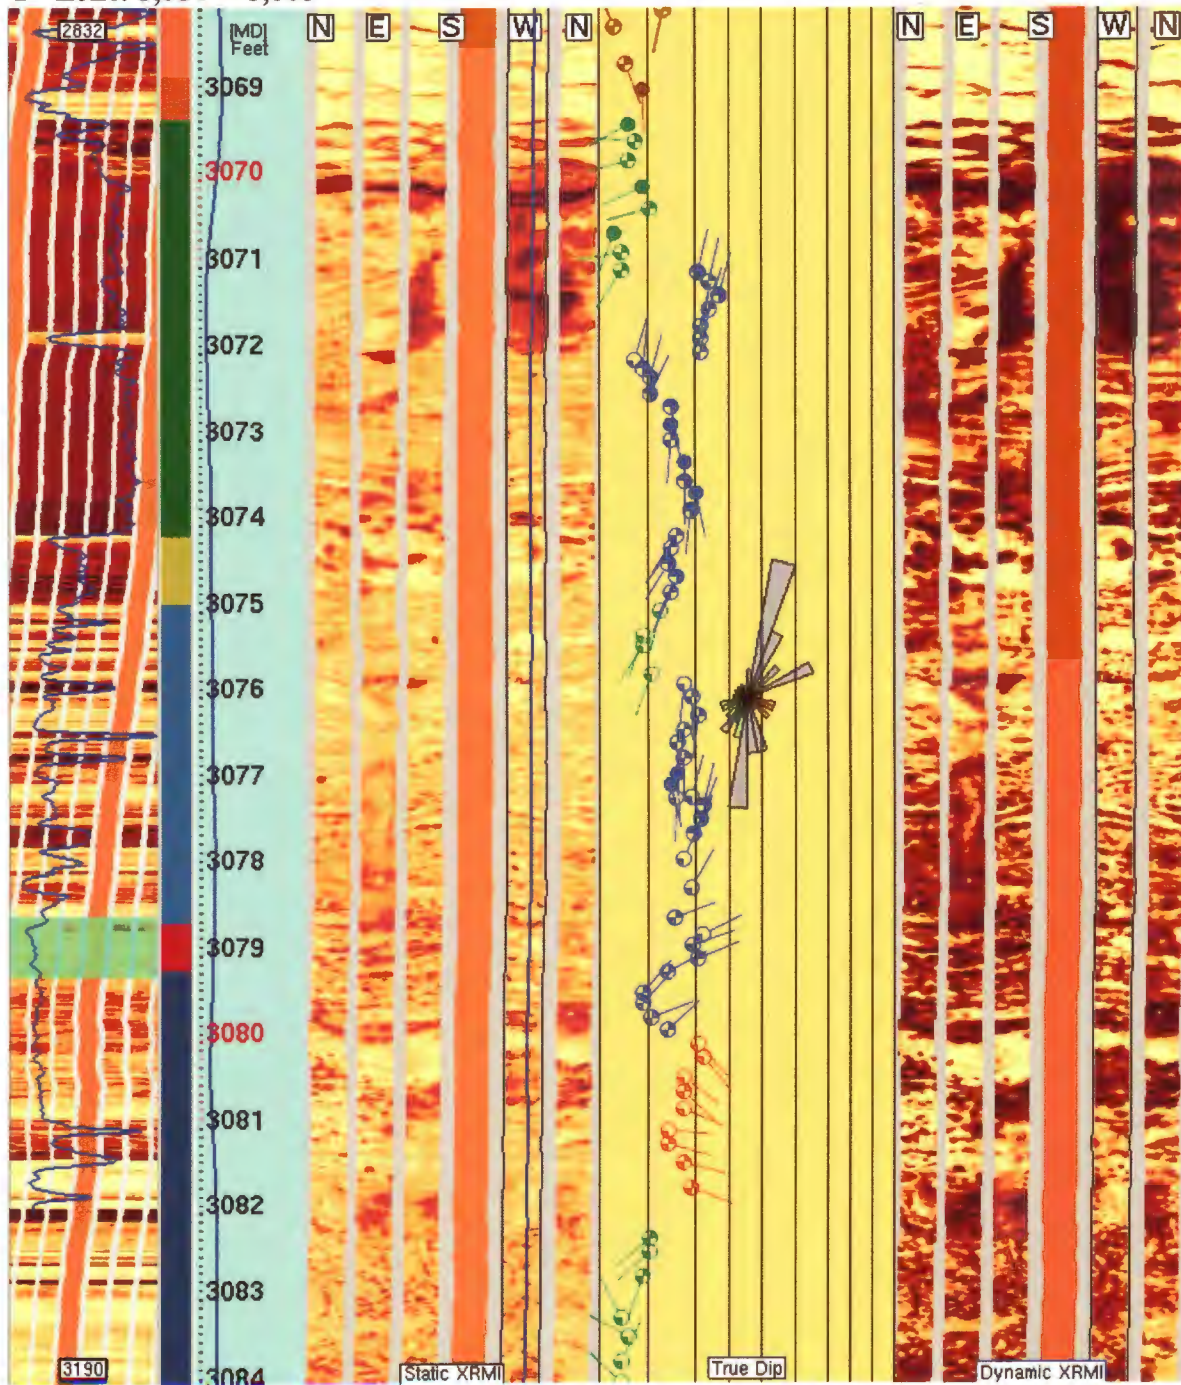
"F" Zone: 3,084' – 3,068'

Image sample of the static and dynamic image of "F" Zone with ~2 ft above and below the zone. The "F" Zone occurs from 3,082 ft to 3,070 ft. Below the "F" Zone is low-quality planar bedding follow-up deformation bedding, whereas above "F" zone is limestone with stylolite features. The "F" zones consist of crossbedding oolitic limestone and label with blue tadpoles. The dark browns and orange colors suggest porosity.

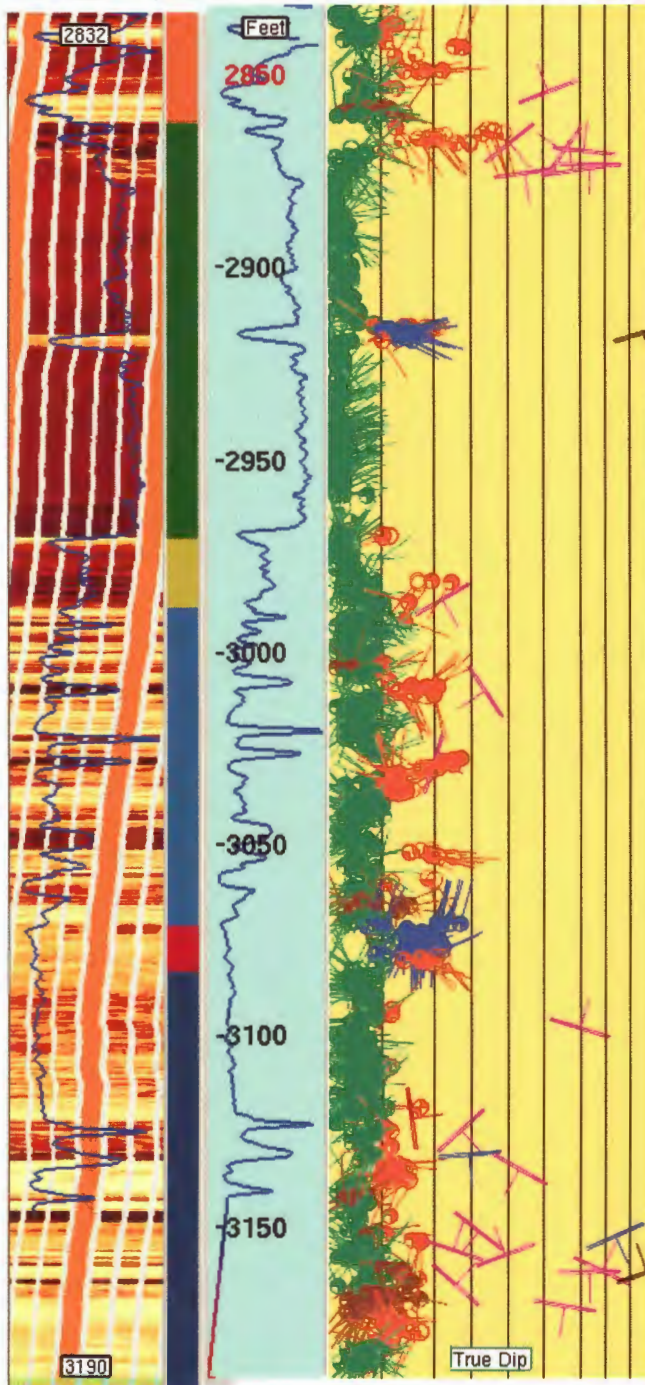
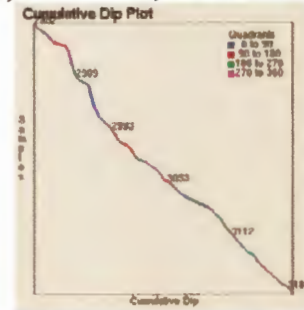
CONTINUOUS IMAGE AND CUMULATIVE DIP PLOT 11,600 ft. – 10,300 ft

The cumulative dip plot pictured above plots the average dip magnitude vs depth. A decrease in slope represents an increase in the average bedding dip magnitude.

Continuous image and cumulative dip plot showing all manually picked beds and fractures within the logged interval of the Bensch #4 well (3,190' – 2,832'). The continuous plot is a small scale view of the logged interval and provides a way to view the occurrence and distribution of the different types of bedding and fractures that were interpreted. The cumulative dip plot method provides a way to analyze dip angle as a function of depth and is used for determining/detecting faults and unconformable surfaces by deflection points in the bedding dip data. Please see the more detailed summary bedding and fracture data and formation statistics on the following pages.

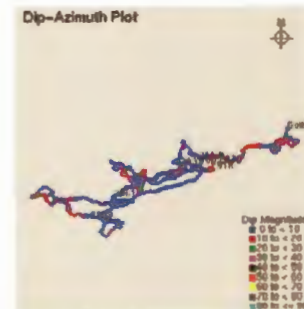
The dip-azimuth plot above shows the general dip direction. The beds had slightly trending to the ENE-WSW direction.

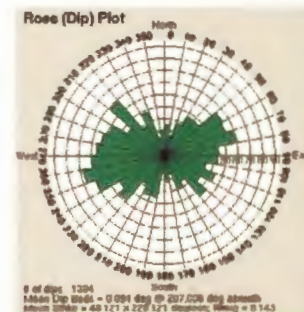
Bedding
(n = 1304)
Average strike: 0.9°/208°

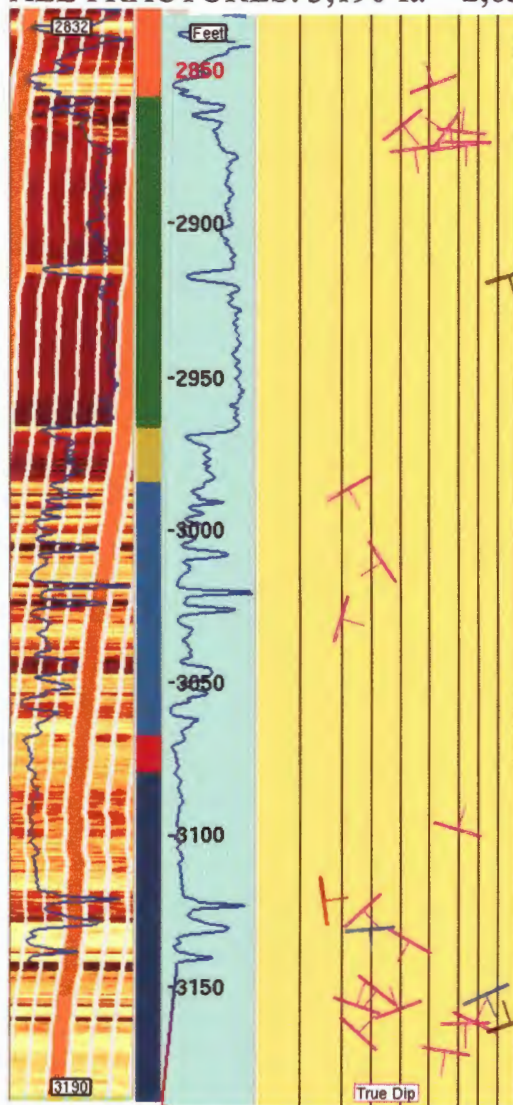
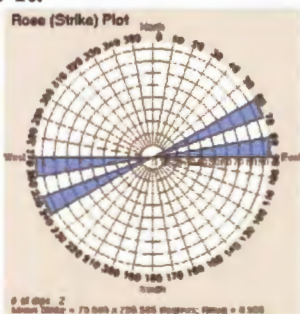
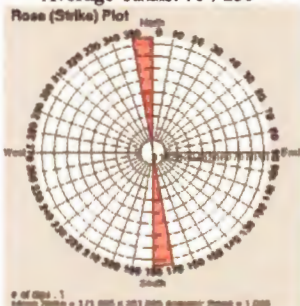
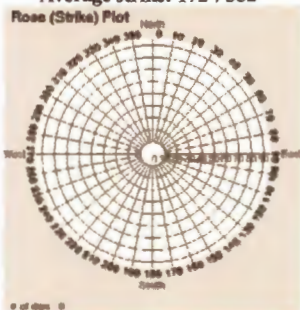
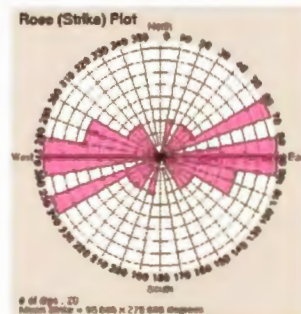
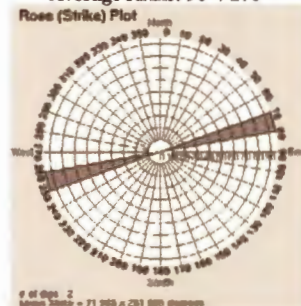
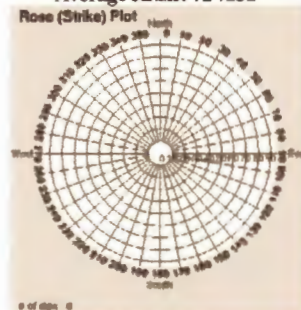
ALL FRACTURES: 3,190 ft. – 2,832 ft.

NATURAL OPEN FRACTURES
(n=2)

Average strike: 76°/256°

CLOSED FRACTURES
(n=1)

Average strike: 172°/352°

PARTIAL FRACTURES
(n=20)

Average strike: 96°/276°

INDUCED FRACTURES
(n=2)

Average strike: 72°/252°

Continuous image showing the orientations and distributions of **natural open**, **mineralized closed**, **partial**, and **drilling-induced** fractures as well as **faults** and **micro faults** that were observed in the logged interval of the **Bensch #4** well. Rose plots to the right show the overall orientation of all fractures types and average strikes within this interval.

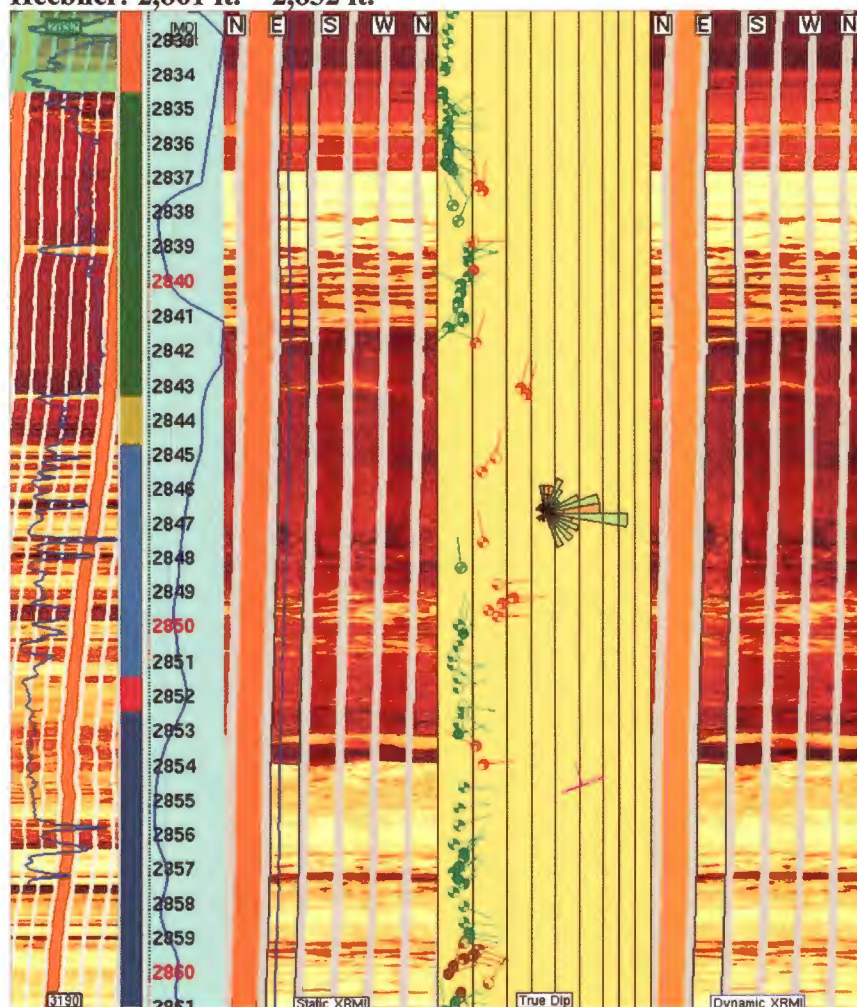
Heebner: 2,861 ft. – 2,832 ft.

Average Dip/Azimuth: 3.0°/ 73°

Average Dip/Azimuth: 12°/42°

Average strike: 69°/ 249°

Heebner was observed as limestone and shale beds. Some deformation bedding was observed in the shale bed.

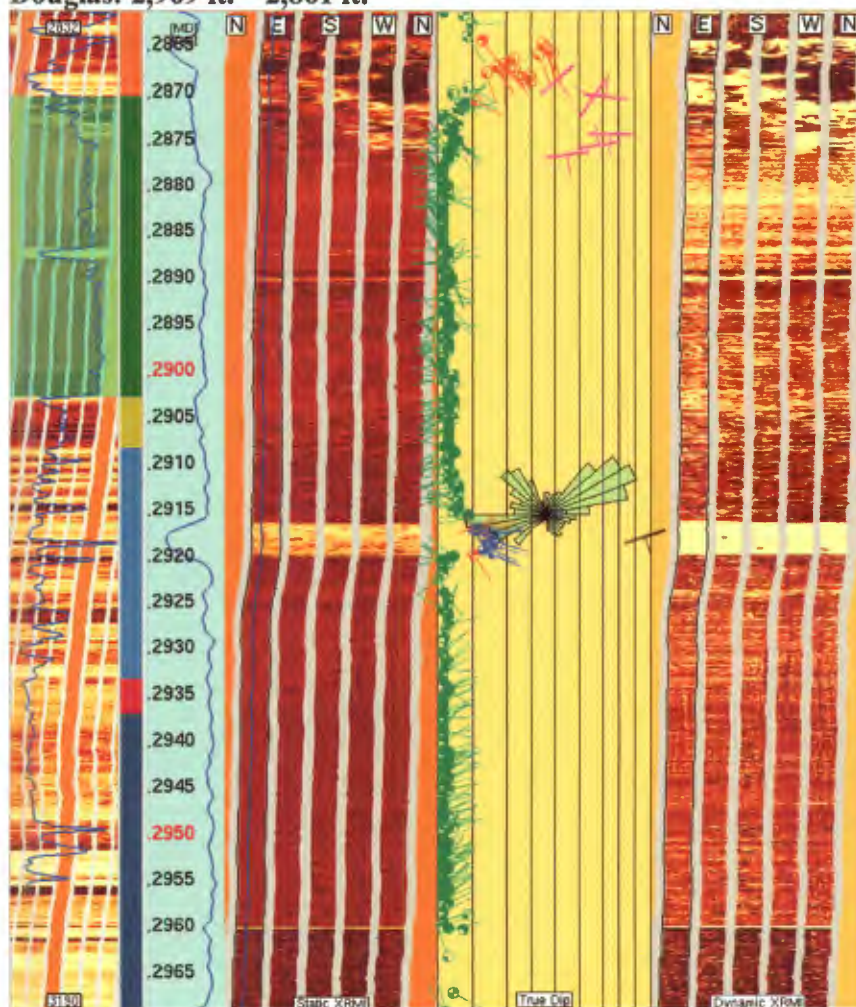
Douglas: 2,969 ft. – 2,861 ft.

Bedding
(n = 275)

Average Dip/Azimuth: 0.2°/ 332°

DEFORMATION BEDDING
(n = 24)

Average Dip/Azimuth: 14°/ 186°

PARTIAL FRACTURES
(n = 6)

Average strike: 94° / 275°

INDUCED FRACTURES
(n = 1)

Average strike: 73°/ 253°

The Douglas image interval was observed as planar shale beds. Based currently observed it appears from 2,965 ft to 2,920 ft appear dipping to the northeast. Then about 5 ft of limestone was deposited with a dip between 10° and 20° in the east direction. The shale above the limestone appears have a west dip direction. However, there may be some discrepancy with very low angle bedding. Deformation bedding was observed in the top 10 ft of the Douglas.

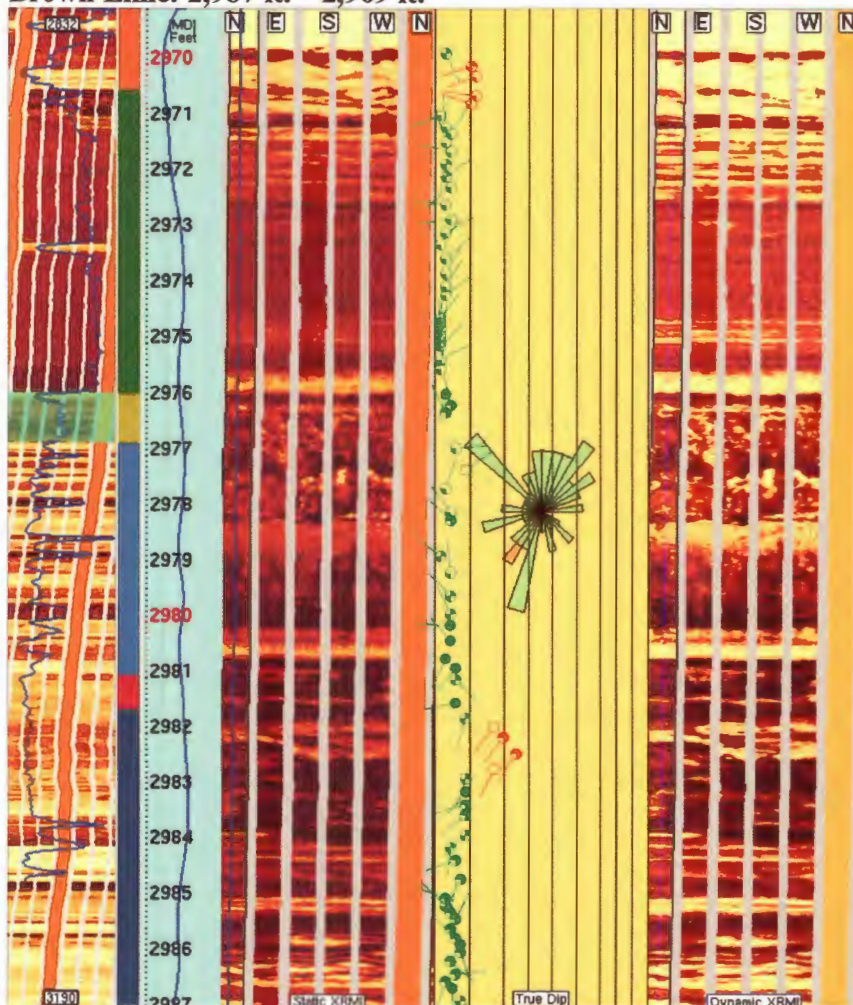
Brown Lime: 2,987 ft. – 2,969 ft.

Bedding
(n = 65)

Average Dip/Azimuth: 0.6°/254°

DEFORMATION BEDDING
(n = 8)

Average Dip/Azimuth: 14°/232°

Image of Brown Lime comprised low angle limestone and shale beds that average around 0.6°. The beds were observed at very low angles, so there can be some discrepancy with very low angle bedding.

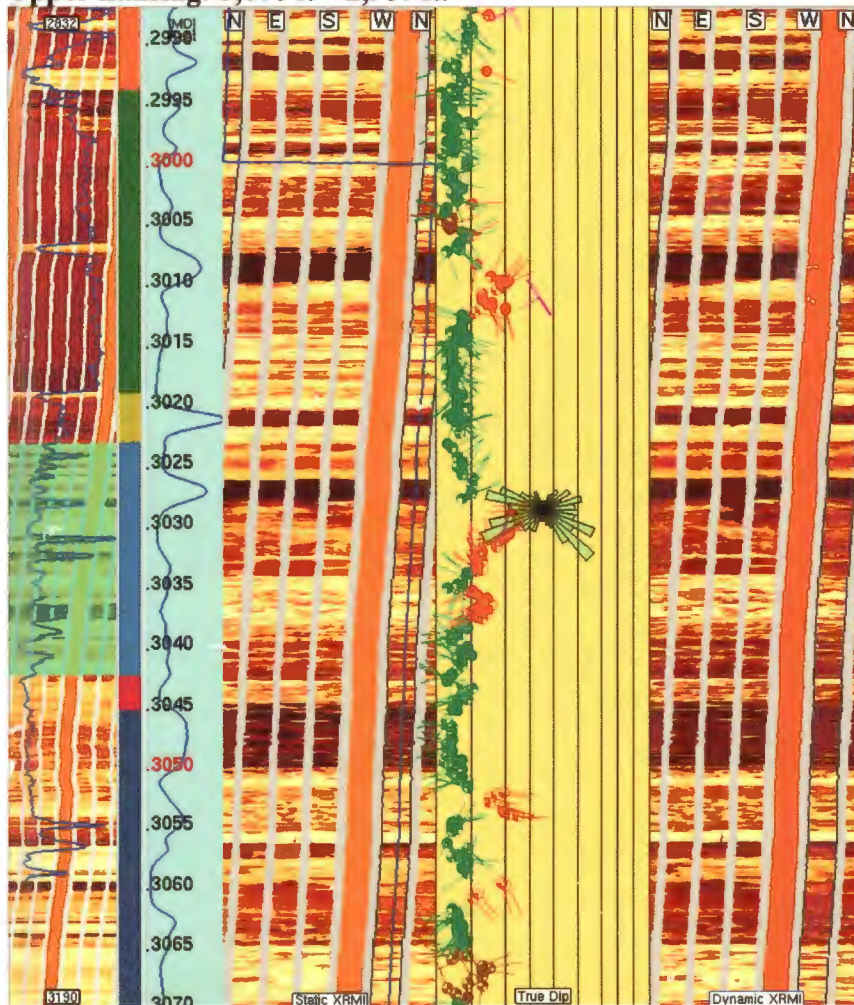
Upper Lansing: 3,070 ft – 2,987 ft.

Bedding
(n = 247)

Average Dip/Azimuth: 0.8°/ 206°

DEFORMATION BEDDING
(n = 70)

Average Dip/Azimuth: 2.6°/ 225°

STYLOLITE
(n = 19)

Average Dip/Azimuth: 0.3°/107°

PARTIAL FRACTURES
(n = 3)

Average strike: 70° / 250°

The upper Lansing was observed as limestone and shale beds. The possible bimodal direction, but there may be some discrepancy with very low angle bedding. Some limestone beds are interbedded with clay or contain stylolite features. Few limestone beds appear to contain several fossil fragments. Few partial fractures were observed.

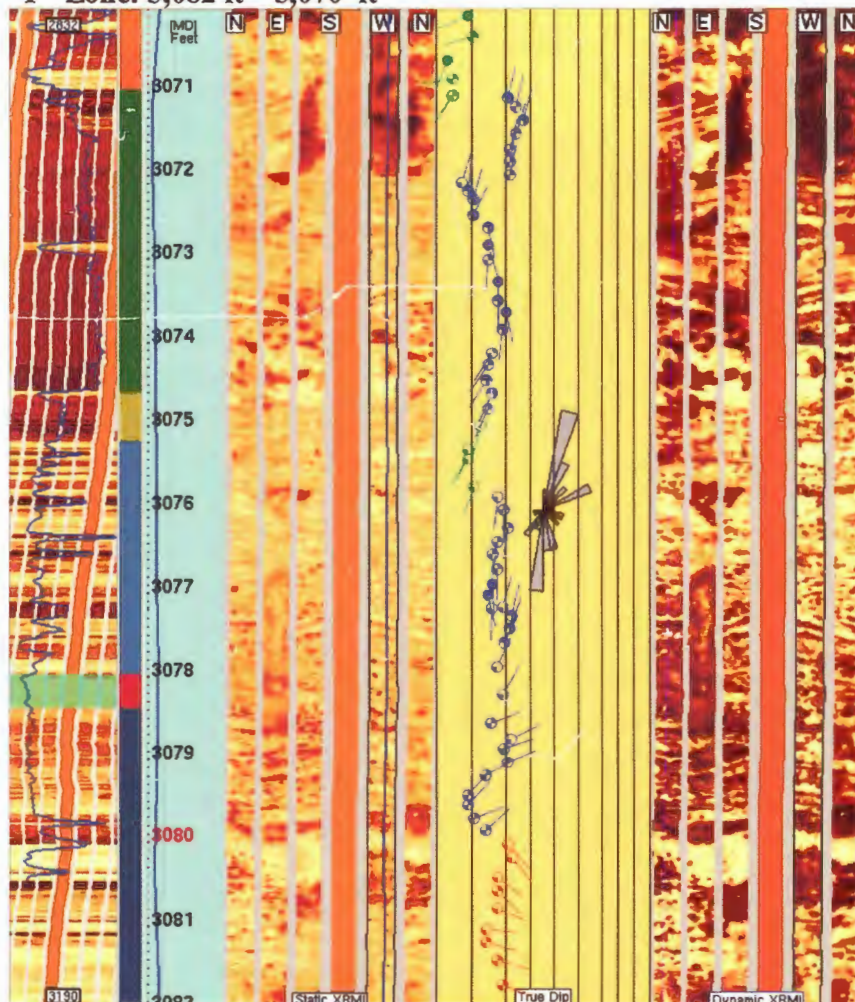
"F" Zone: 3,082 ft – 3,070 ft

BEDDING
(n=9)
Average Dip/Azimuth: 7.3°/218°

DEFORMATION BEDDING
(n=9)
Average Dip/Azimuth: 17°/120°

Image interval of the "F" zone which was considered as the zone of interest. There was reworking occurred for this zone. The oolitic facies was observed for the sedimentary bedding indicated by the blue tadpoles. The dark conductivity spots are possible mud filled porosity. The orange color of the static image suggests porosity may be interconnected.

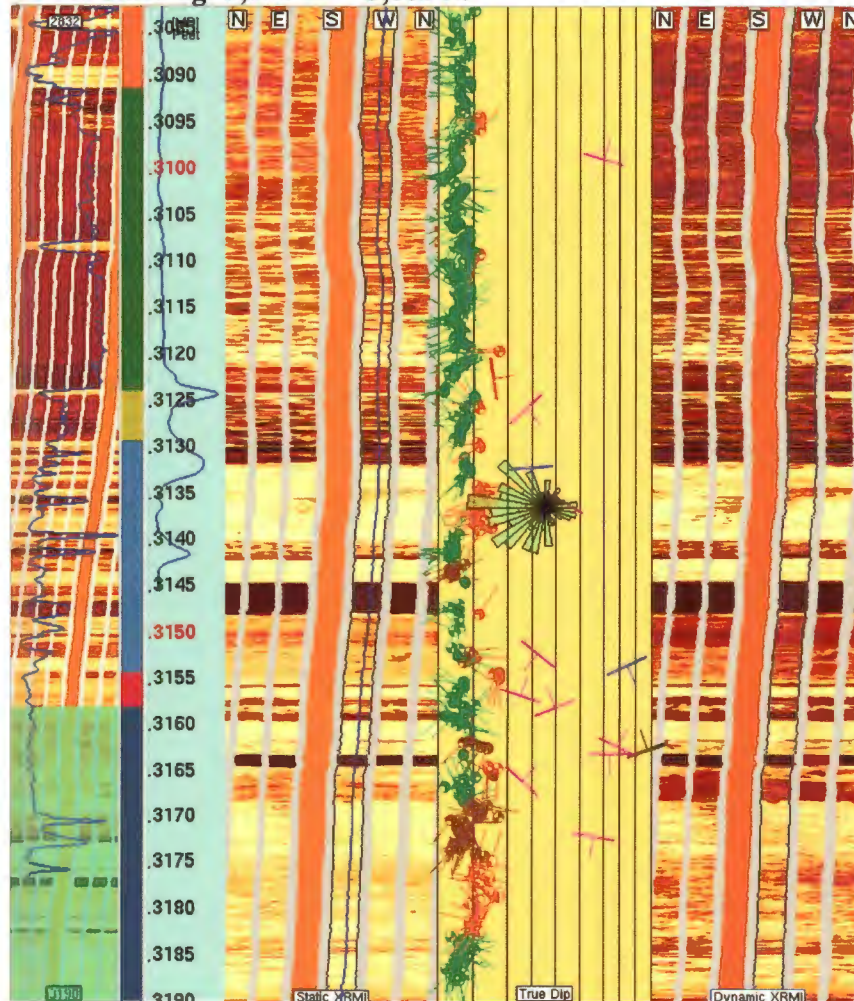
Lower Lansing: 3,190 ft. – 3,082 ft.

Average Dip/Azimuth: 2.0° / 253°

Average Dip/Azimuth: 6.4° / 241°

Average Dip/Azimuth: 2.3° / 227°

Average strike: 65° / 246°

Average strike: 172° / 351°

Average strike: 107° / 288°

Average strike: 71° / 251°

The Lower Lansing was observed as limestone and shale beds. From 3,130 to 3,082 ft appears limestone with interbedded shales. Planar and deformation bedding along with stylolite was observed dipping to the southeast direction. Natural conductive, resistive, and partial fractures were seen in slightly random in directions. Fractures were mostly seen in the Lower Lansing.
