Pioneer Energy Services

# Dual Compensated Porosity Log

Database File: vess\_082112hd.db  
Dataset Pathname: dil/vstack  
Presentation Format: cdl  
Dataset Creation: Tue Aug 21 20:54:43 2012  
Charted by: Depth in Feet scaled 1:600

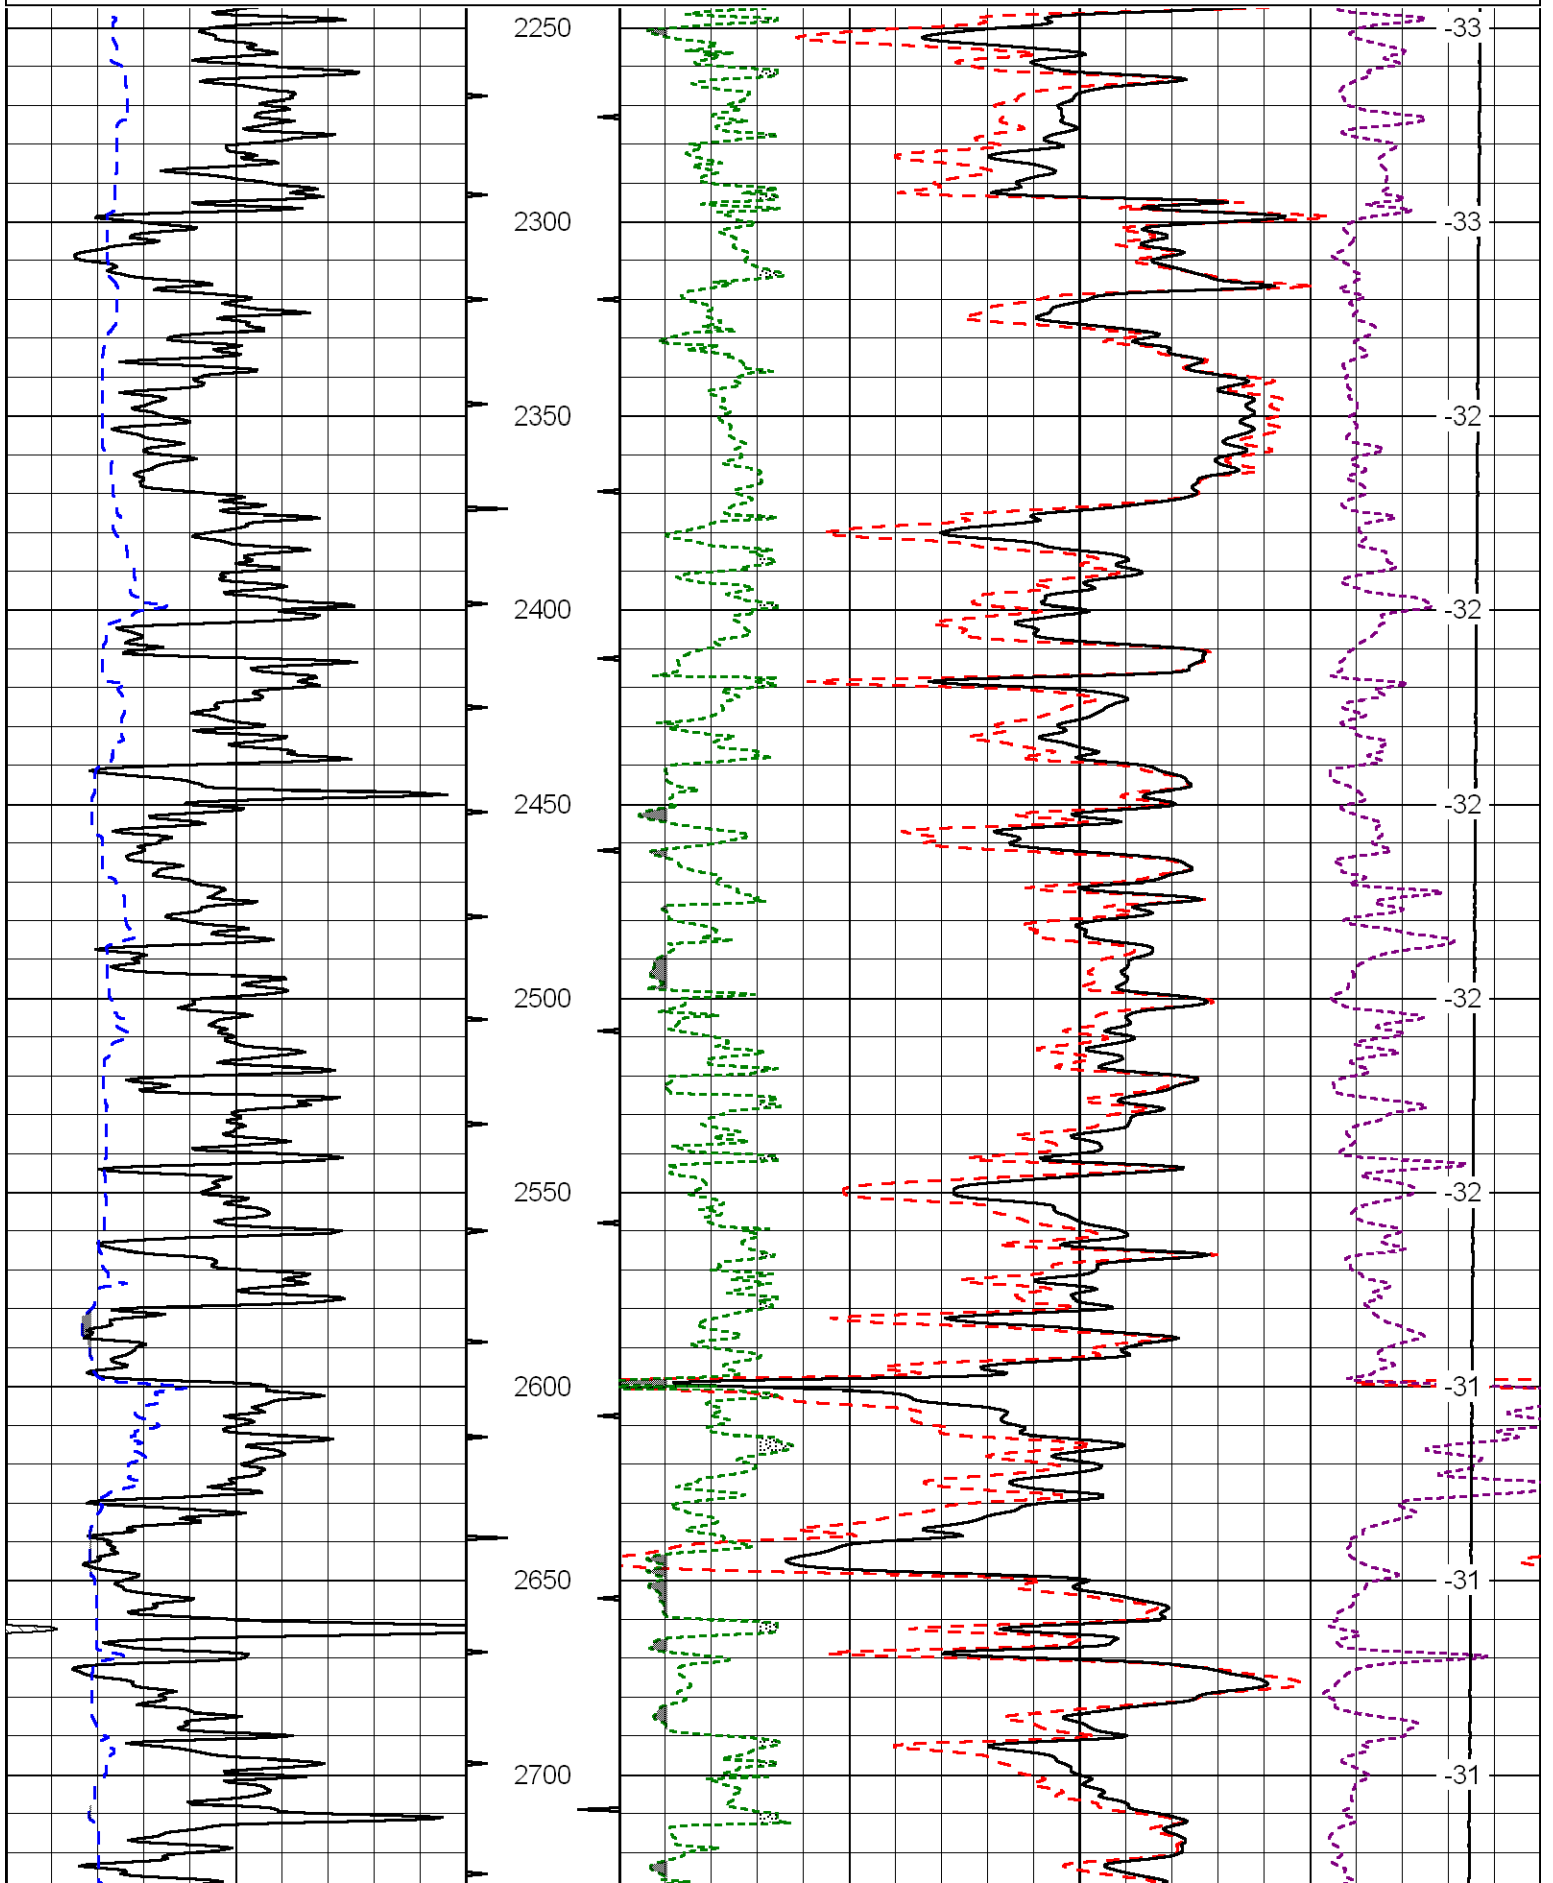
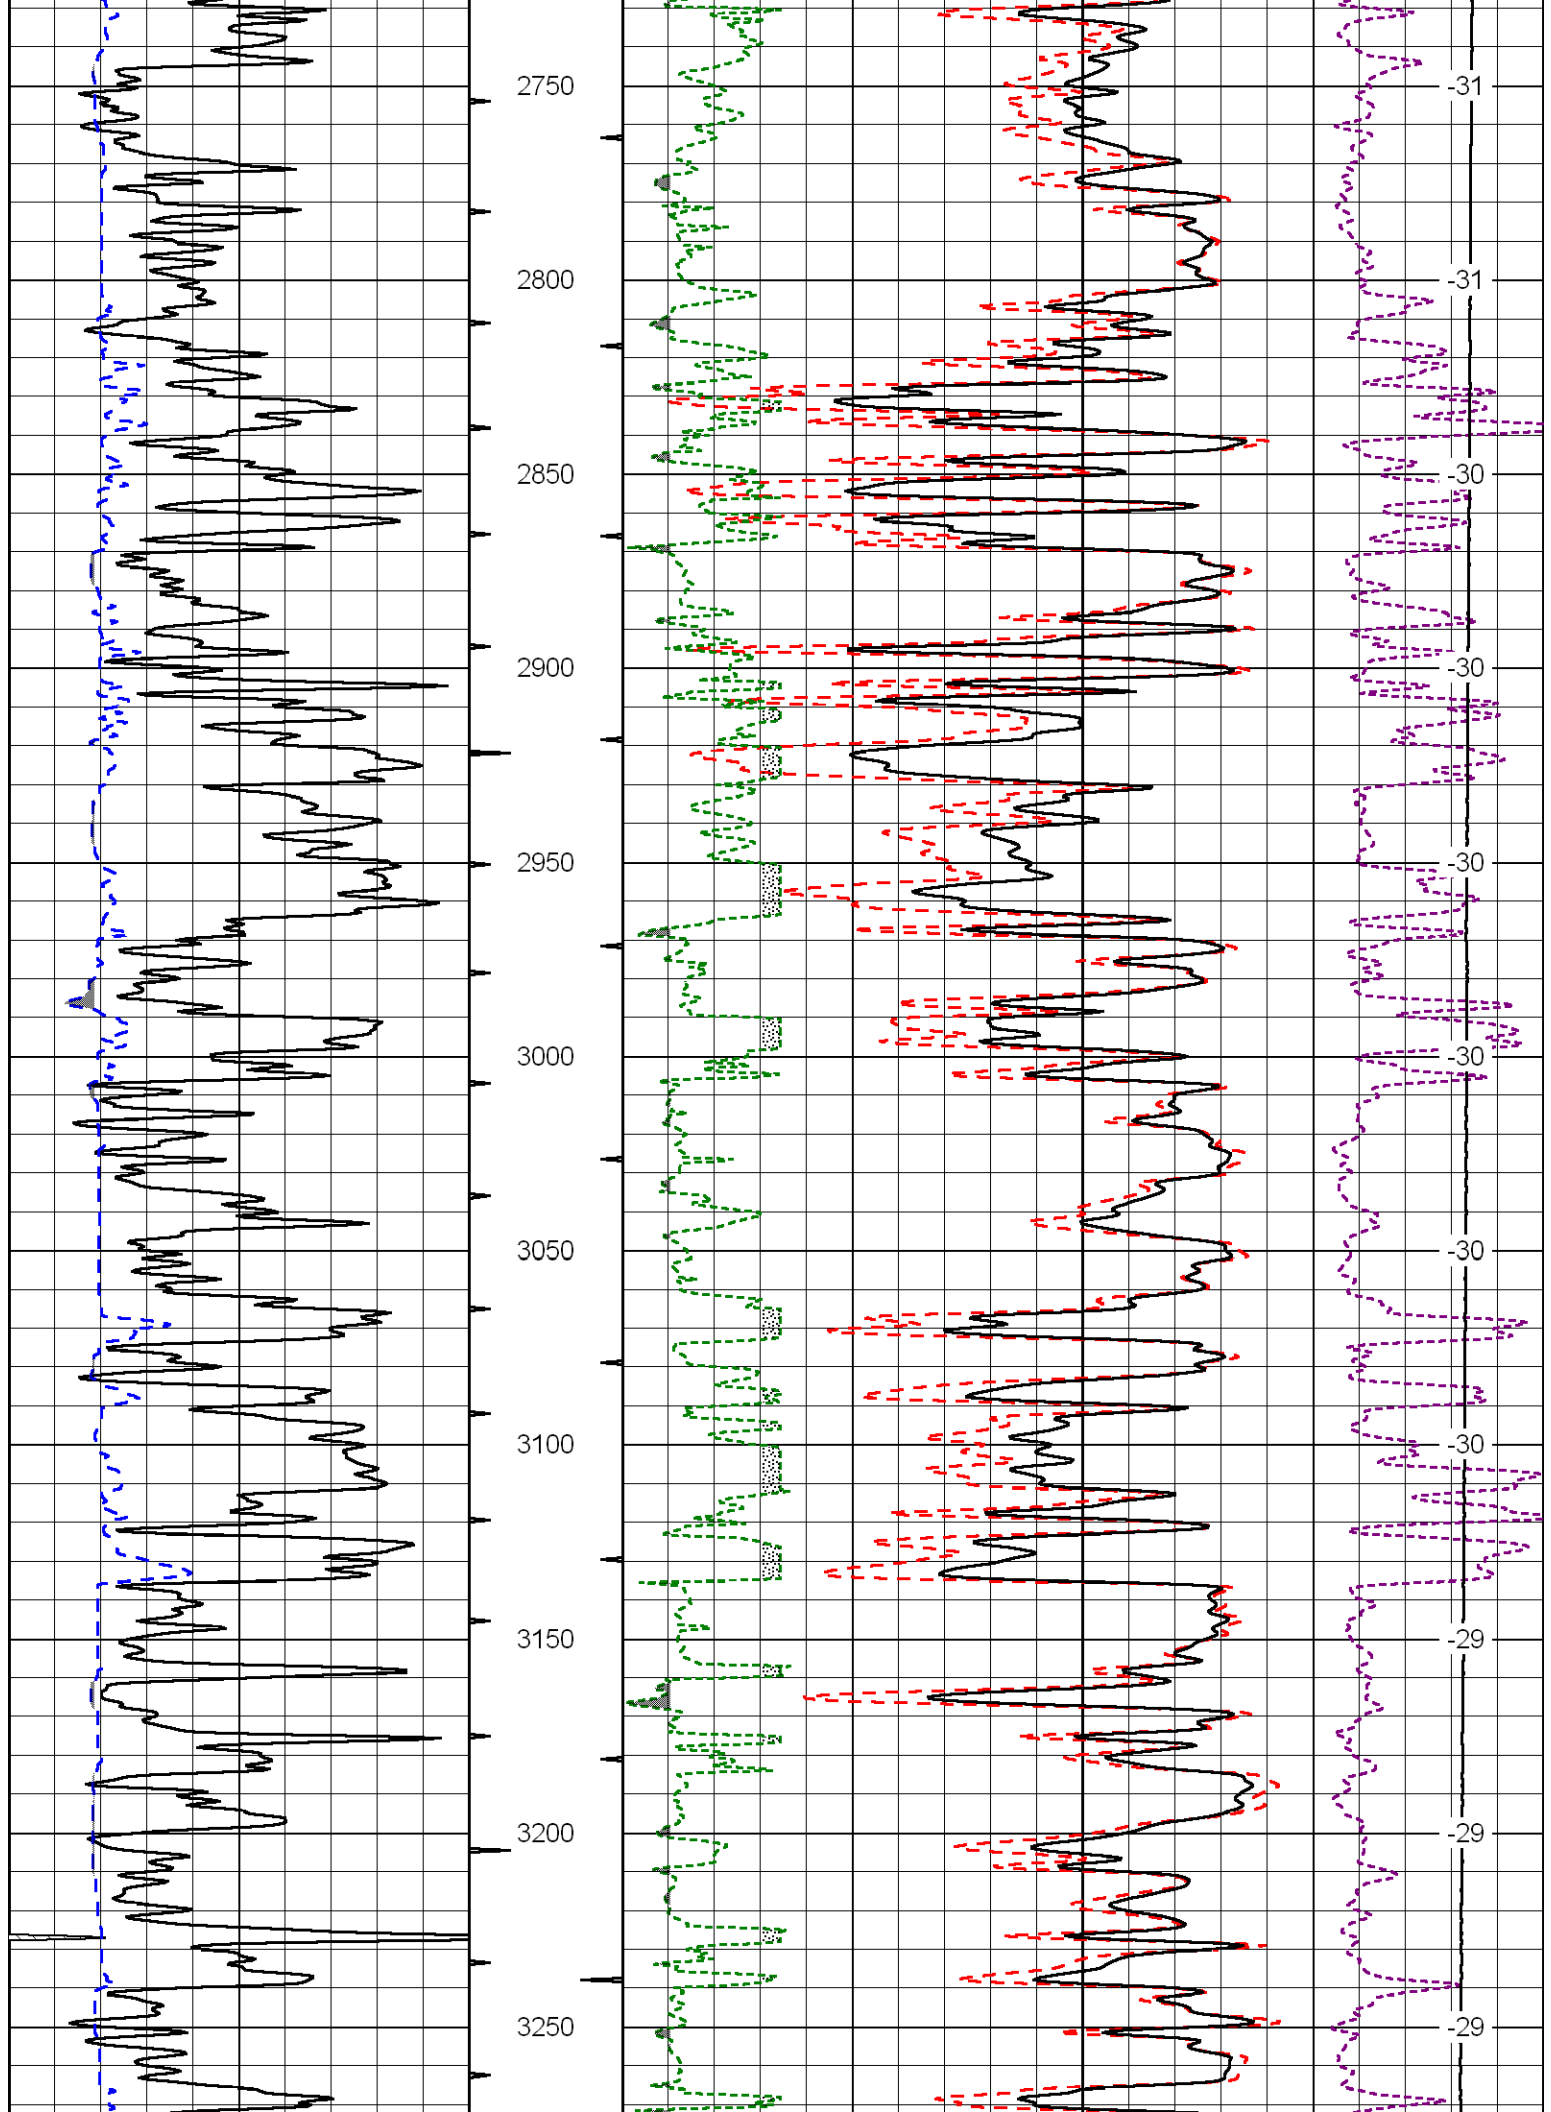
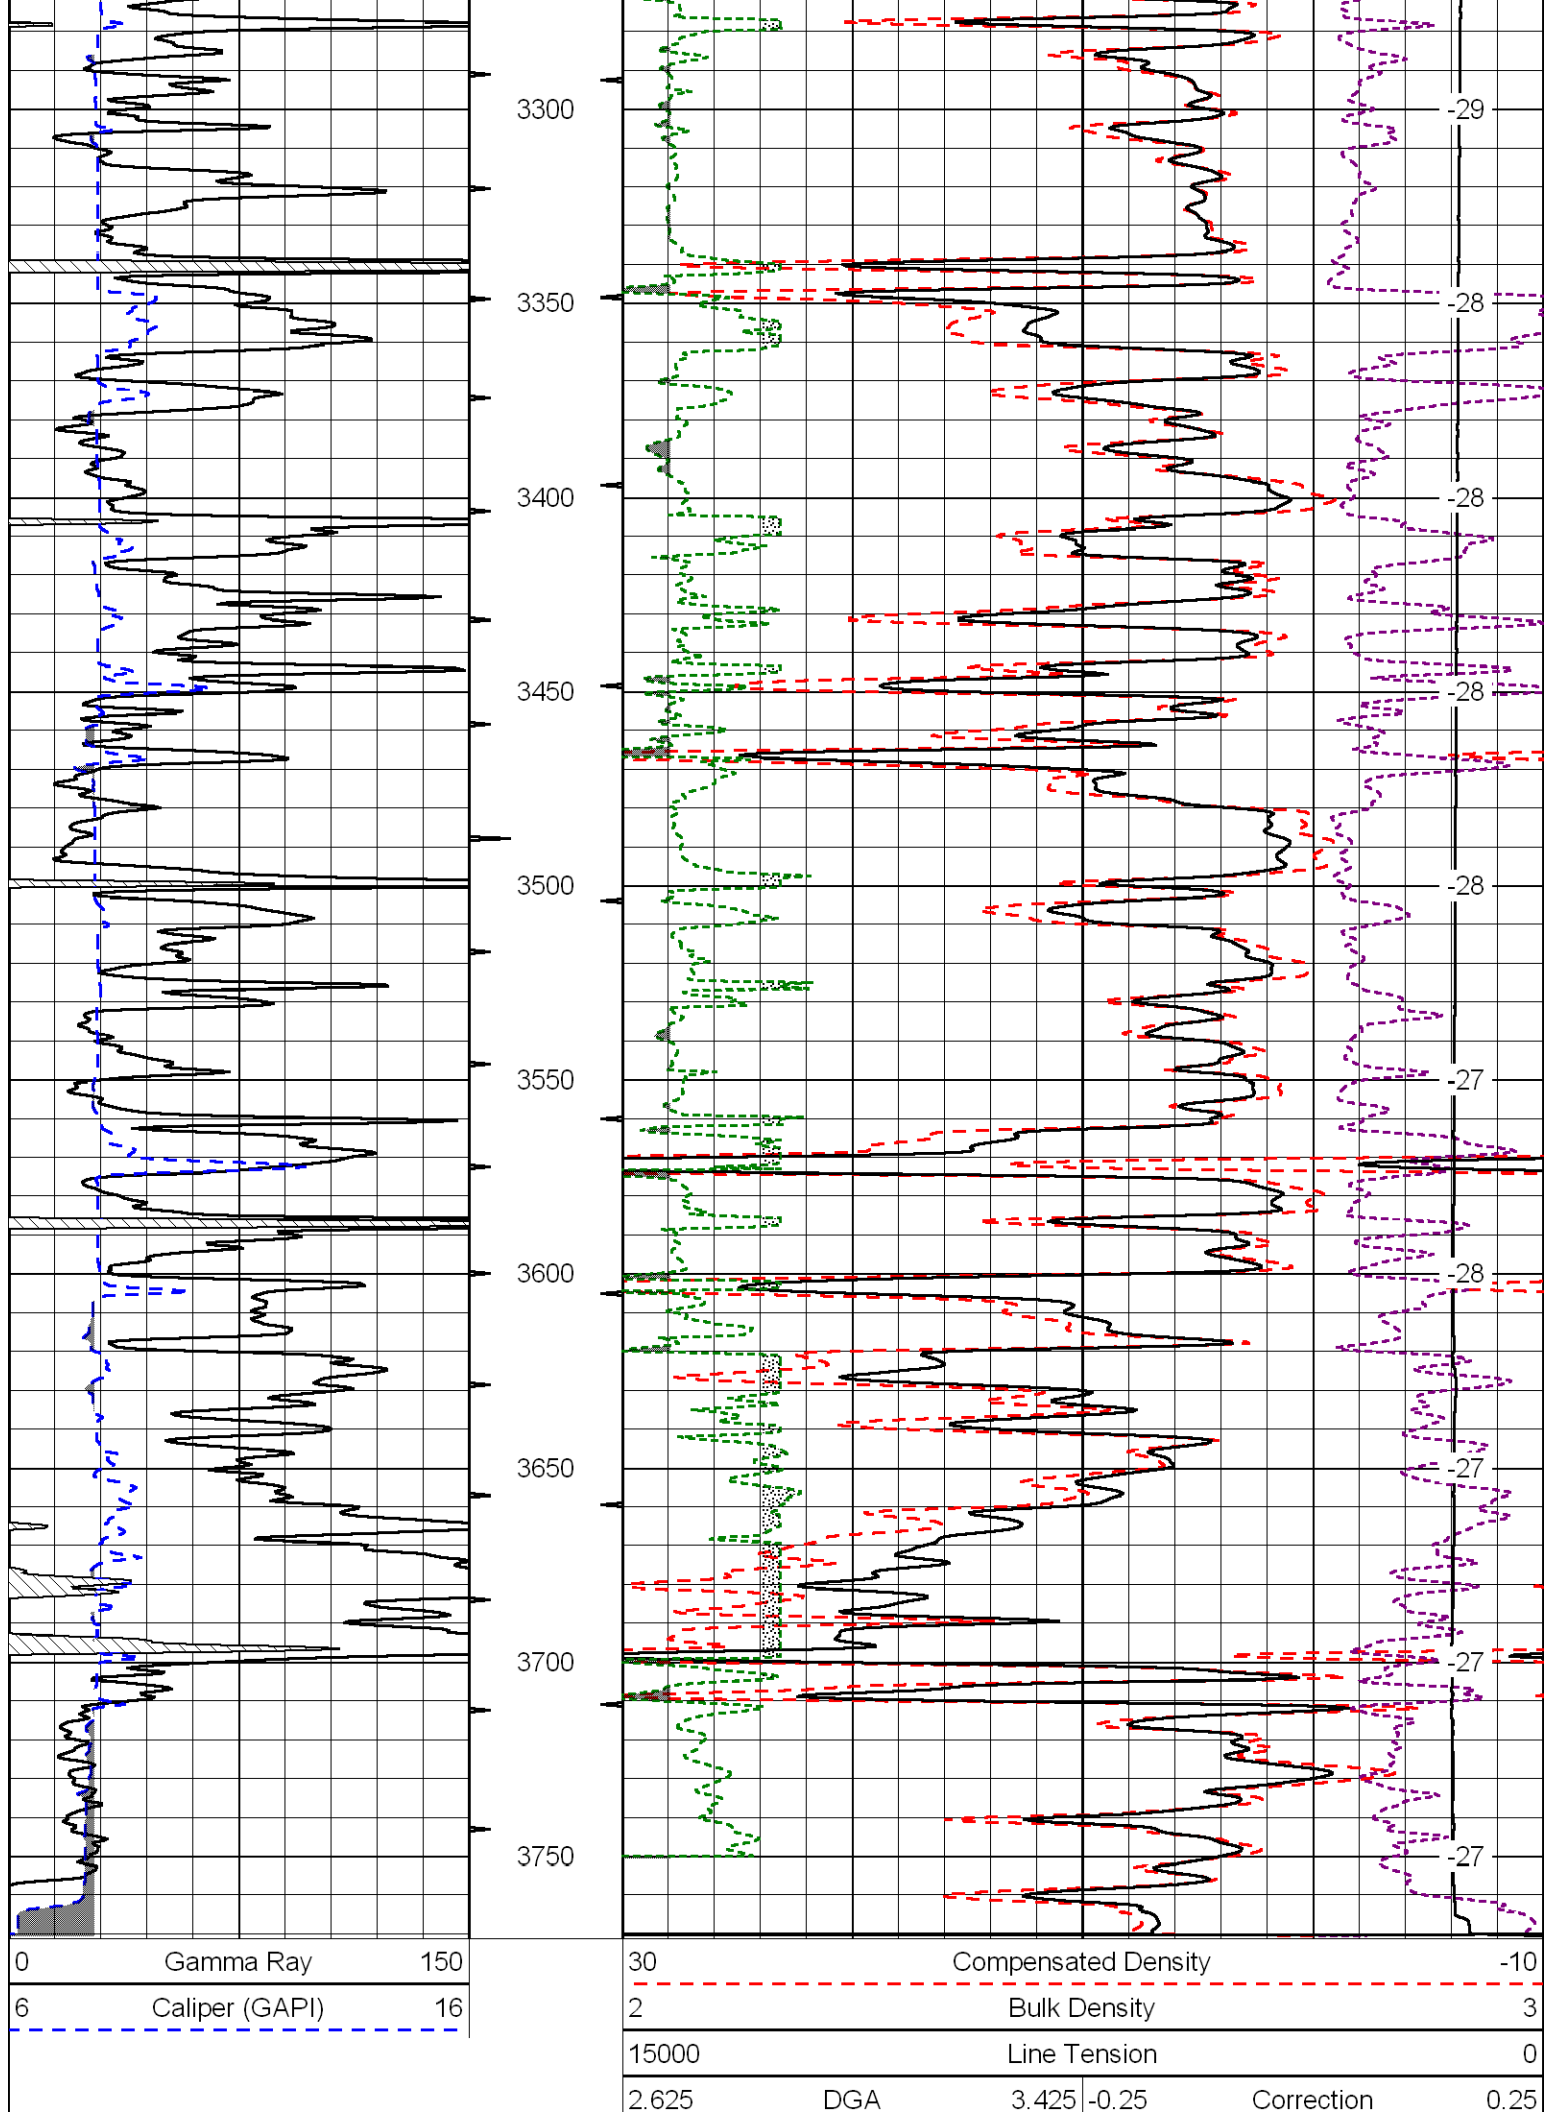
| 0 | Gamma Ray | 150 |
| 6 | Caliper (GAPI) | 16 |

| 30 | Compensated Density | | | | -10 |
| 2 | Bulk Density | | | | 3 |
| 15000 | Line Tension | | | | 0 |
| 2.625 | DGA | 3.425 | -0.25 | Correction | 0.25 |
