Pioneer Energy Services

# Dual Compensated Porosity Log

Database File: vess\_082112hd.db  
Dataset Pathname: dil/vstack  
Presentation Format: cdl  
Dataset Creation: Tue Aug 21 20:54:43 2012  
Charted by: Depth in Feet scaled 1:600

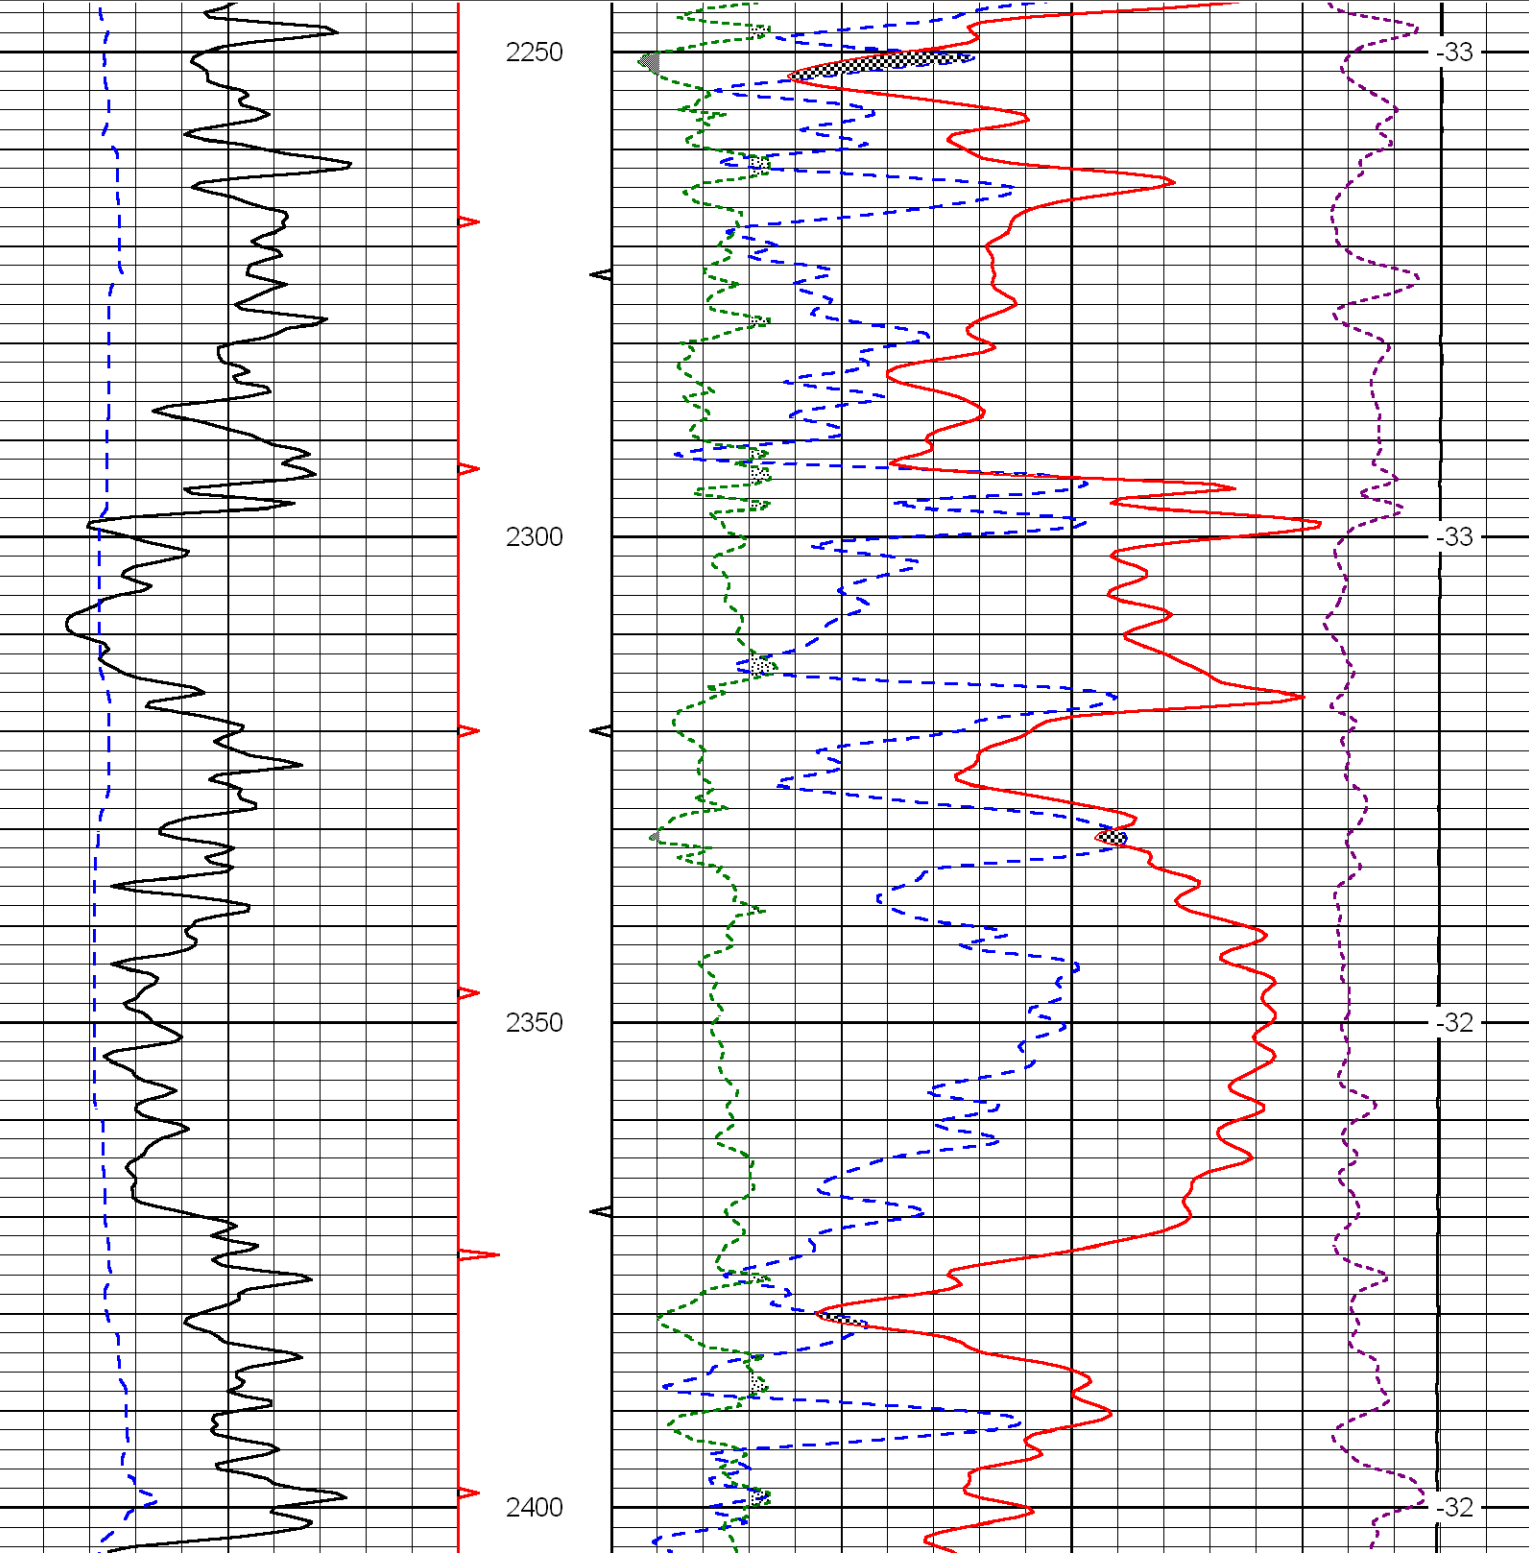
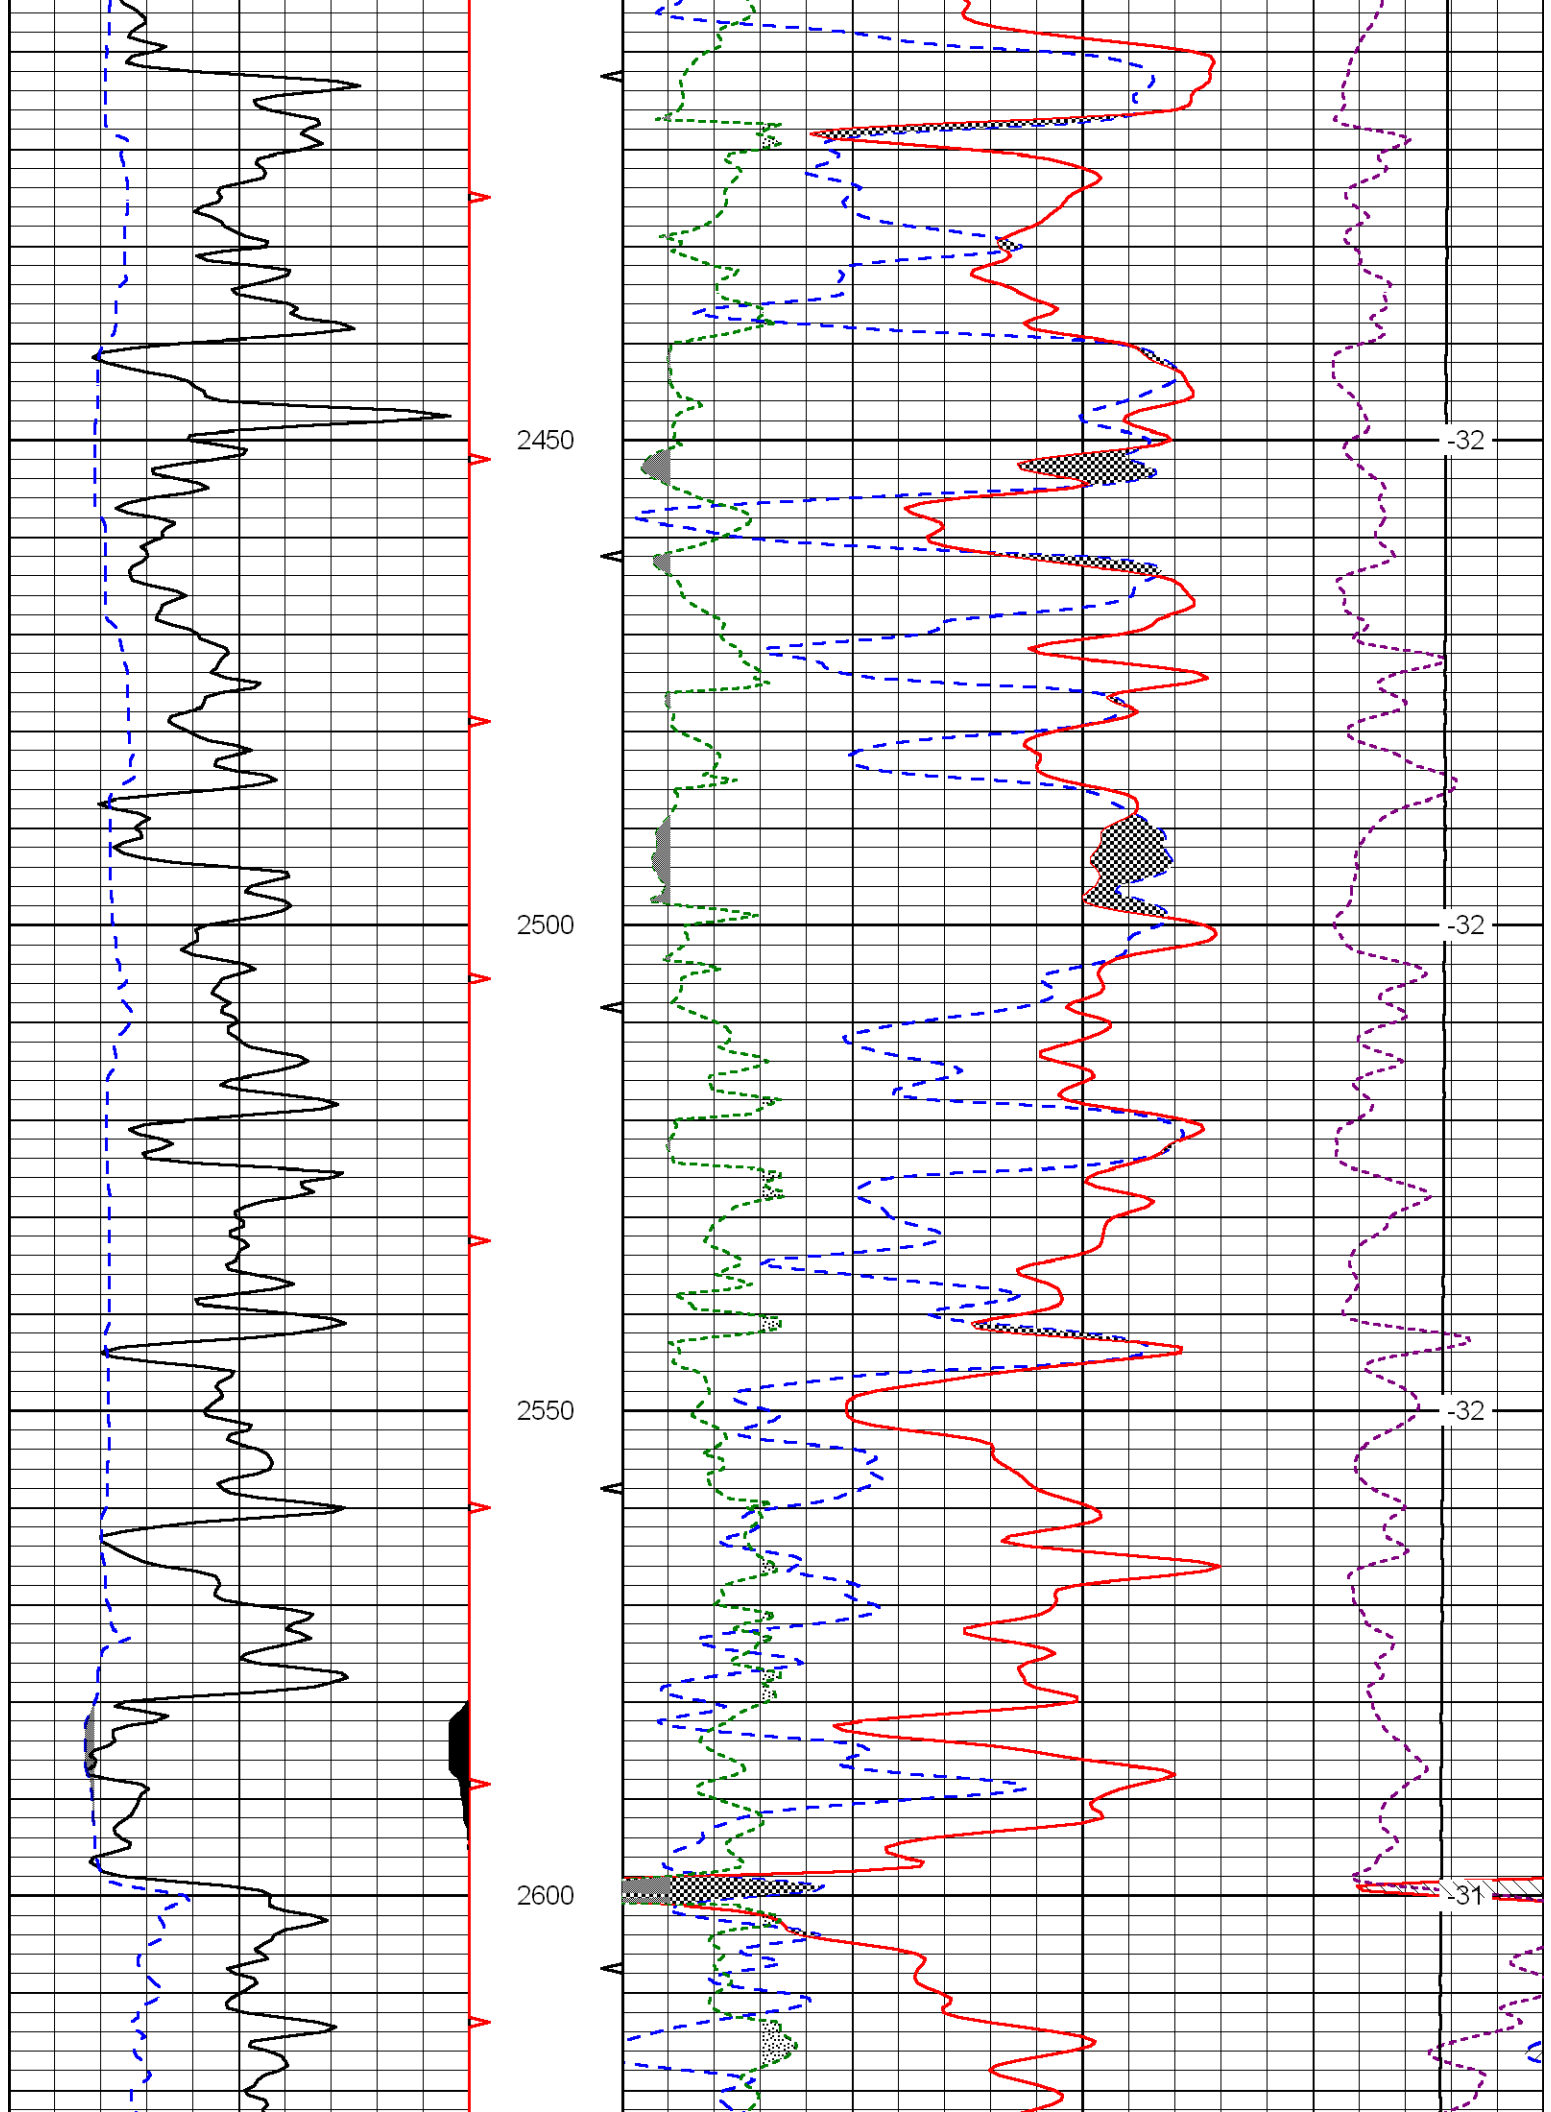
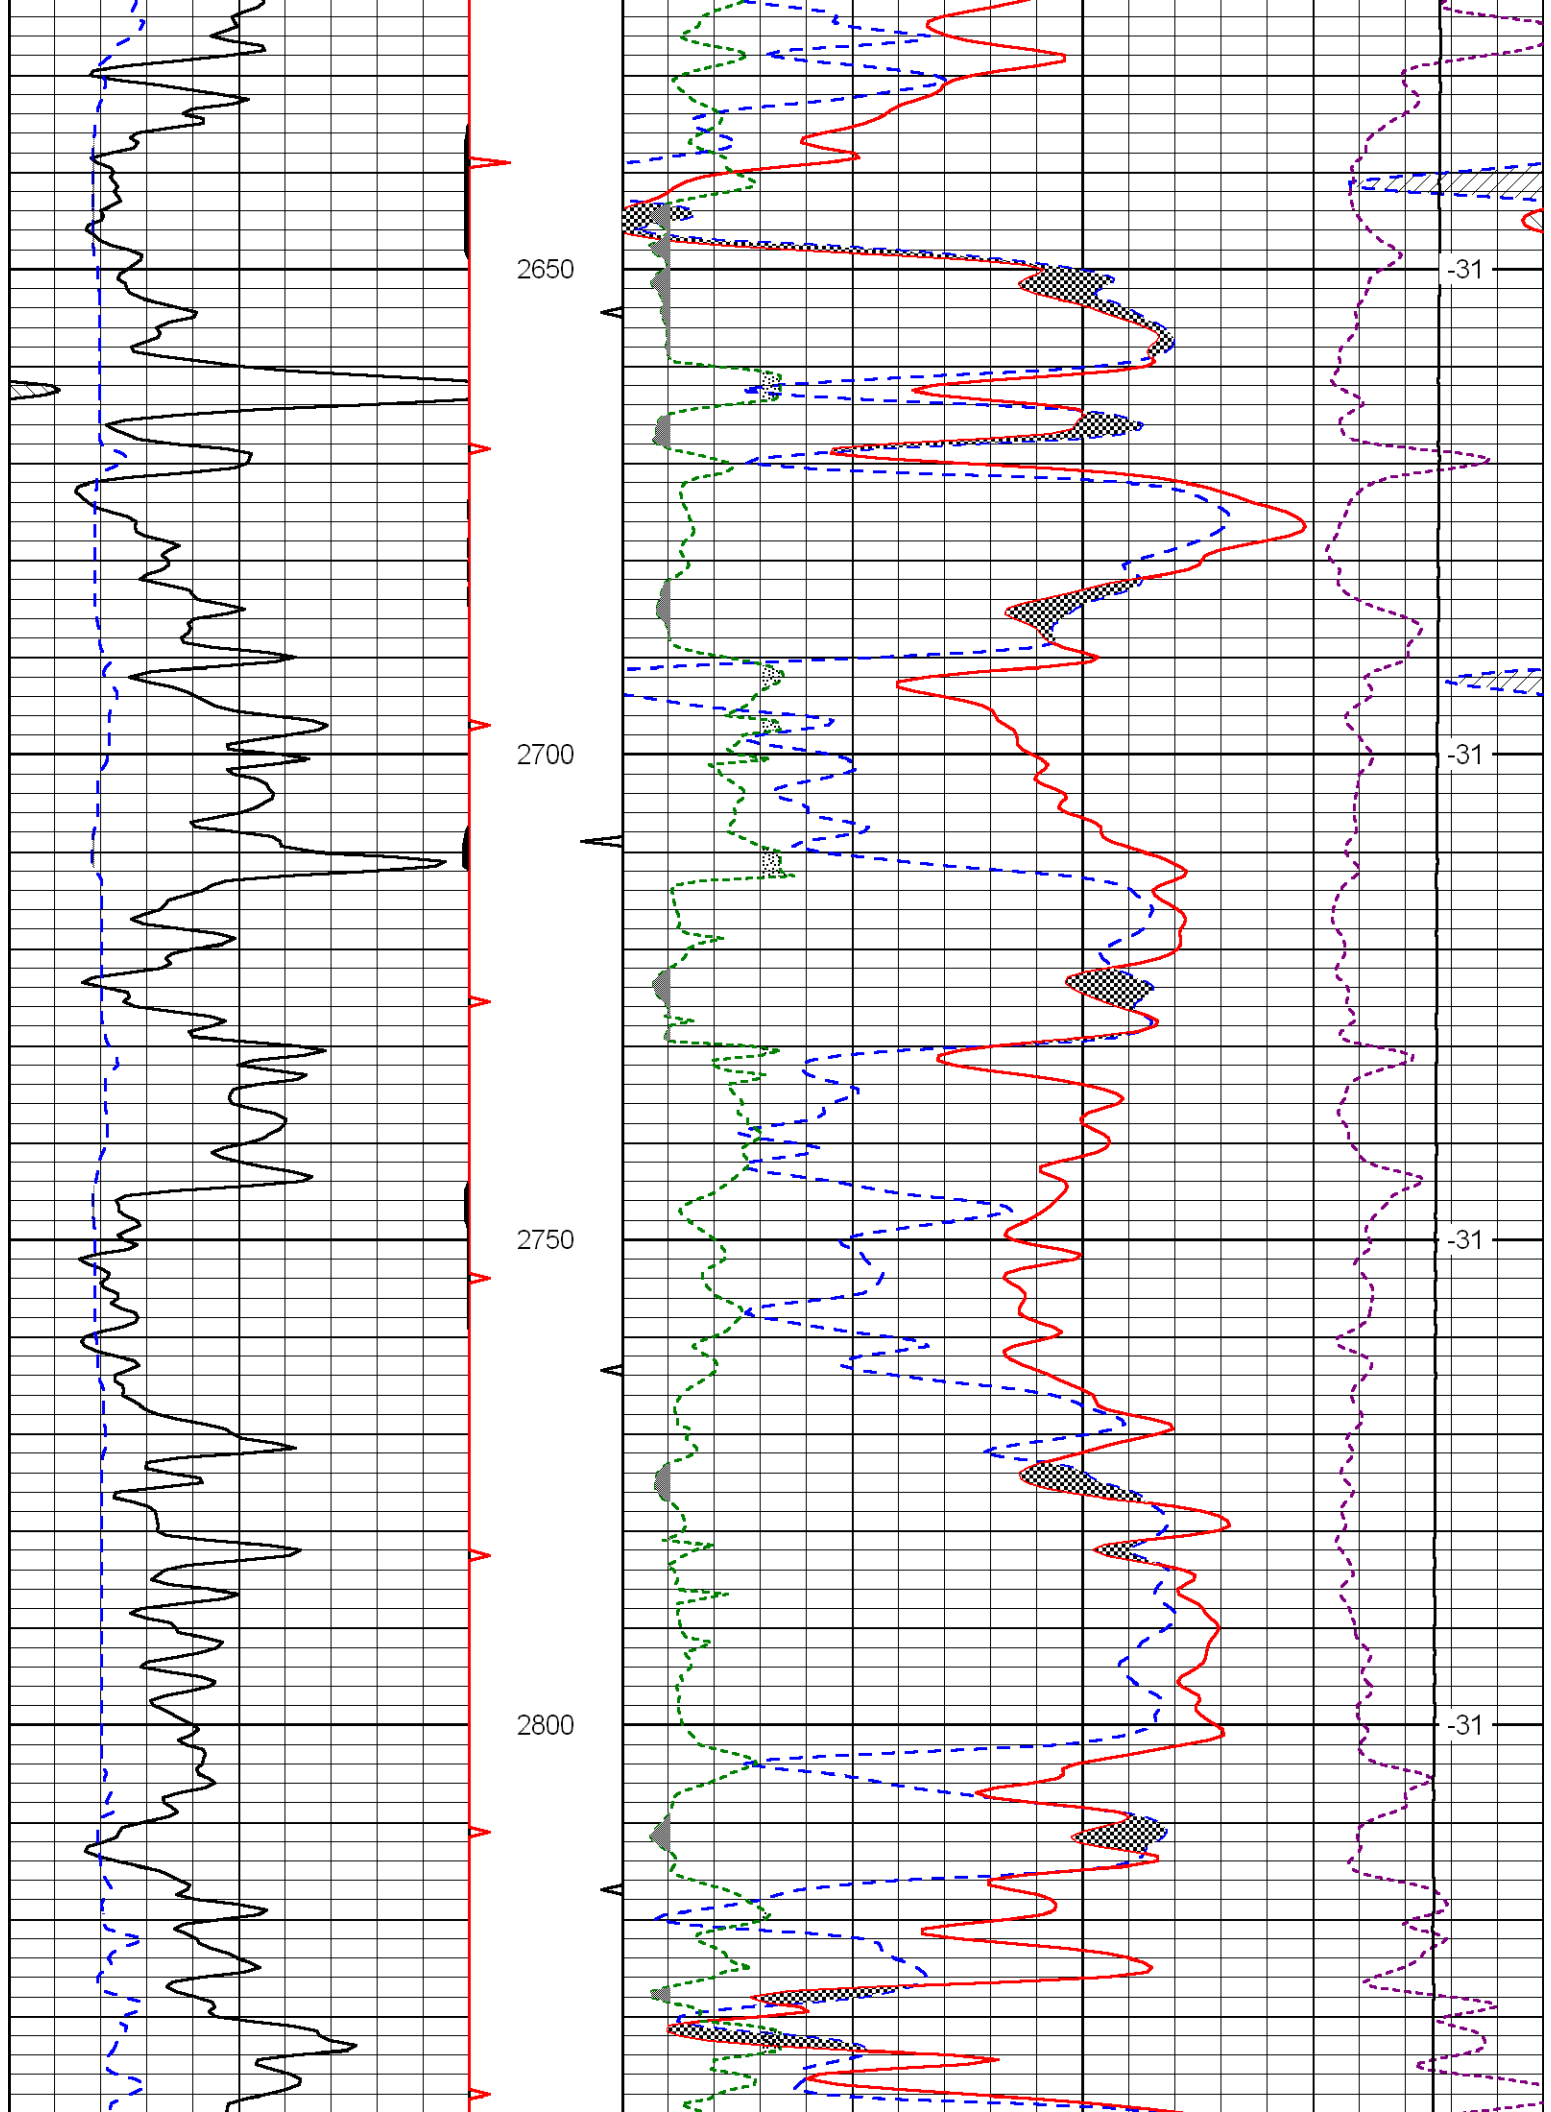
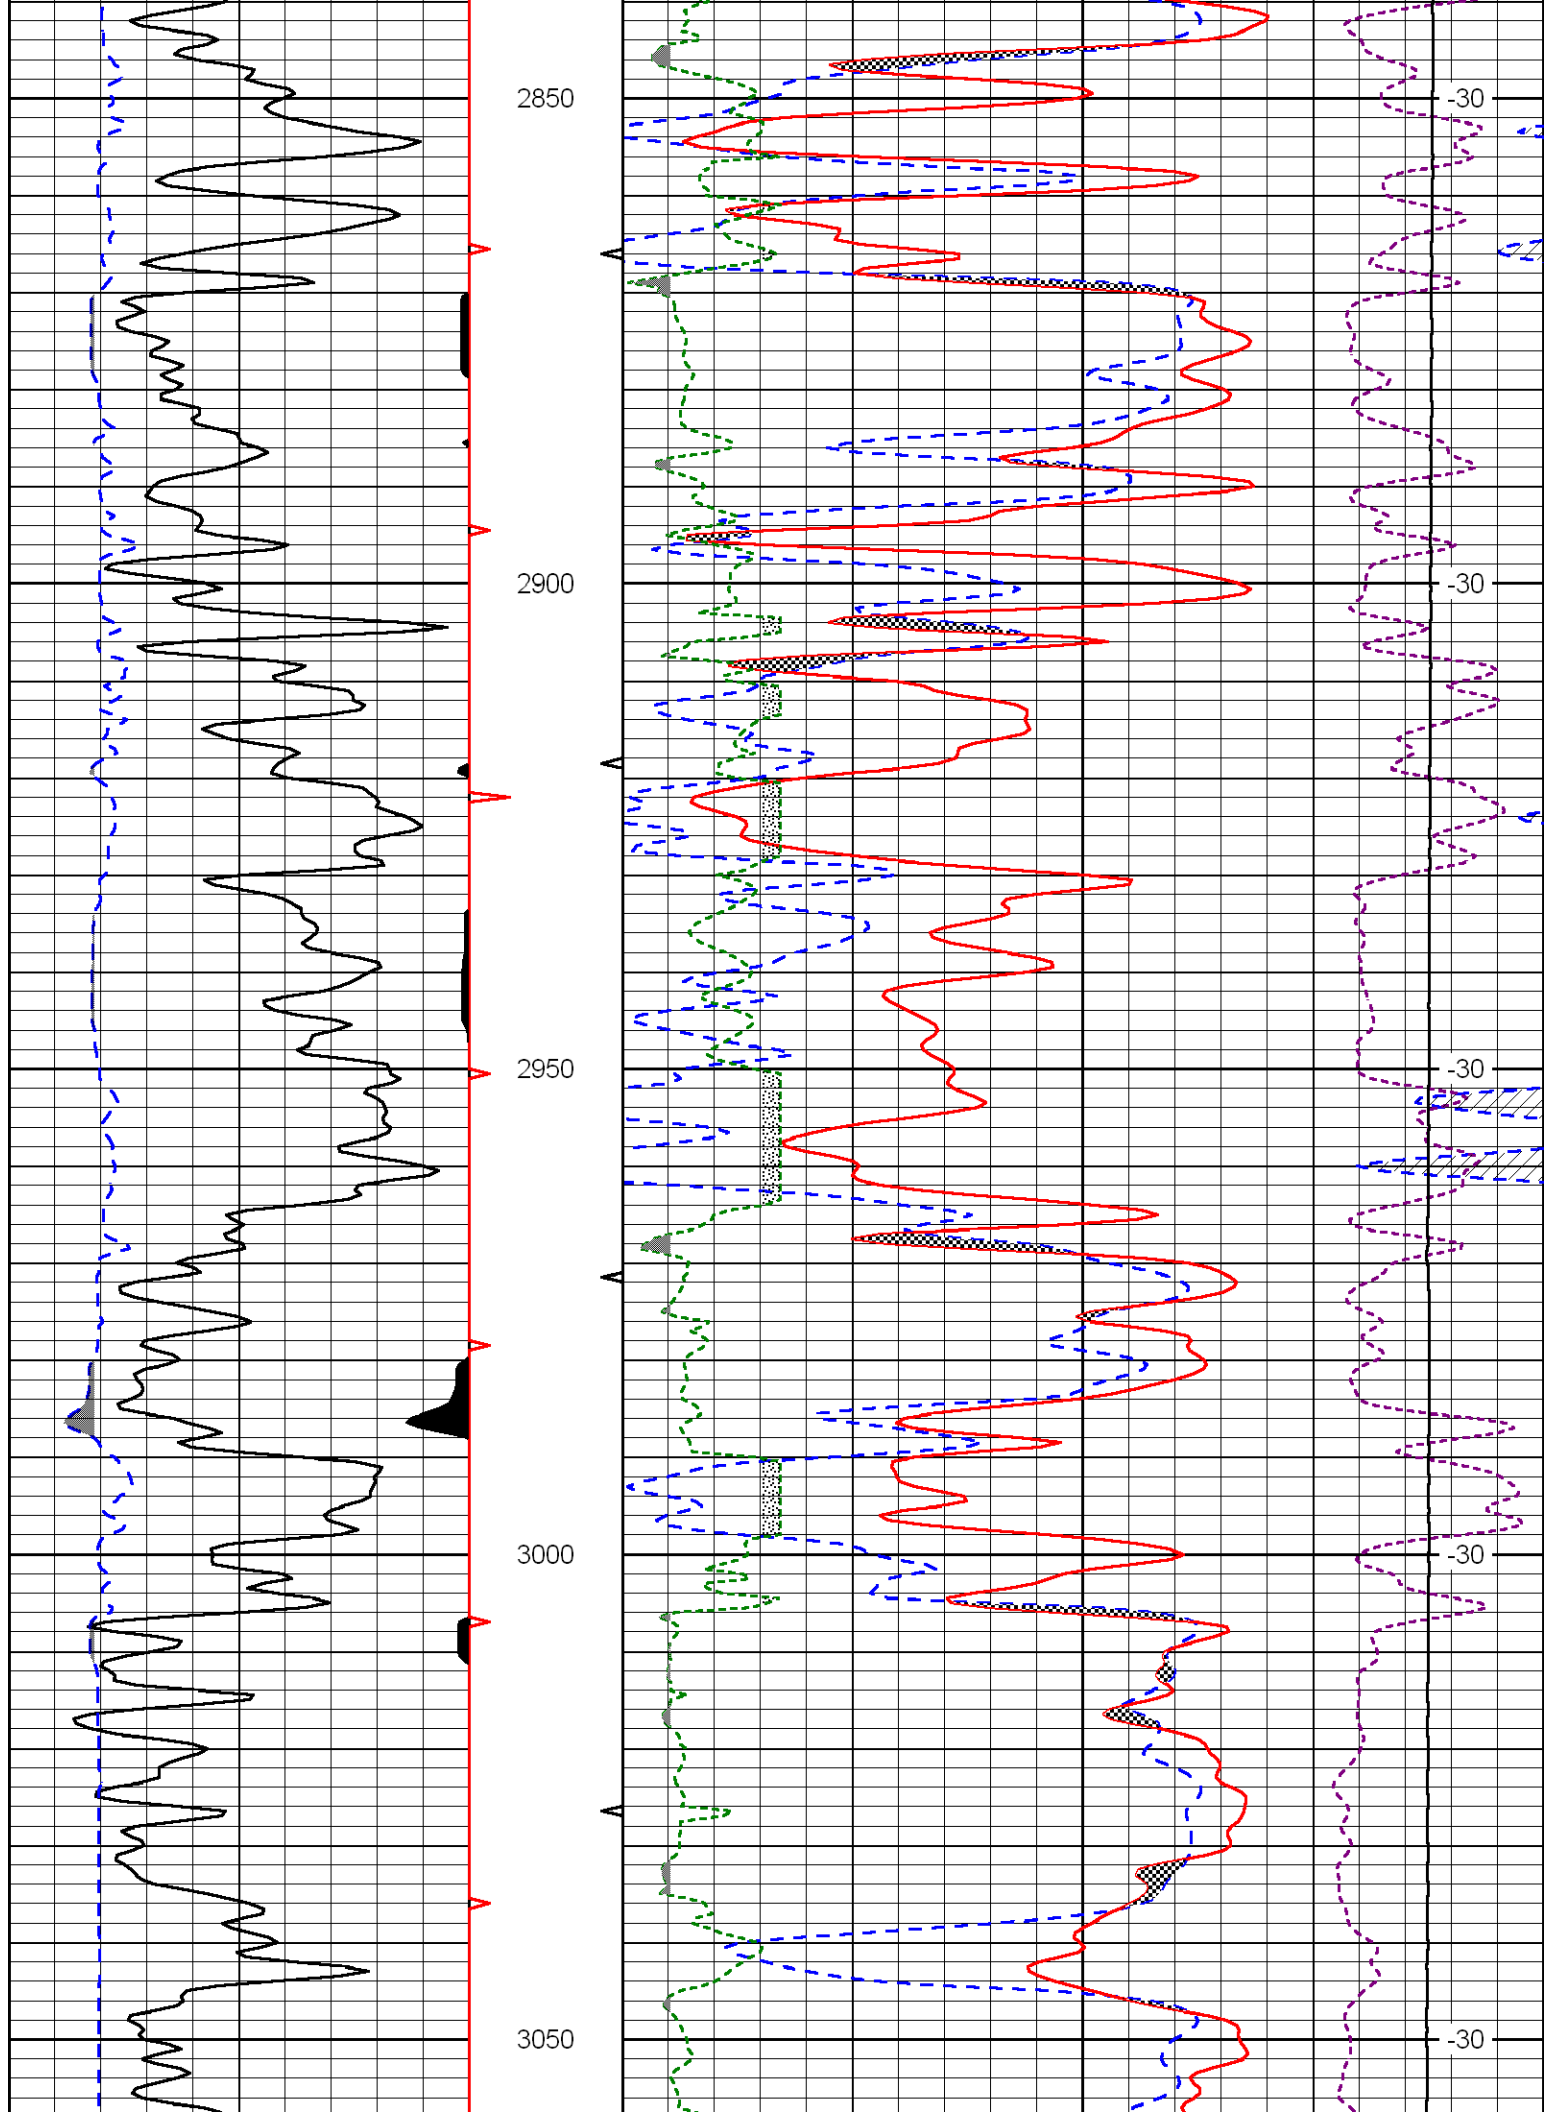
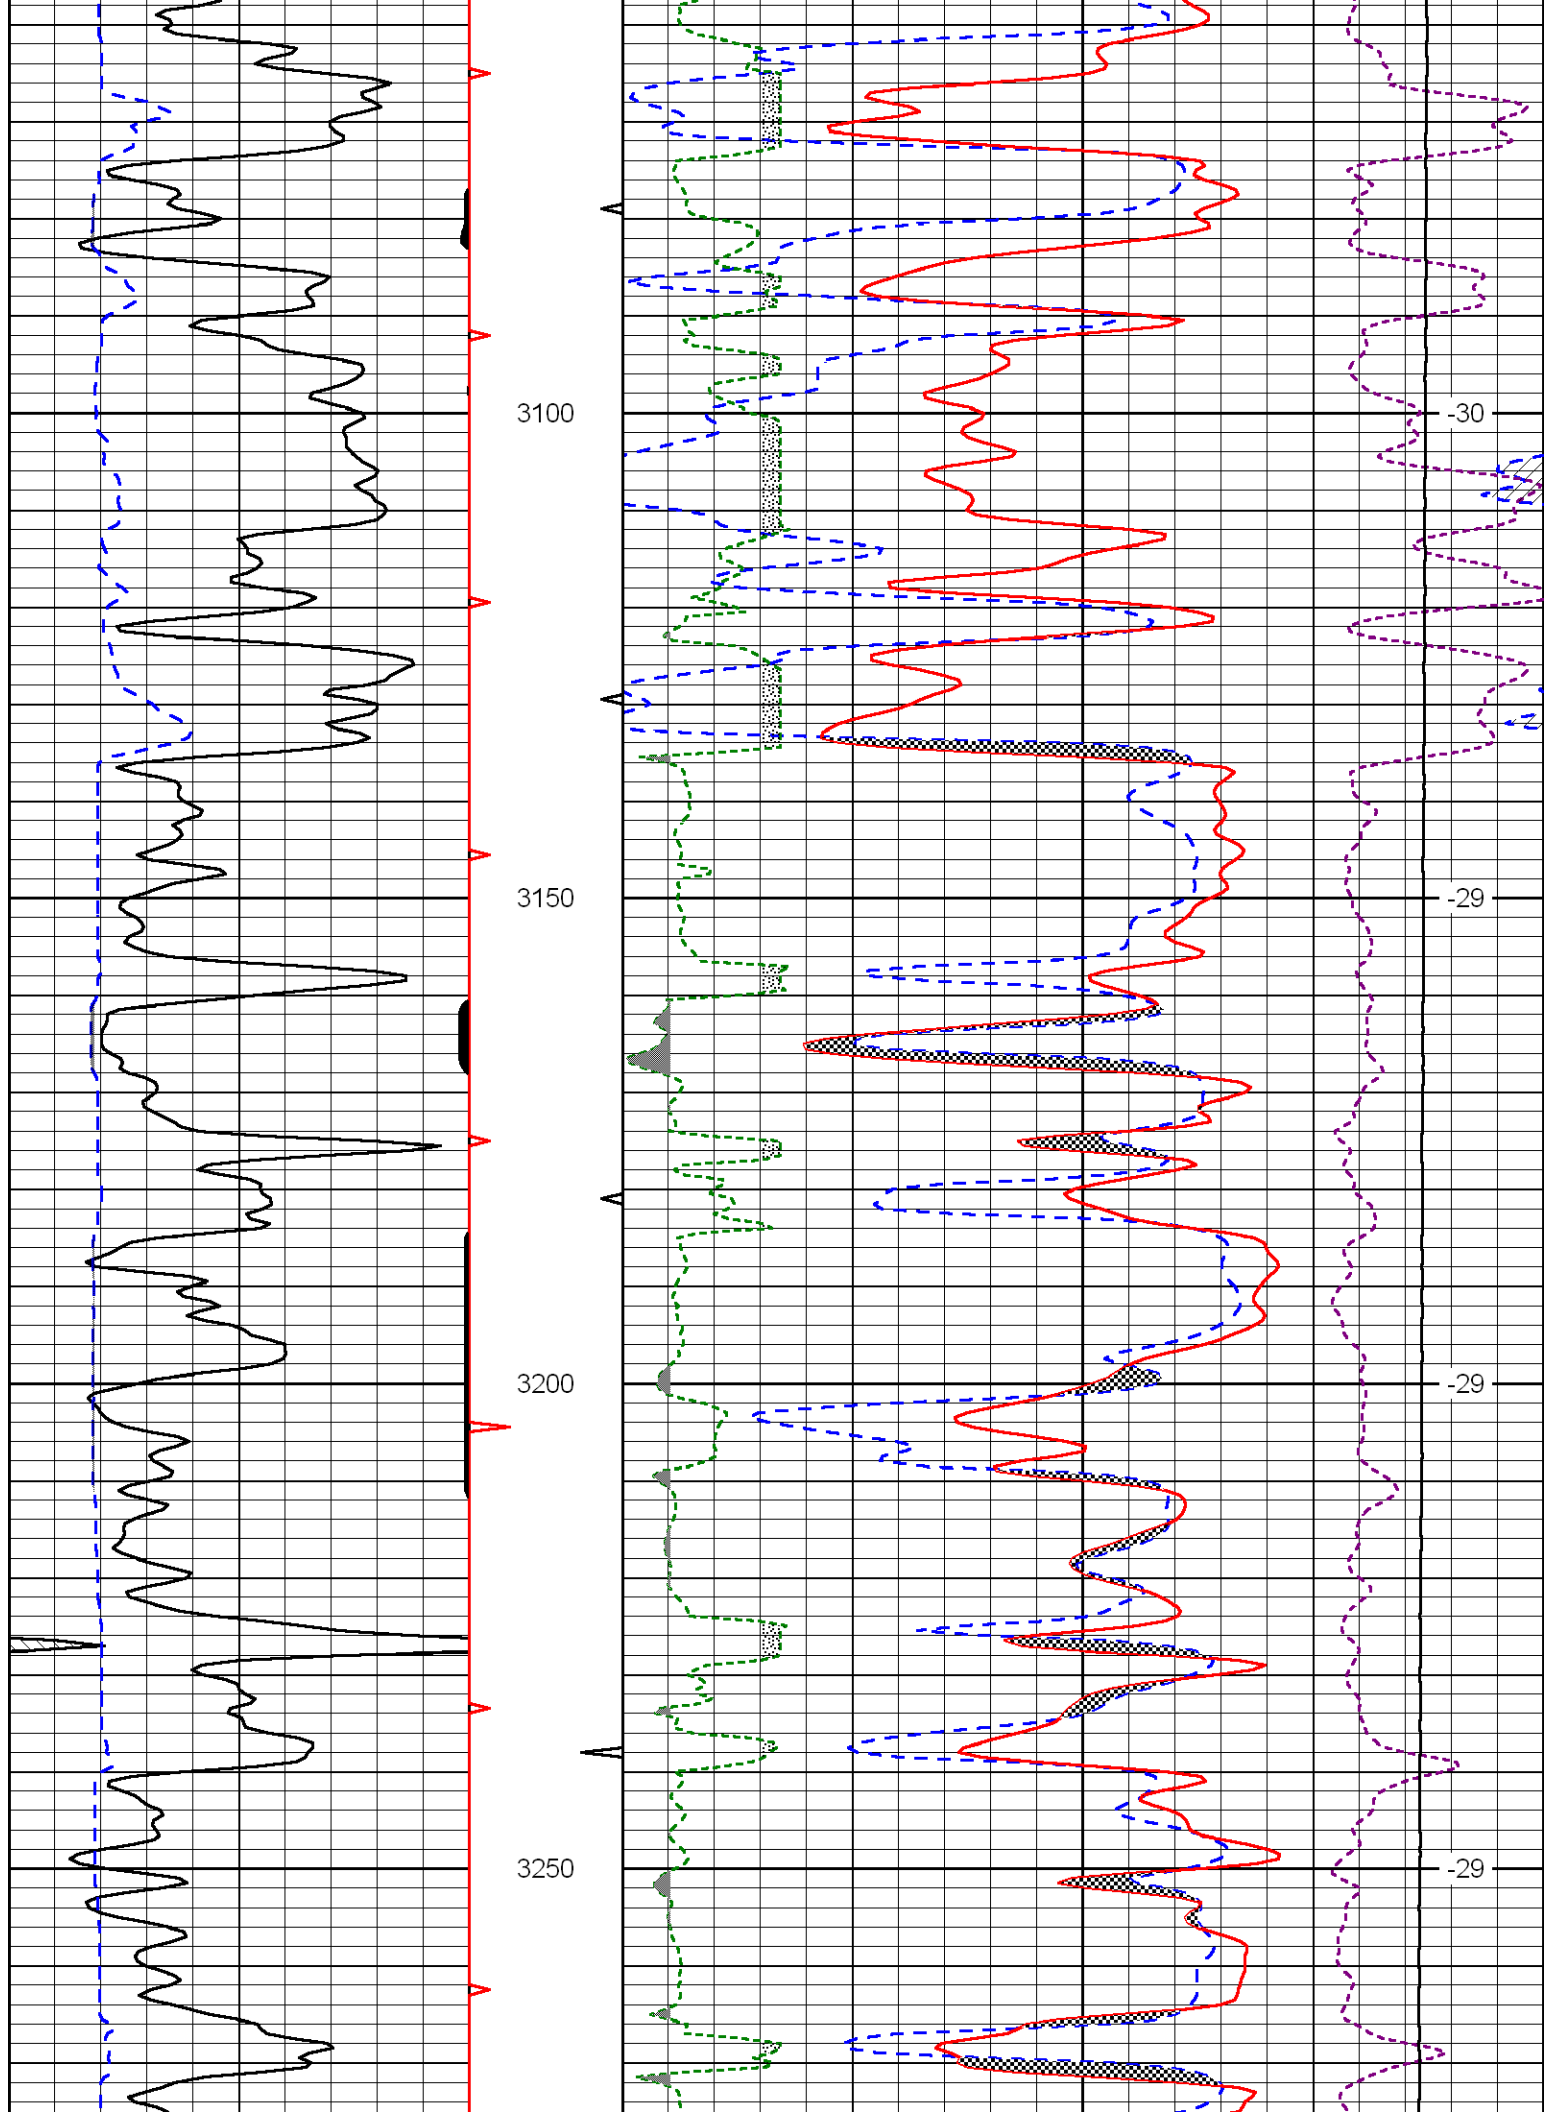
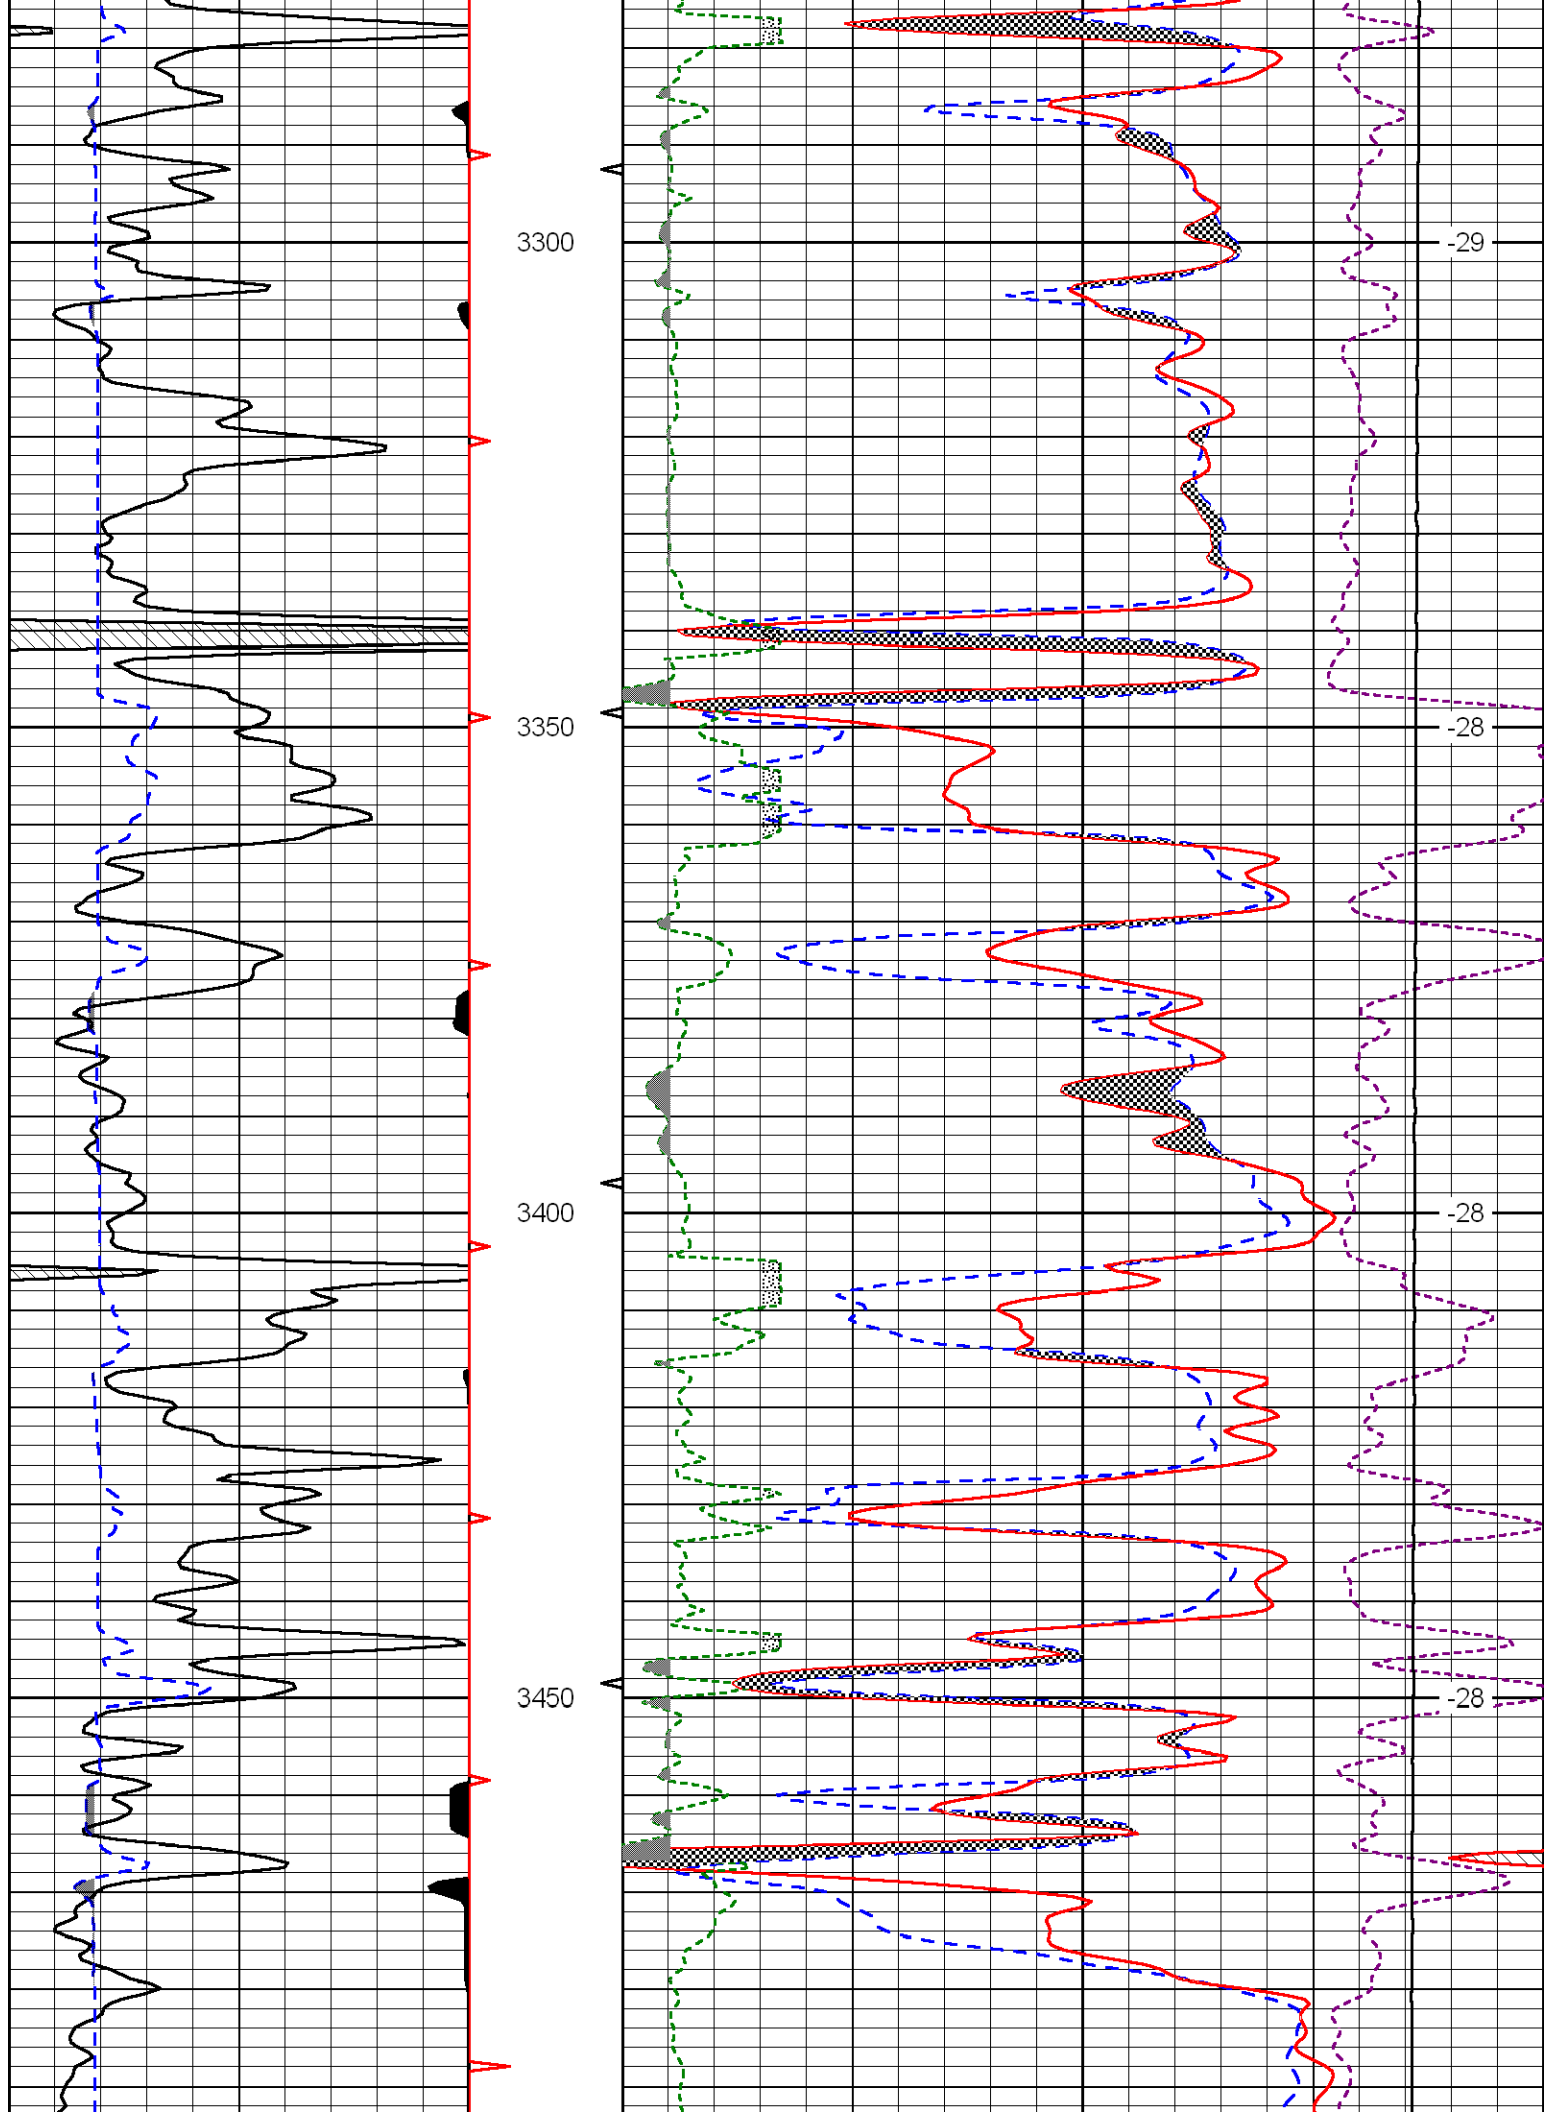
Depth in Feet scaled 1:240

| 0 | Gamma Ray | 150 | 30 | CNLS | | | -10 | |
| 6 | Caliper (GAPI) | 16 | 30 | Compensated Density (2.71 ma) | | | -10 | |
| | | | 2.625 | DGA | 3.425 | -0.25 | Correction | 0.25 |
| | | | 10000 | Line Tension | | | | 0 |
