## Pioneer Energy Services

# Dual Compensated Porosity Log

Database File: c:\warrior\data\c g oil\_s&j # 1\cgoil\_s&j\_1hd.db  
Dataset Pathname: dil/cgstck  
Presentation Format: cdl  
Dataset Creation: Sun Jul 14 03:05:46 2013  
Charted by: Depth in Feet scaled 1:600

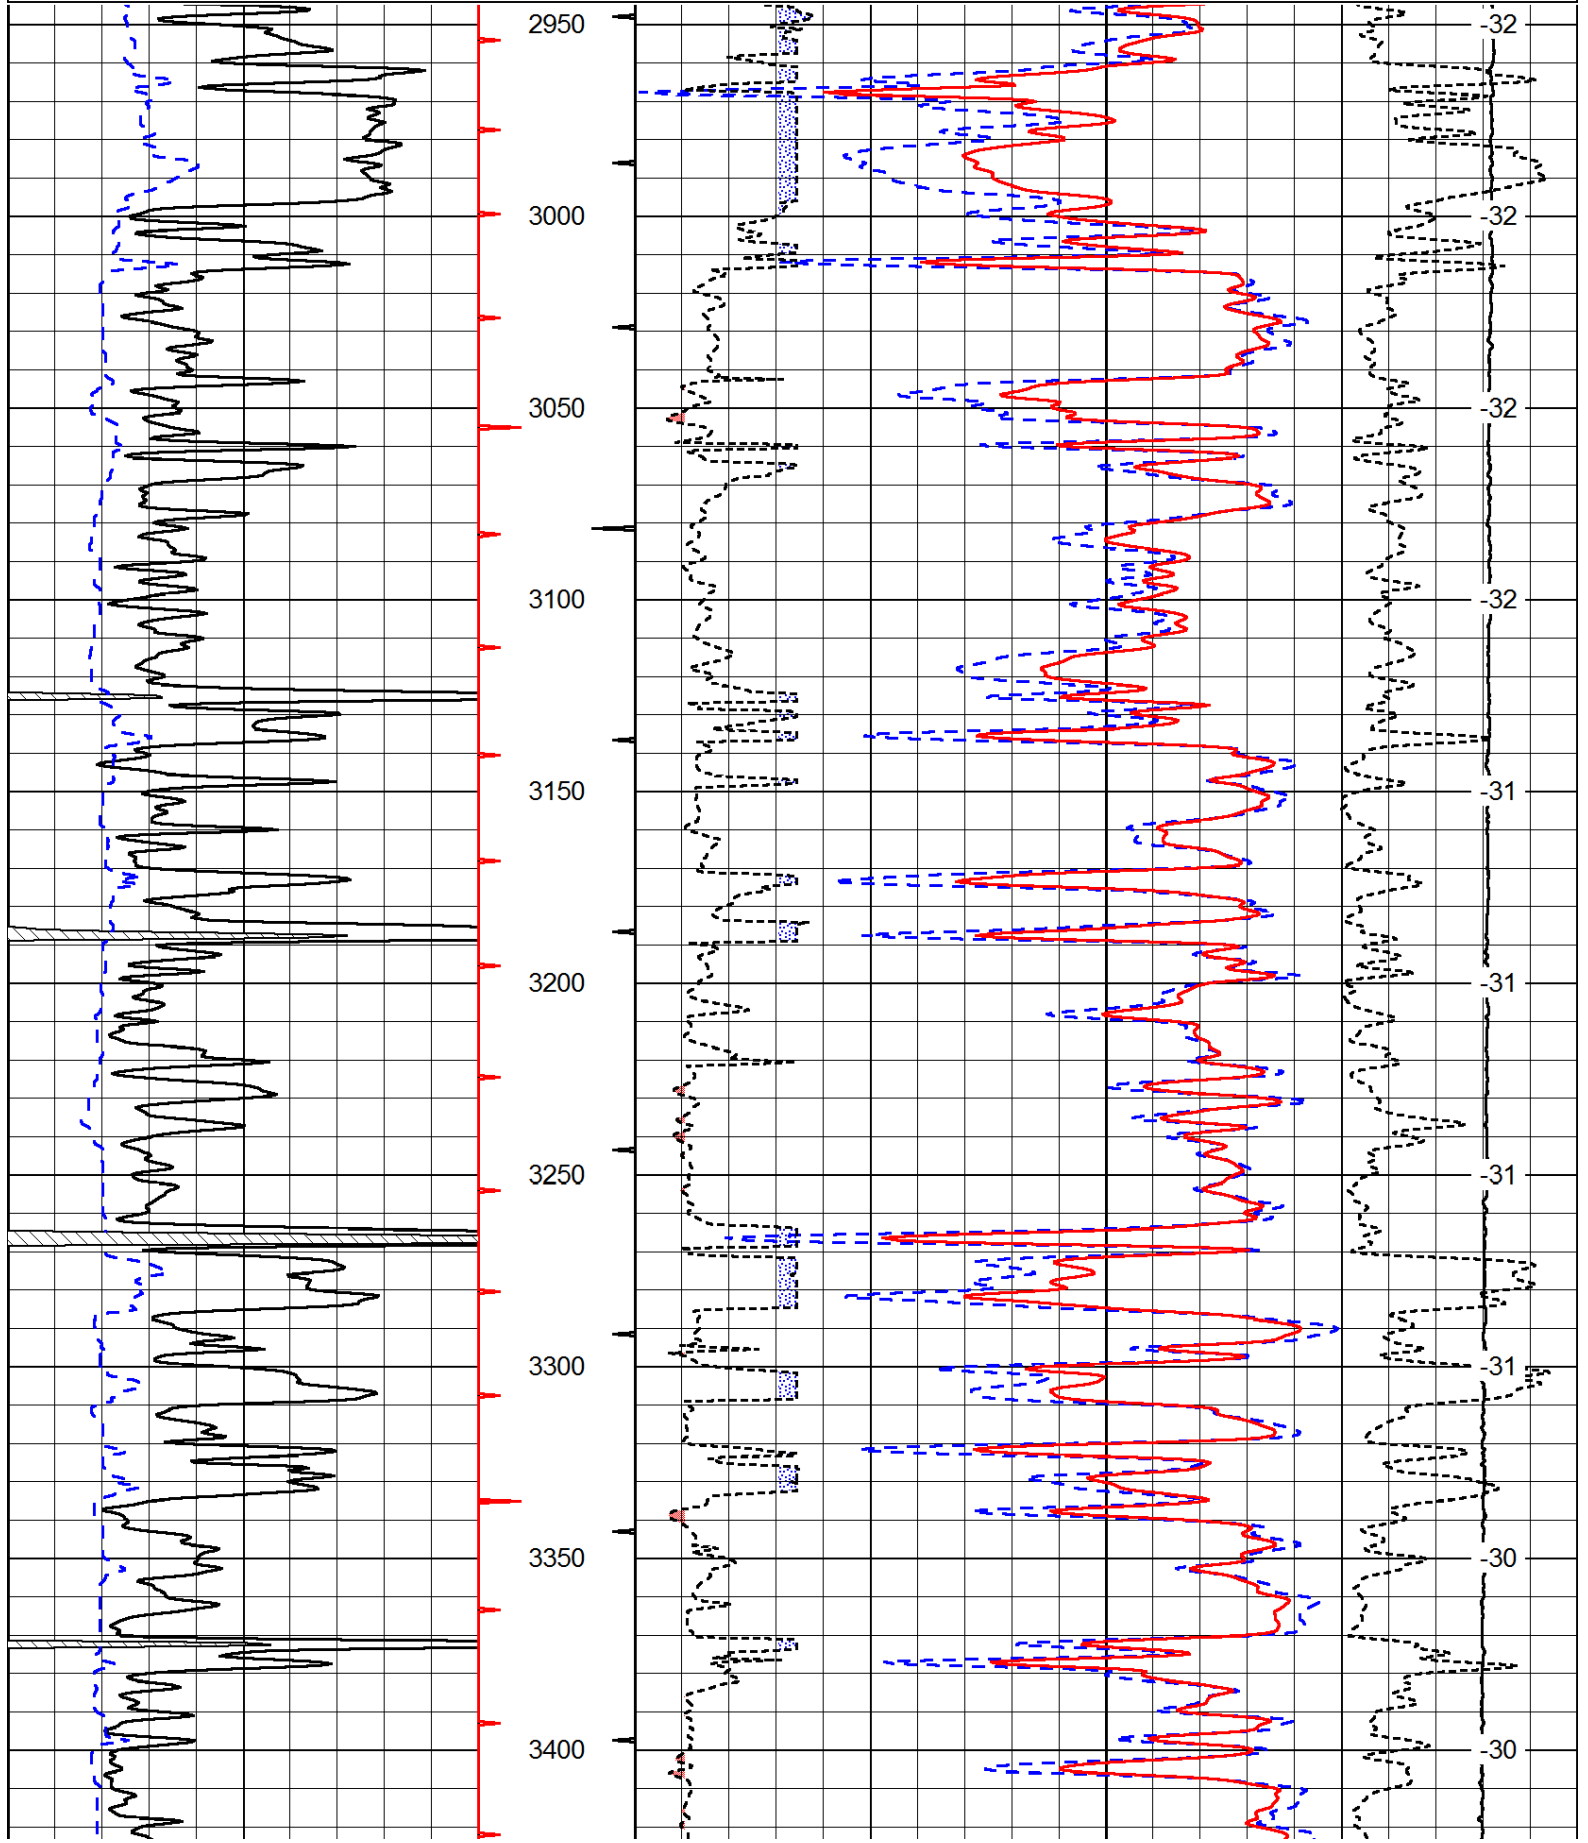
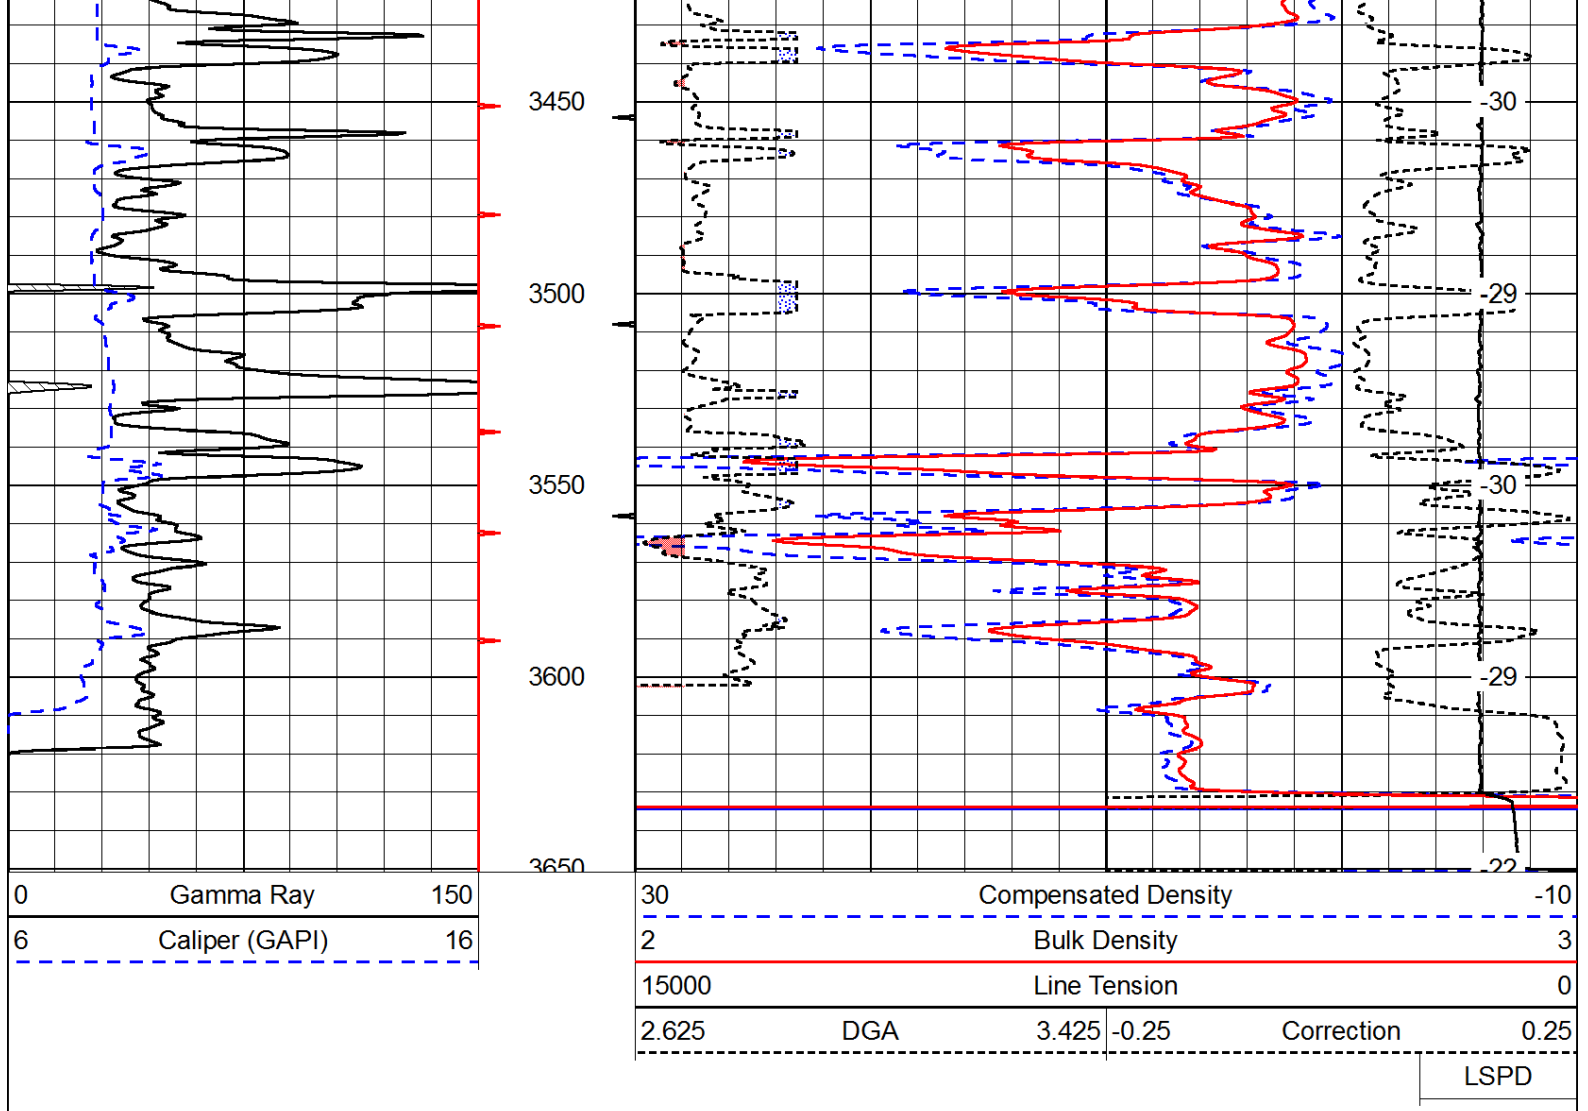
| 0 | Gamma Ray | 150 | 30 | Compensated Density | | -10 | | |
| 6 | Caliper (GAPI) | 16 | 2 | Bulk Density | | 3 | | |
| | | | 15000 | Line Tension | | 0 | | |
| | | | 2.625 | DGA | 3.425 | -0.25 | Correction | 0.25 |

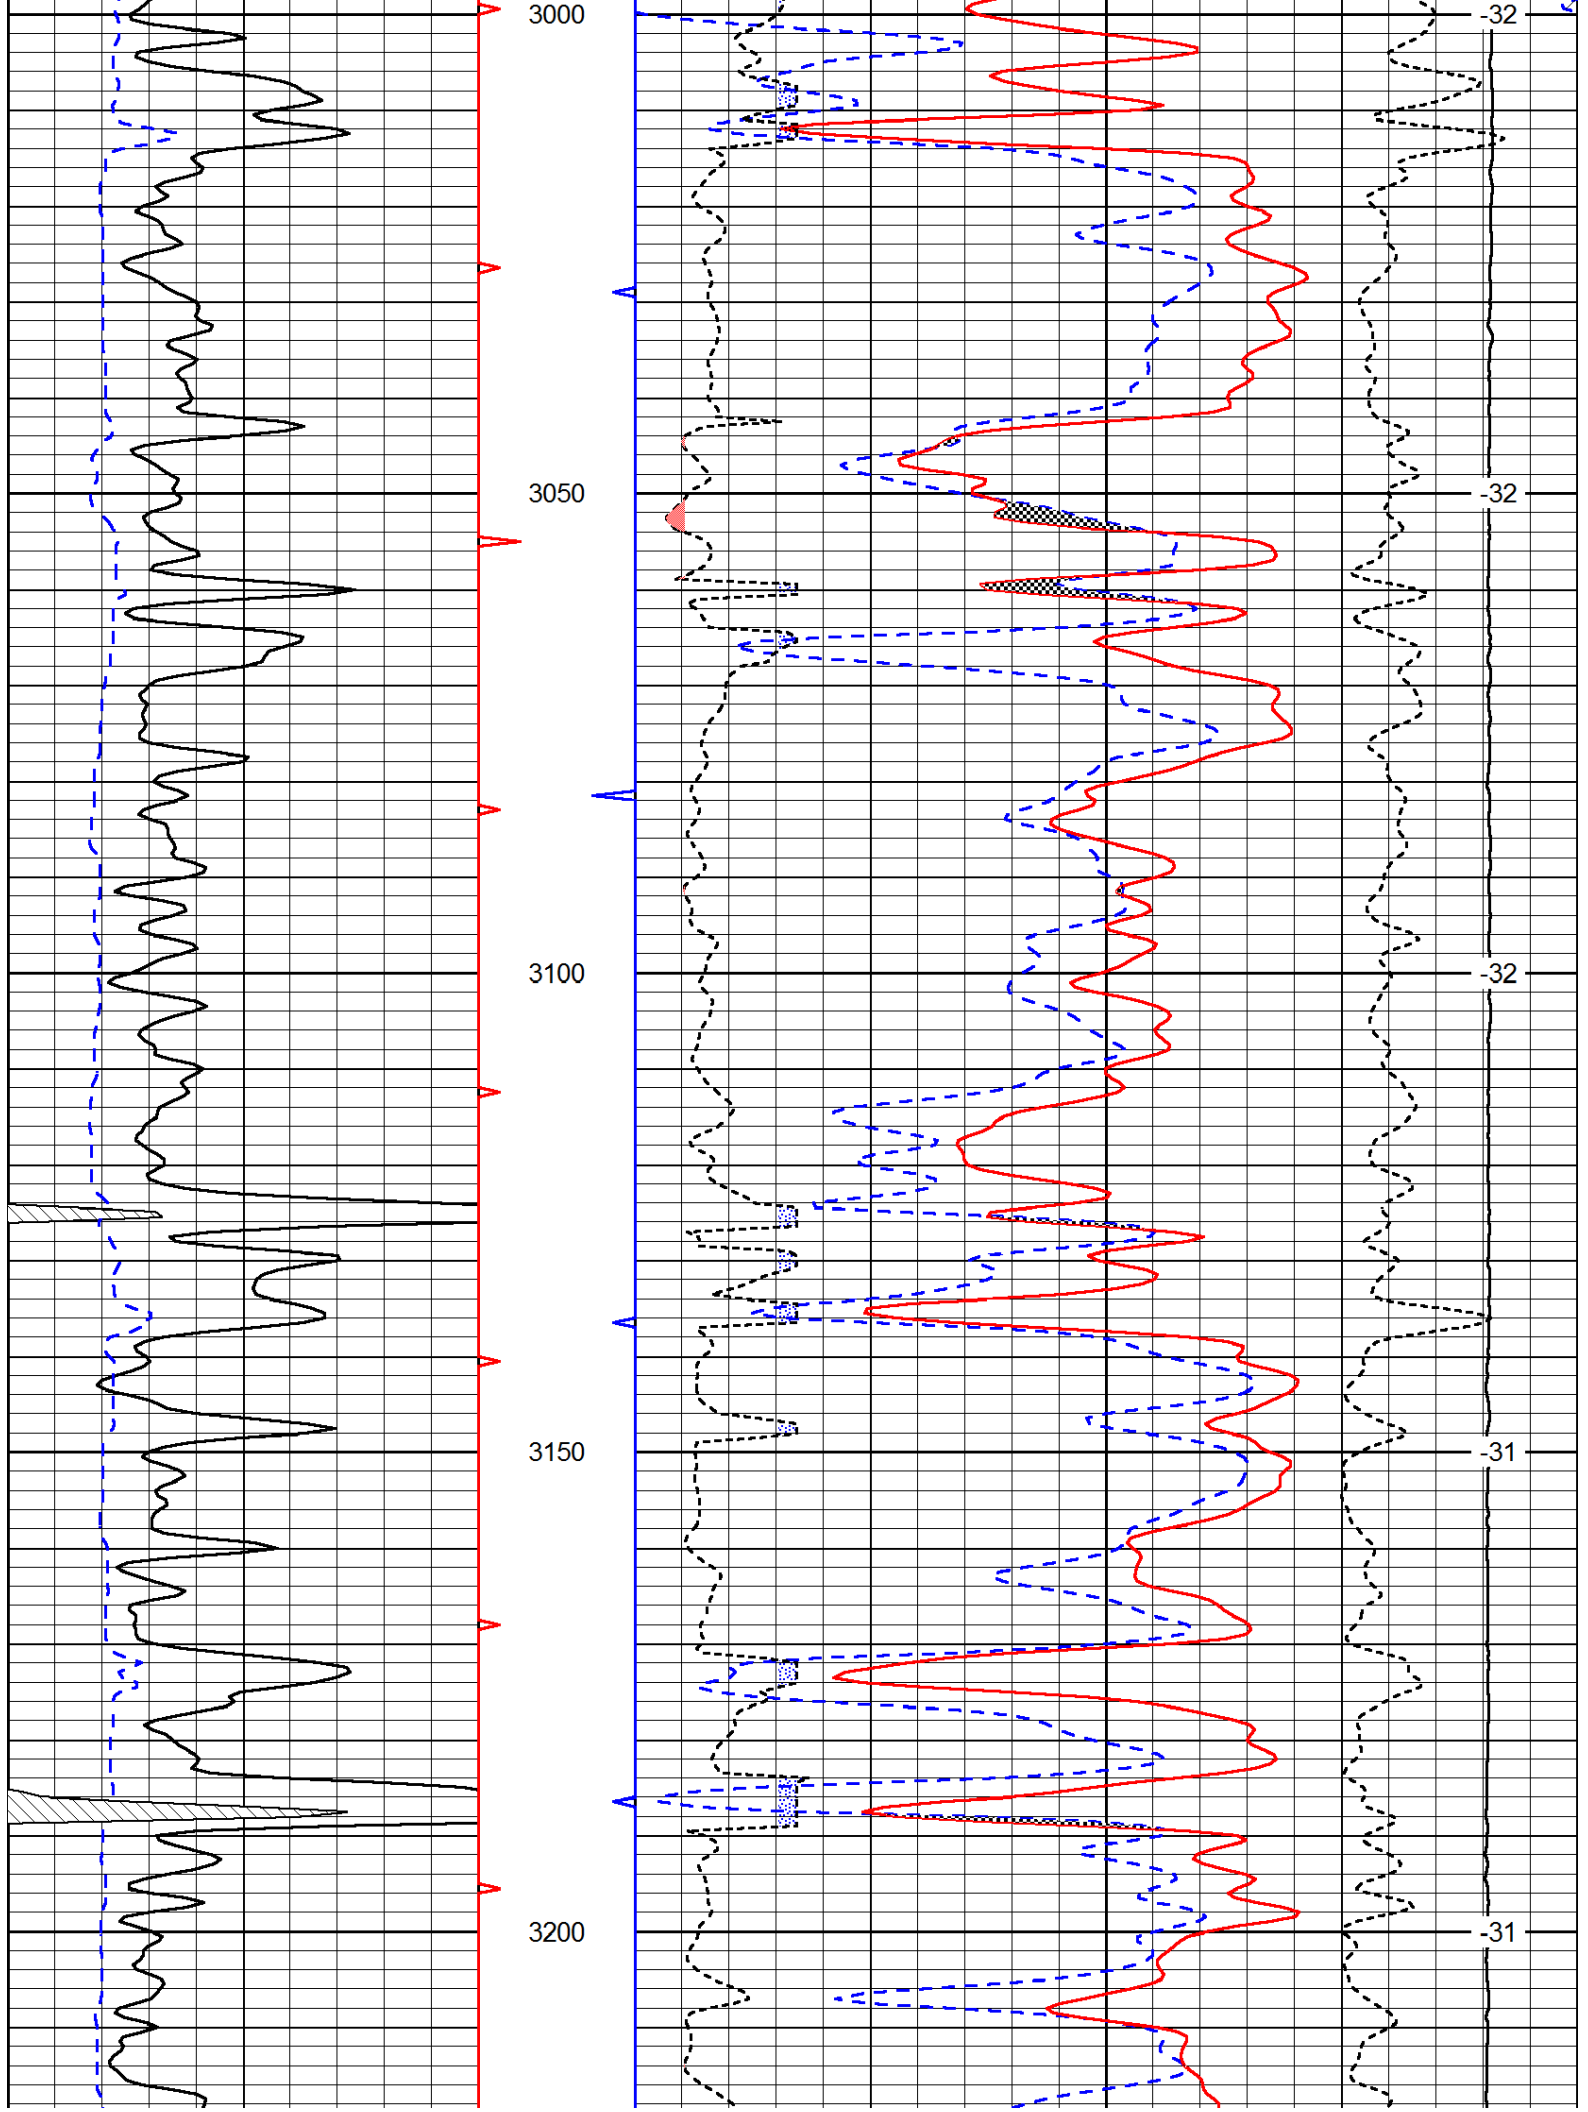
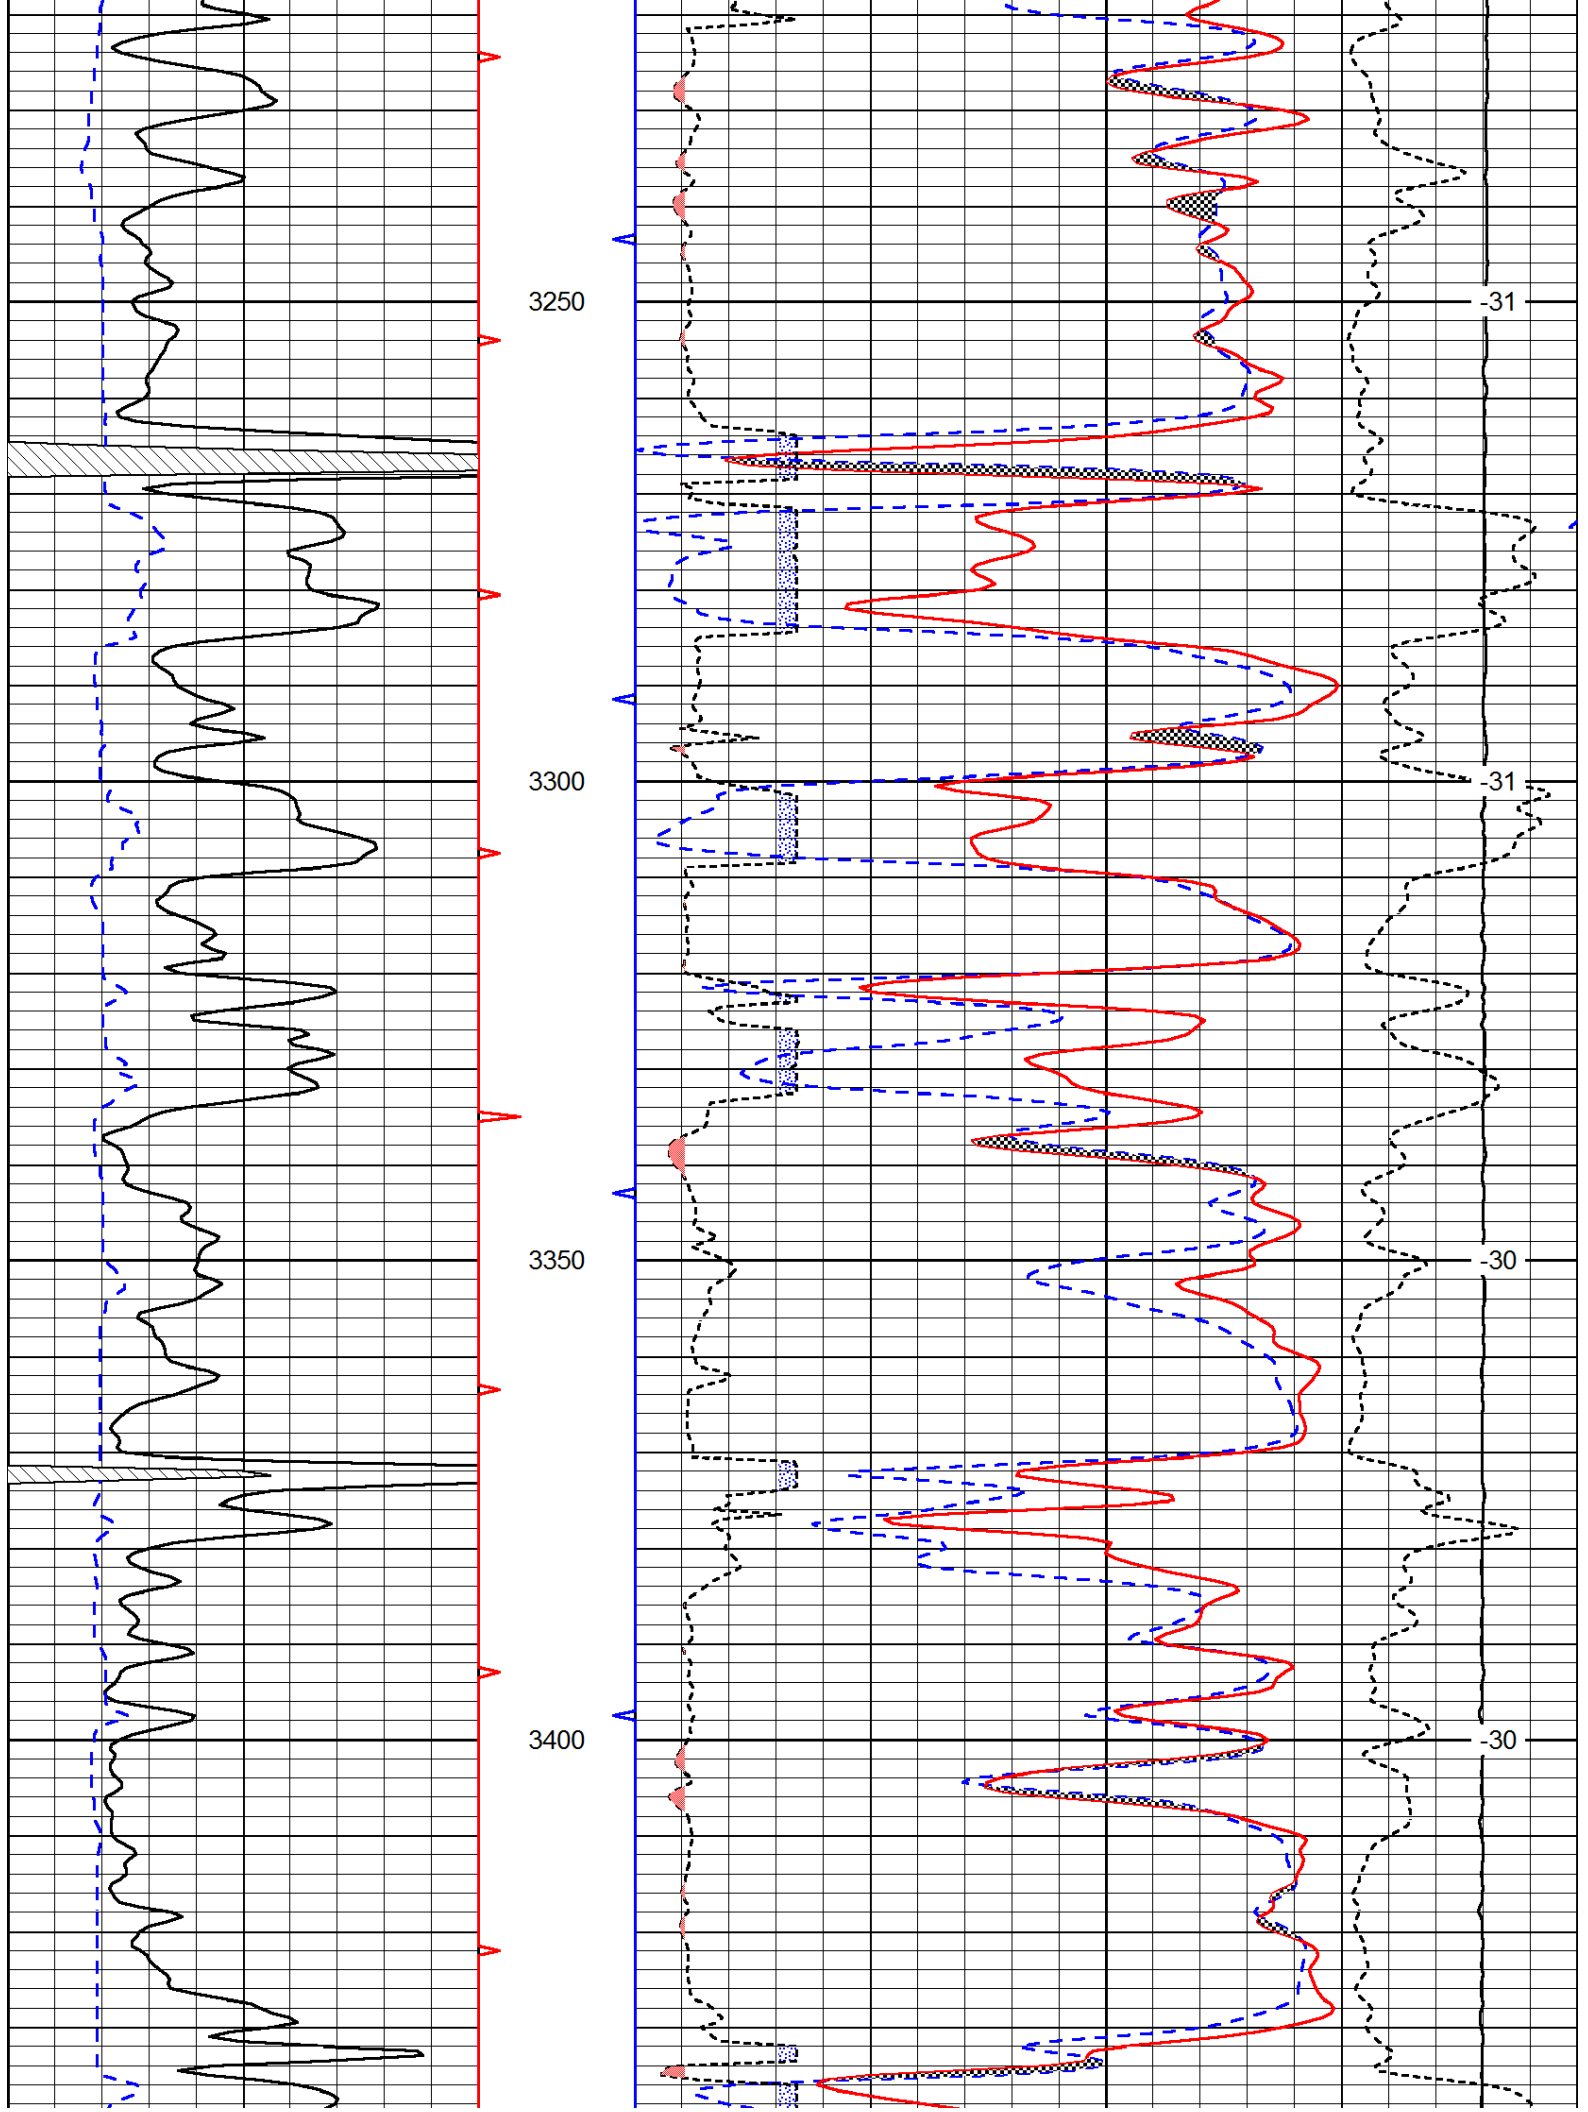
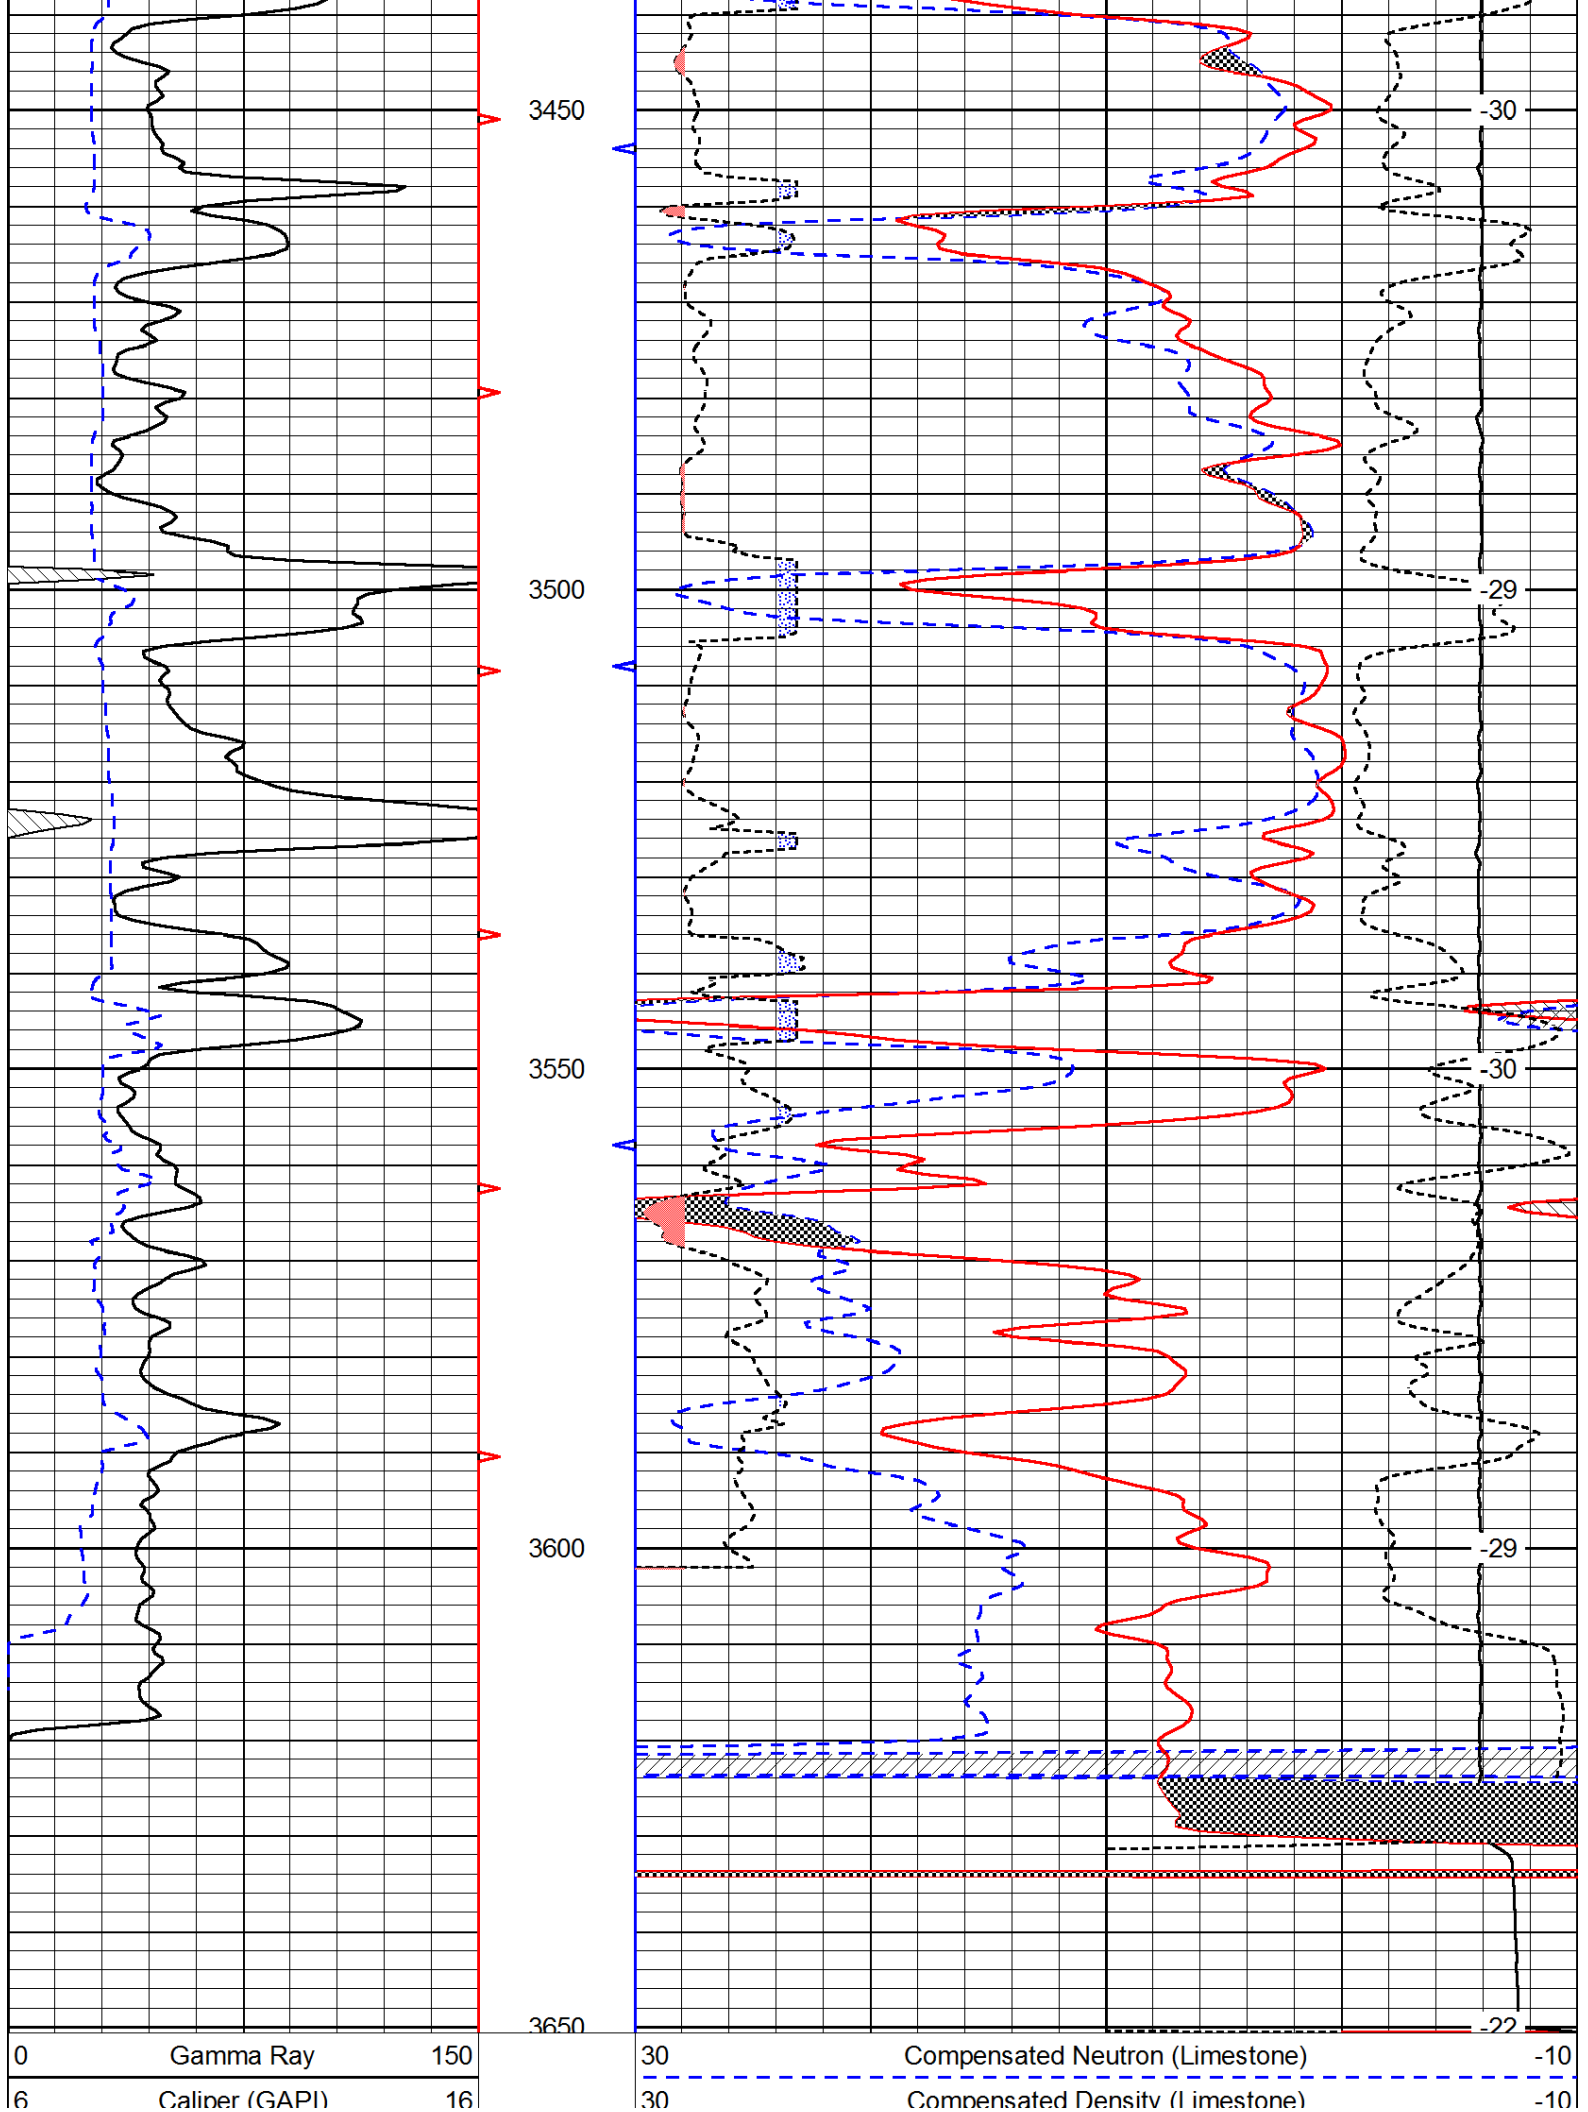
Database File: c:\warrior\data\c g oil\_s&j # 1\cgoil\_s&j\_1hd.db  
Dataset Pathname: dil/cgstck  
Presentation Format: cndlspec  
Dataset Creation: Sun Jul 14 03:05:46 2013  
Charted by: Depth in Feet scaled 1:240

| 2.625 | DGA | 3.425 | -0.25 | Correction | 0.25 |
| 15000 | Line Tension | | | | 0 |
