## Pioneer Energy Services

Beardsley KS, North to AA RD,  
West to 5 1/2 RD, 1/2 North, West Into

Database File: c:\warrior\data\murfin\_burk trust 'a' #3-23\murfin\_burktrust\_a\_3\_23hd.db  
Dataset Pathname: DIL\murfstk  
Presentation Format: cdl  
Dataset Creation: Wed Jan 22 02:22:26 2014  
Charted by: Depth in Feet scaled 1:600

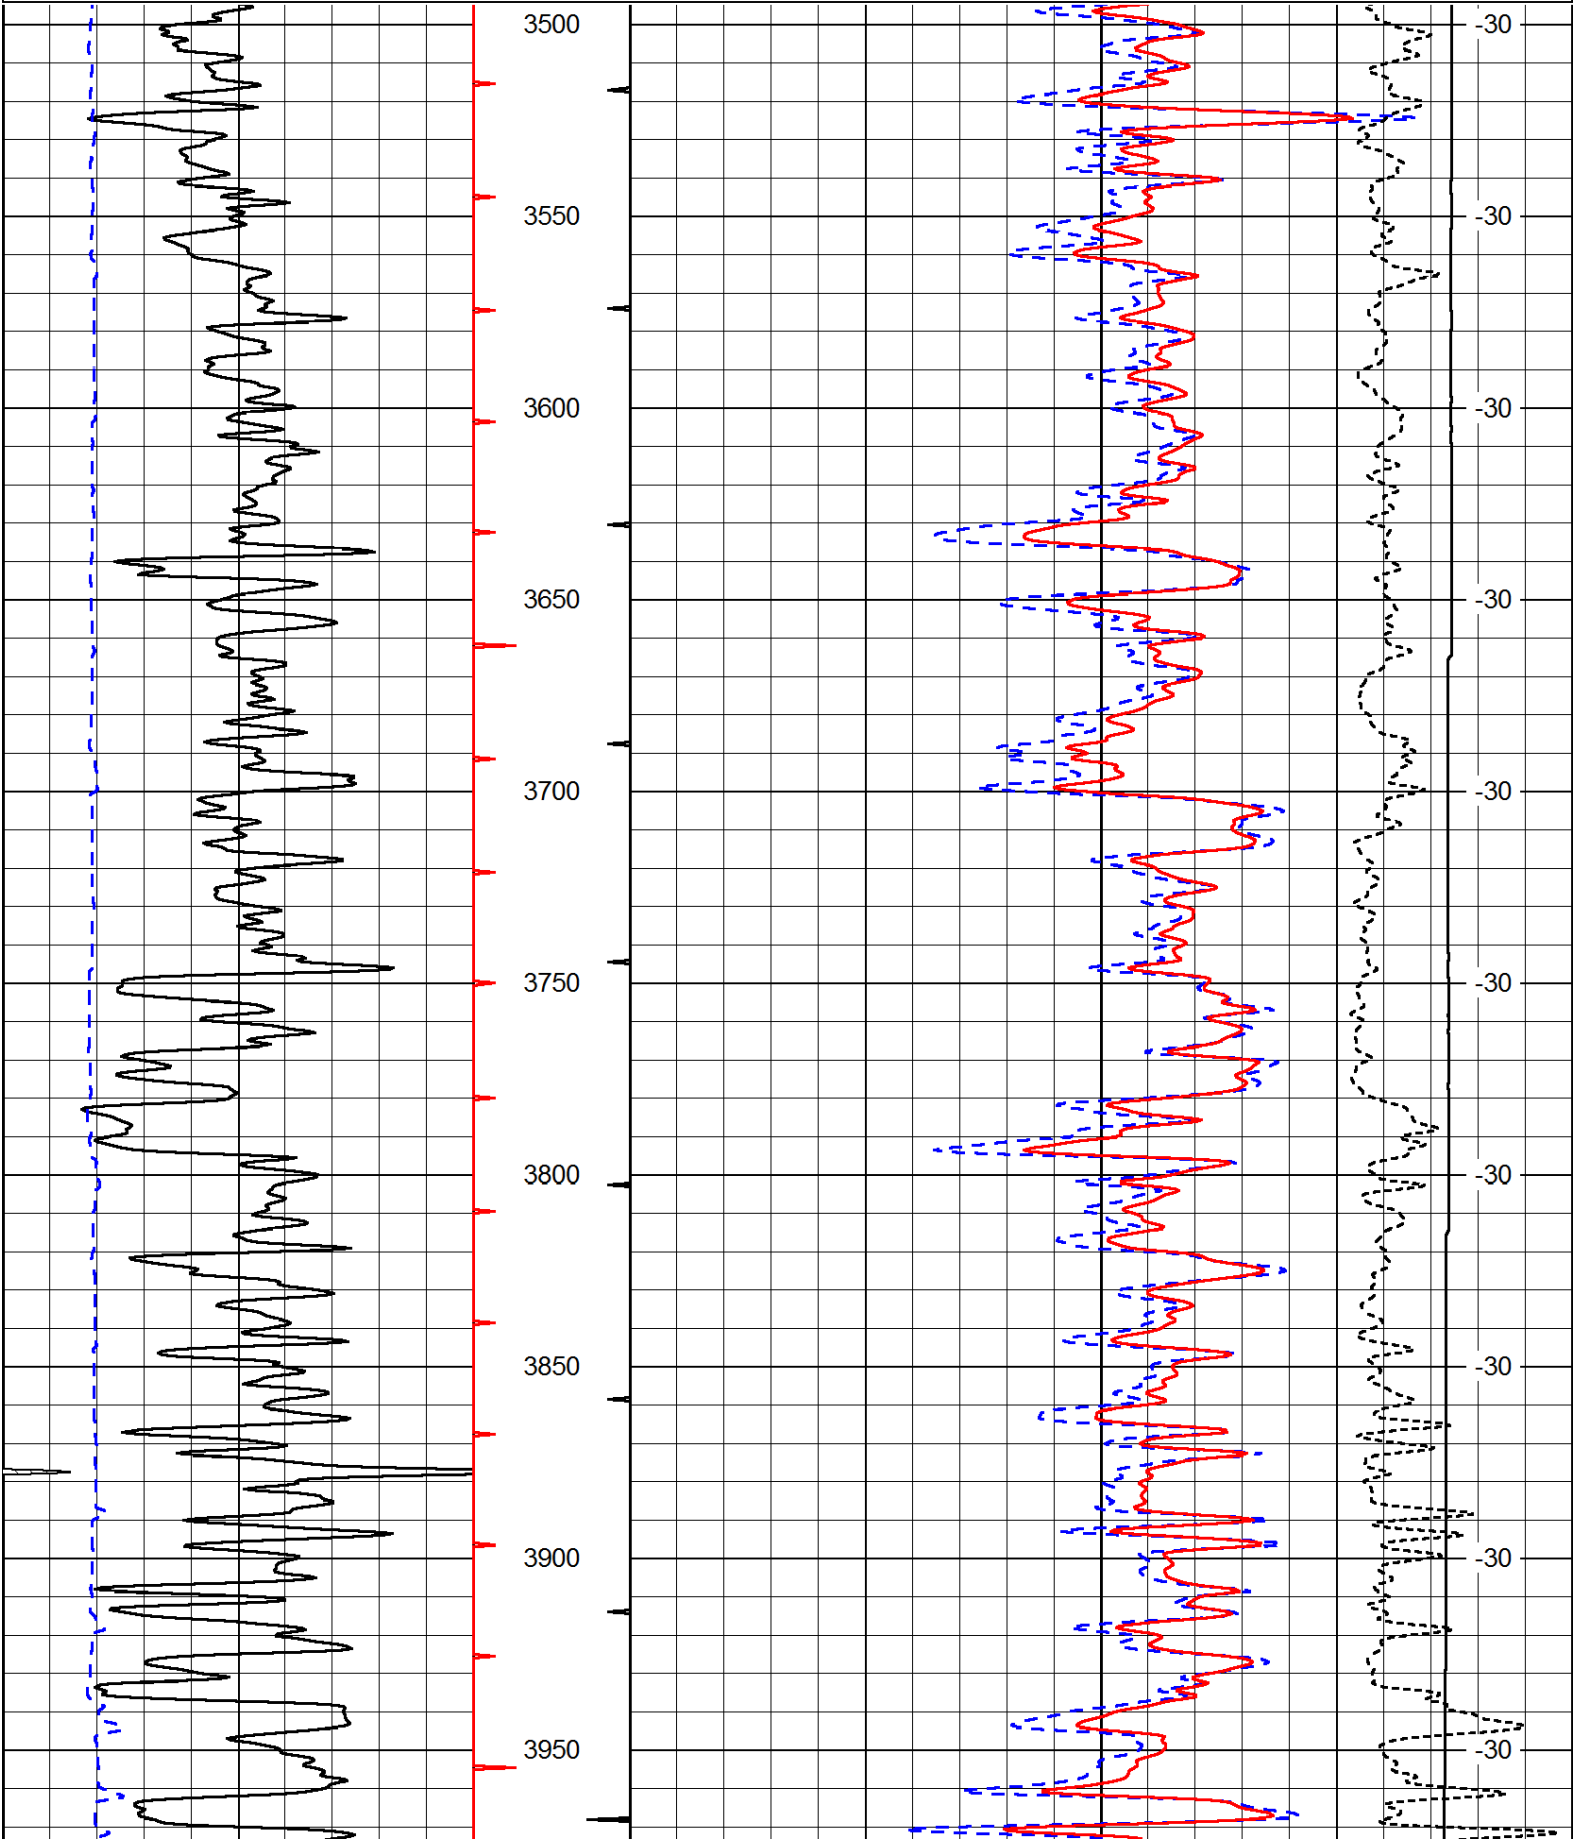
| 0 | Gamma Ray | 150 |
| 6 | Caliper (GAPI) | 16 |

| 30 | Compensated Density | | -10 |
| 2 | Bulk Density | | 3 |
| 15000 | Line Tension | | 0 |
| | -0.25 | Correction | 0.25 |

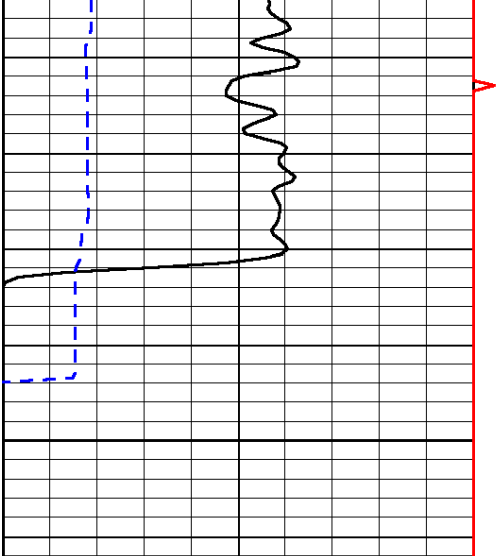
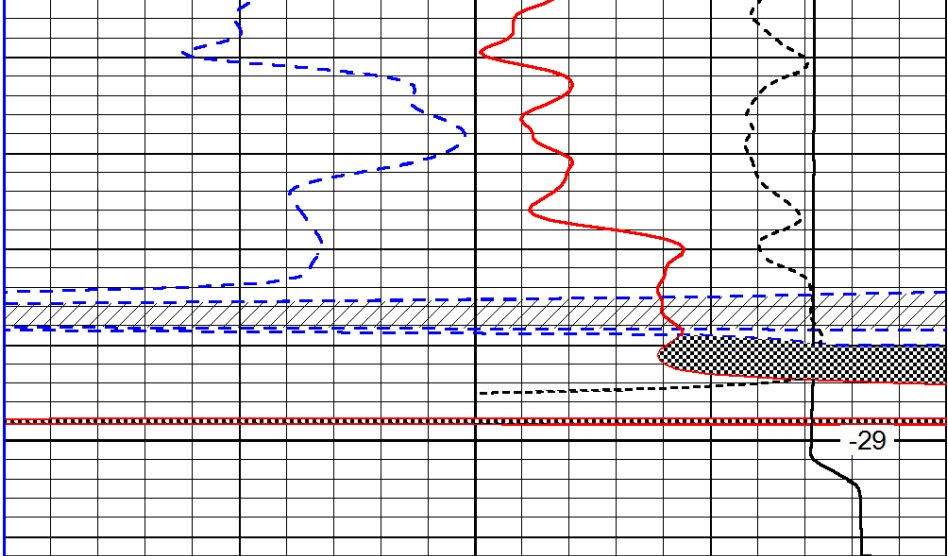
4550

| 0 | Gamma Ray | 150 |
| 6 | Caliper (GAPI) | 16 |

| 30 | Compensated Neutron (Limestone) | -10 |
| 30 | Compensated Density (Limestone) | -10 |
| 15000 | Line Tension | 0 |
| -0.25 | Correction | 0.25 |
