# Diamond Testing General Report

<b>Company Name</b>	Trans Pacific Oil Corp	<b>Well Name</b>	Cambron 'A' #1-14
<b>Well Operator</b>	Trans Pacific Oil Corp	<b>Unique Well ID</b>	DST #4 Mississippian 4272'-4331'
<b>Contact</b>	Beth Isern	<b>Surface Location</b>	Sec 14-18s-24w-Ness Co.-KS
<b>Site Contact</b>	Bryce Bidleman	<b>Test Unit</b>	#5
<b>Field</b>	Unspecified	<b>Pool</b>	Unspecified
<b>Well Type</b>	Vertical	<b>Job Number</b>	F081
<b>Prepared By</b>	Jake Fahrenbruch	<b>Qualified By</b>	Bryce Bidleman

<b>Test Type</b>	Conventional Bottom-Hole	<b>Test Purpose</b>	Initial Test
<b>Formation</b>	Mississippian 4272'-4331'	<b>Gauge Name</b>	0062
<b>Start Test Date</b>	2013/01/10	<b>Start Test Time</b>	15:22:00
<b>Final Test Date</b>	2013/01/10	<b>Final Test Time</b>	00:00:00

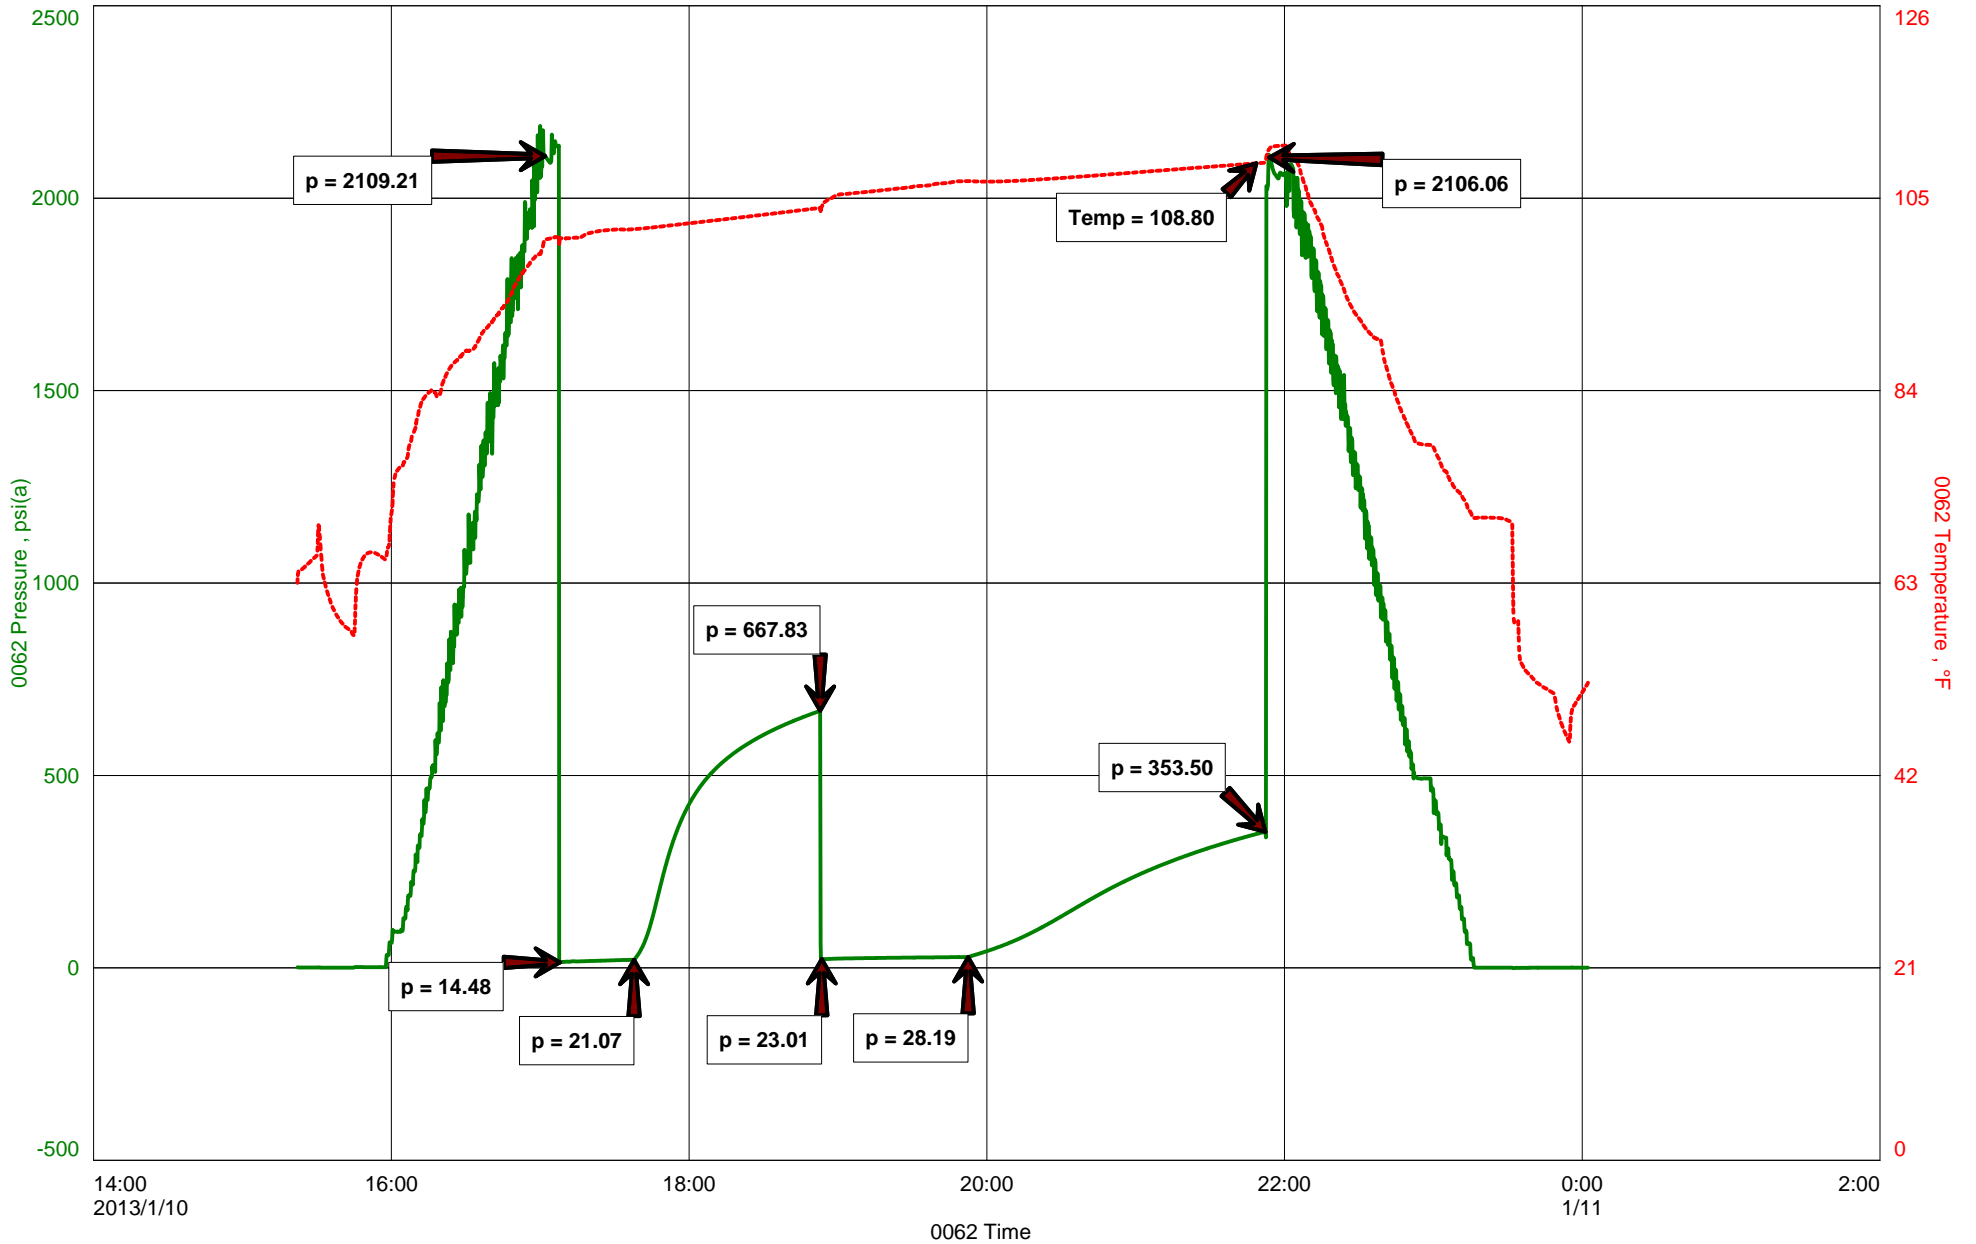
# Cambron 'A' #1-14

Trans Pacific Oil Corp  
DST #4 Mississippian 4272'-4331'  
Start Test Date: 2013/01/10  
Final Test Date: 2013/01/10

Cambron 'A' #1-14  
Formation: Mississippian 4272'-4331'  
Pool: Unspecified  
Job Number: F081

IHP	2109
IFP	14 - 21
ISIP	668
FFP	23 - 28
FSIP	354
FHP	2106
