**GEO. O. WILLIAMS**2125 N. W. 16TH STREET  
OKLAHOMA CITY, OKLA.

September 11, 1948

Mr. Walter Zeigler  
Ryan Petroleum Co.  
First National Bank Bldg.  
Dallas, Texas

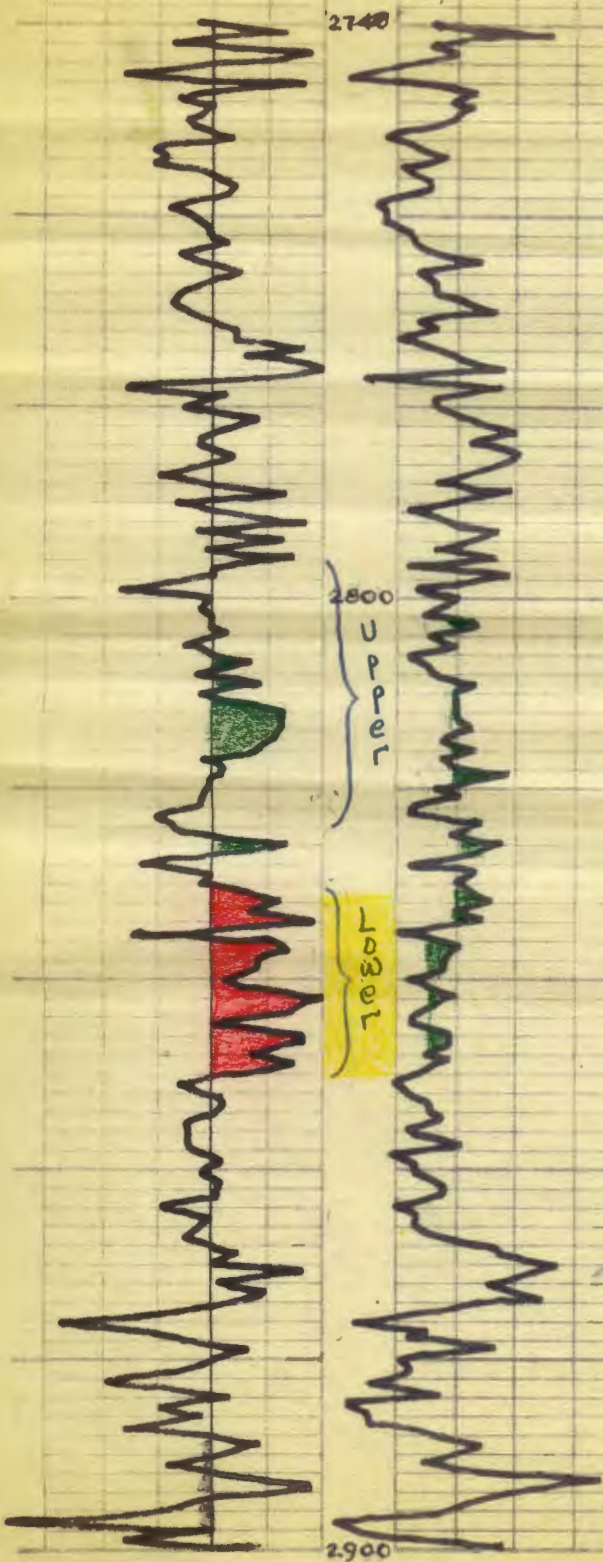
SE SW SE  
12-30<sup>S</sup> - 5<sup>E</sup>

+ 0 -

12FJ4 is on the location you are about to drill. This shows good negative charge at the horizon of the "Lower" sand, accompanied by no high resistivity. I can find only one reason for this combination: High connate water content in a finer grained sand.
