**GEO. O. WILLIAMS**2125 N. W. 10TH STREET  
OKLAHOMA CITY, OKLA.

September 11, 1948

12FJ1 is on your "Lower" Bartlesville well, and shows up the sand beautifully with high negative charge on the porosity side, and high resistivity through the pay zone.

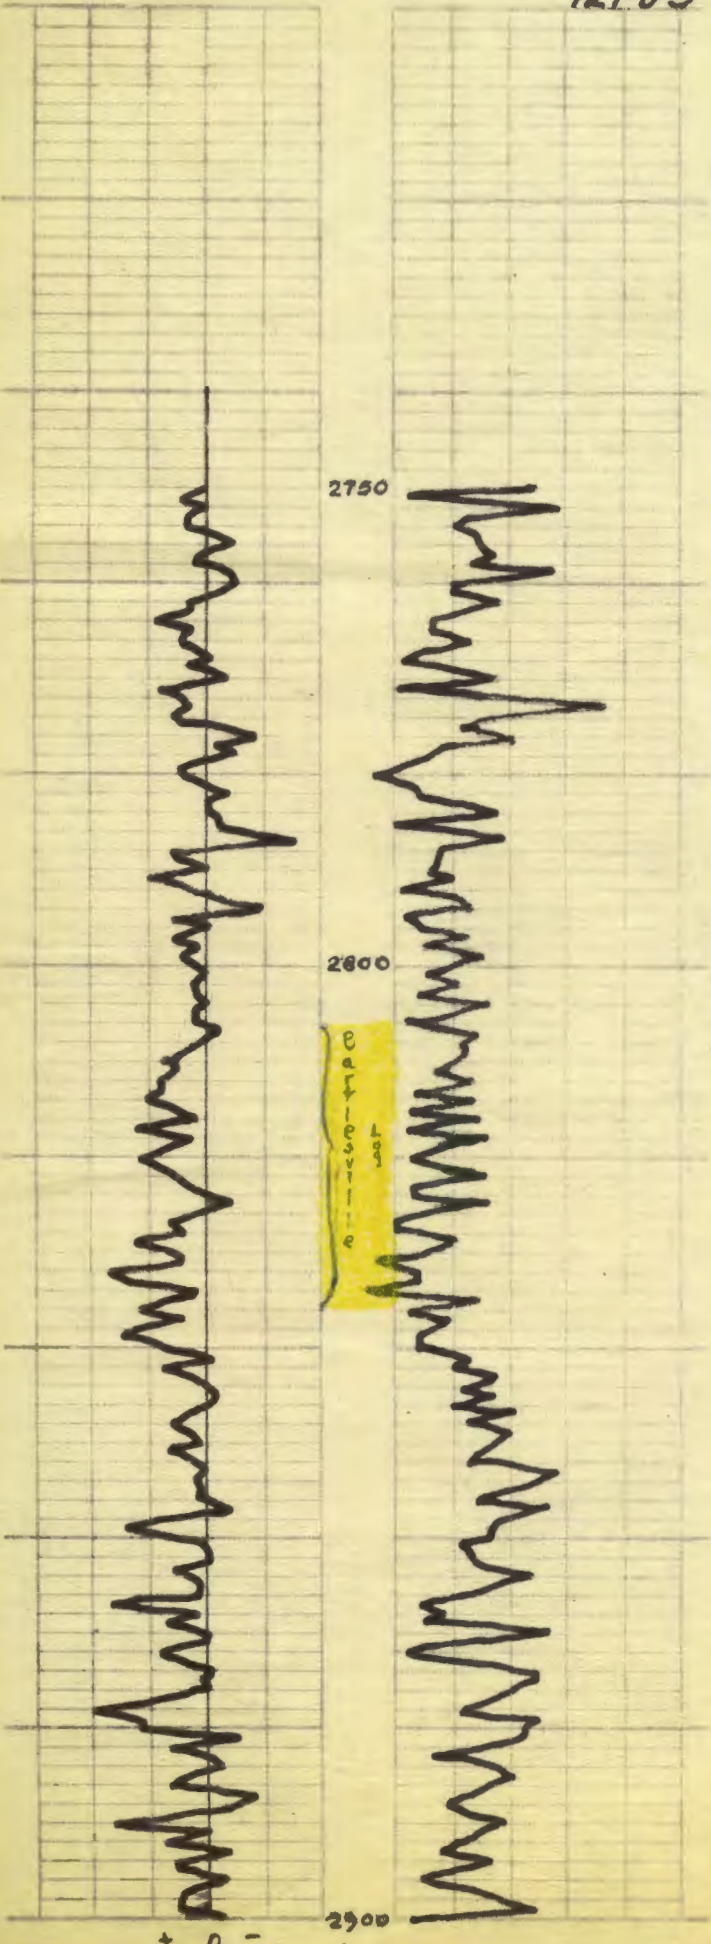
12FJ5

SW SW SE  
12-30<sup>s</sup>-5<sup>r</sup>

Hand 3

12 FJ5 is on the south "Upper" sand producer in Section 12, and does not show any recommendable pattern.
