**GEOLOGIC REPORT**

**#1-26H COLBORN**

RE: Geologic Report  
#1-26H Colborn  
SHL: 2210' FNL, 1880' FWL  
BHL: 1485' FWL, 957' FNL  
Sec. 26-33s-12w  
Barber County, Kansas

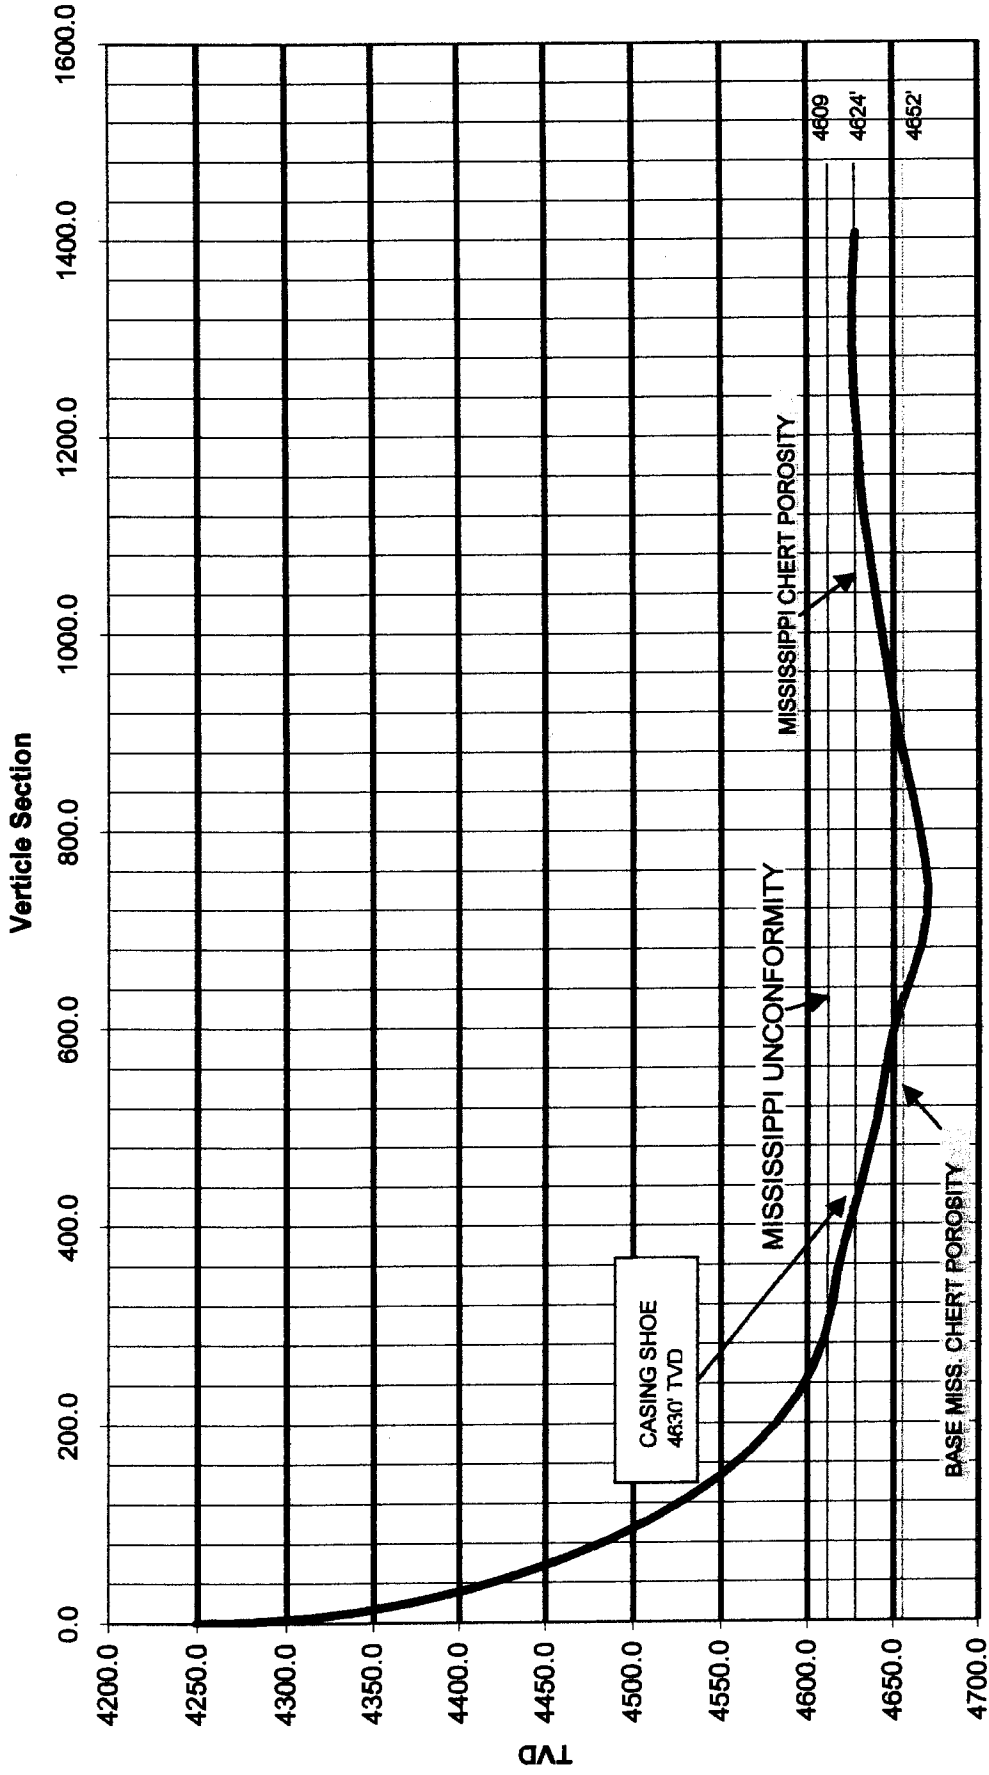
Colborn 1-26H

- Geologic Report on the Well
- X Y Schematic Of The Well Path
- Plan View Of The Well Path
- Directional Survey Of The Well Path
- Daily Progress Report Of The Well By Art Merrick, Drilling Engineer
- Plotted Geologic Time And Sample Log
