WATER WELL RECORD

MW2

RE: Monitor Well Elevation Survey  
1301 Oak Street, Elwood, Kansas

FIGURE 5.1 - GROUNDWATER ISOCONCENTRATION MAP: TOTAL BTEX IN WELLS

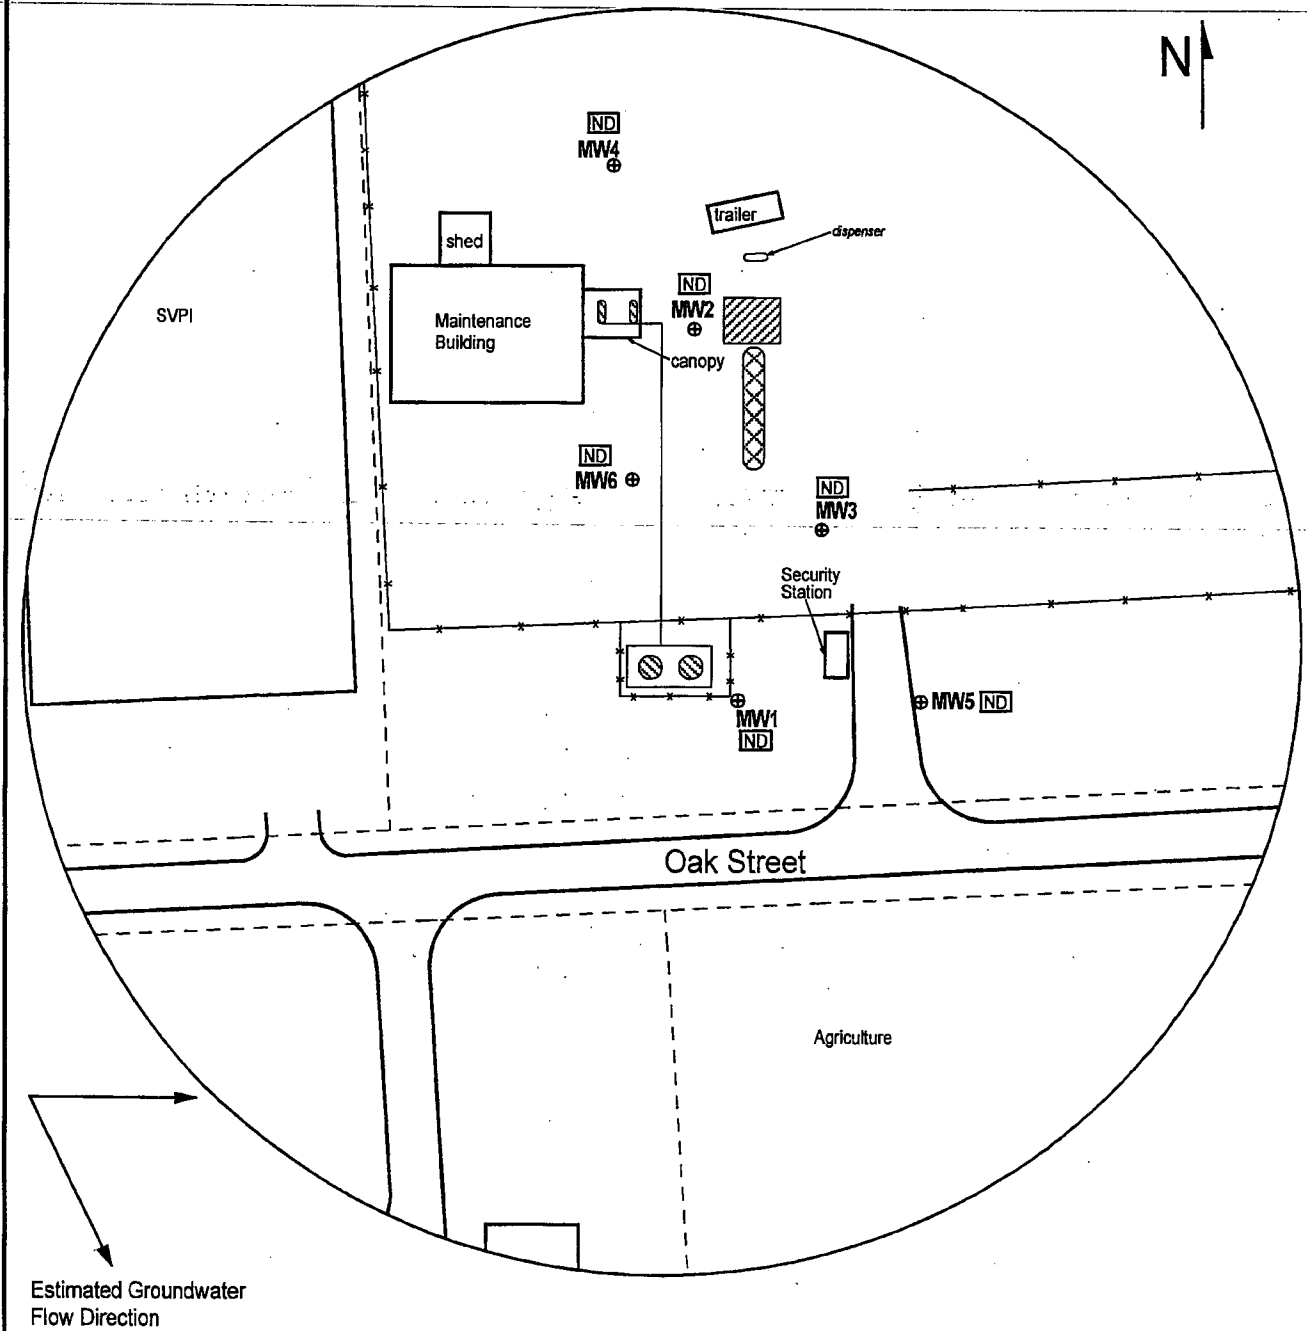
NOTE: Figures exhibited within this report are only to be used within the context of this report. Placement of property lines, wells, structures, and roads is based on the available information from county appraiser maps, surveys, site visits, and/or previous vendor reports and should be considered approximate.

Estimated Groundwater Flow Direction
