WATER WELL RECORD (WWC-5)

<p>REVISIONS</p> <table border="1" style="width: 100%; border-collapse: collapse;"> <tr> <th style="width: 50%;">BY</th> <th style="width: 50%;">REVISIONS</th> </tr> <tr> <td> </td> <td> </td> </tr> </table>	BY	REVISIONS			<p>MILCO Environmental Services, Inc. <small>Kearney, NE (308) 237-5923 McCook, NE (308) 345-4741 Colby, KS (785) 460-1956</small></p>
BY	REVISIONS				
<p>KENSINGTON COOPERATIVE ASSN. TOTAL BTEX ISOCONCENTRATION MAP KENSINGTON, KANSAS U6-092-00406</p>					
<p><small>This document, and the ideas and designs incorporated herein, as an instrument of professional service, is the property of MILCO and is not to be used in whole or in part, for any other project without the written authorization of © 2019 MILCO.</small></p>					
<p>SCALE: 1"=30' PROJECT NO. M278-P1-04 DATE: JANUARY, 2023 FIELD BOOK NA M&A DWG NO. DRAWN BY: BSF APR'YD BY: SHEET</p>					
<p>FIGURE 3.1</p>

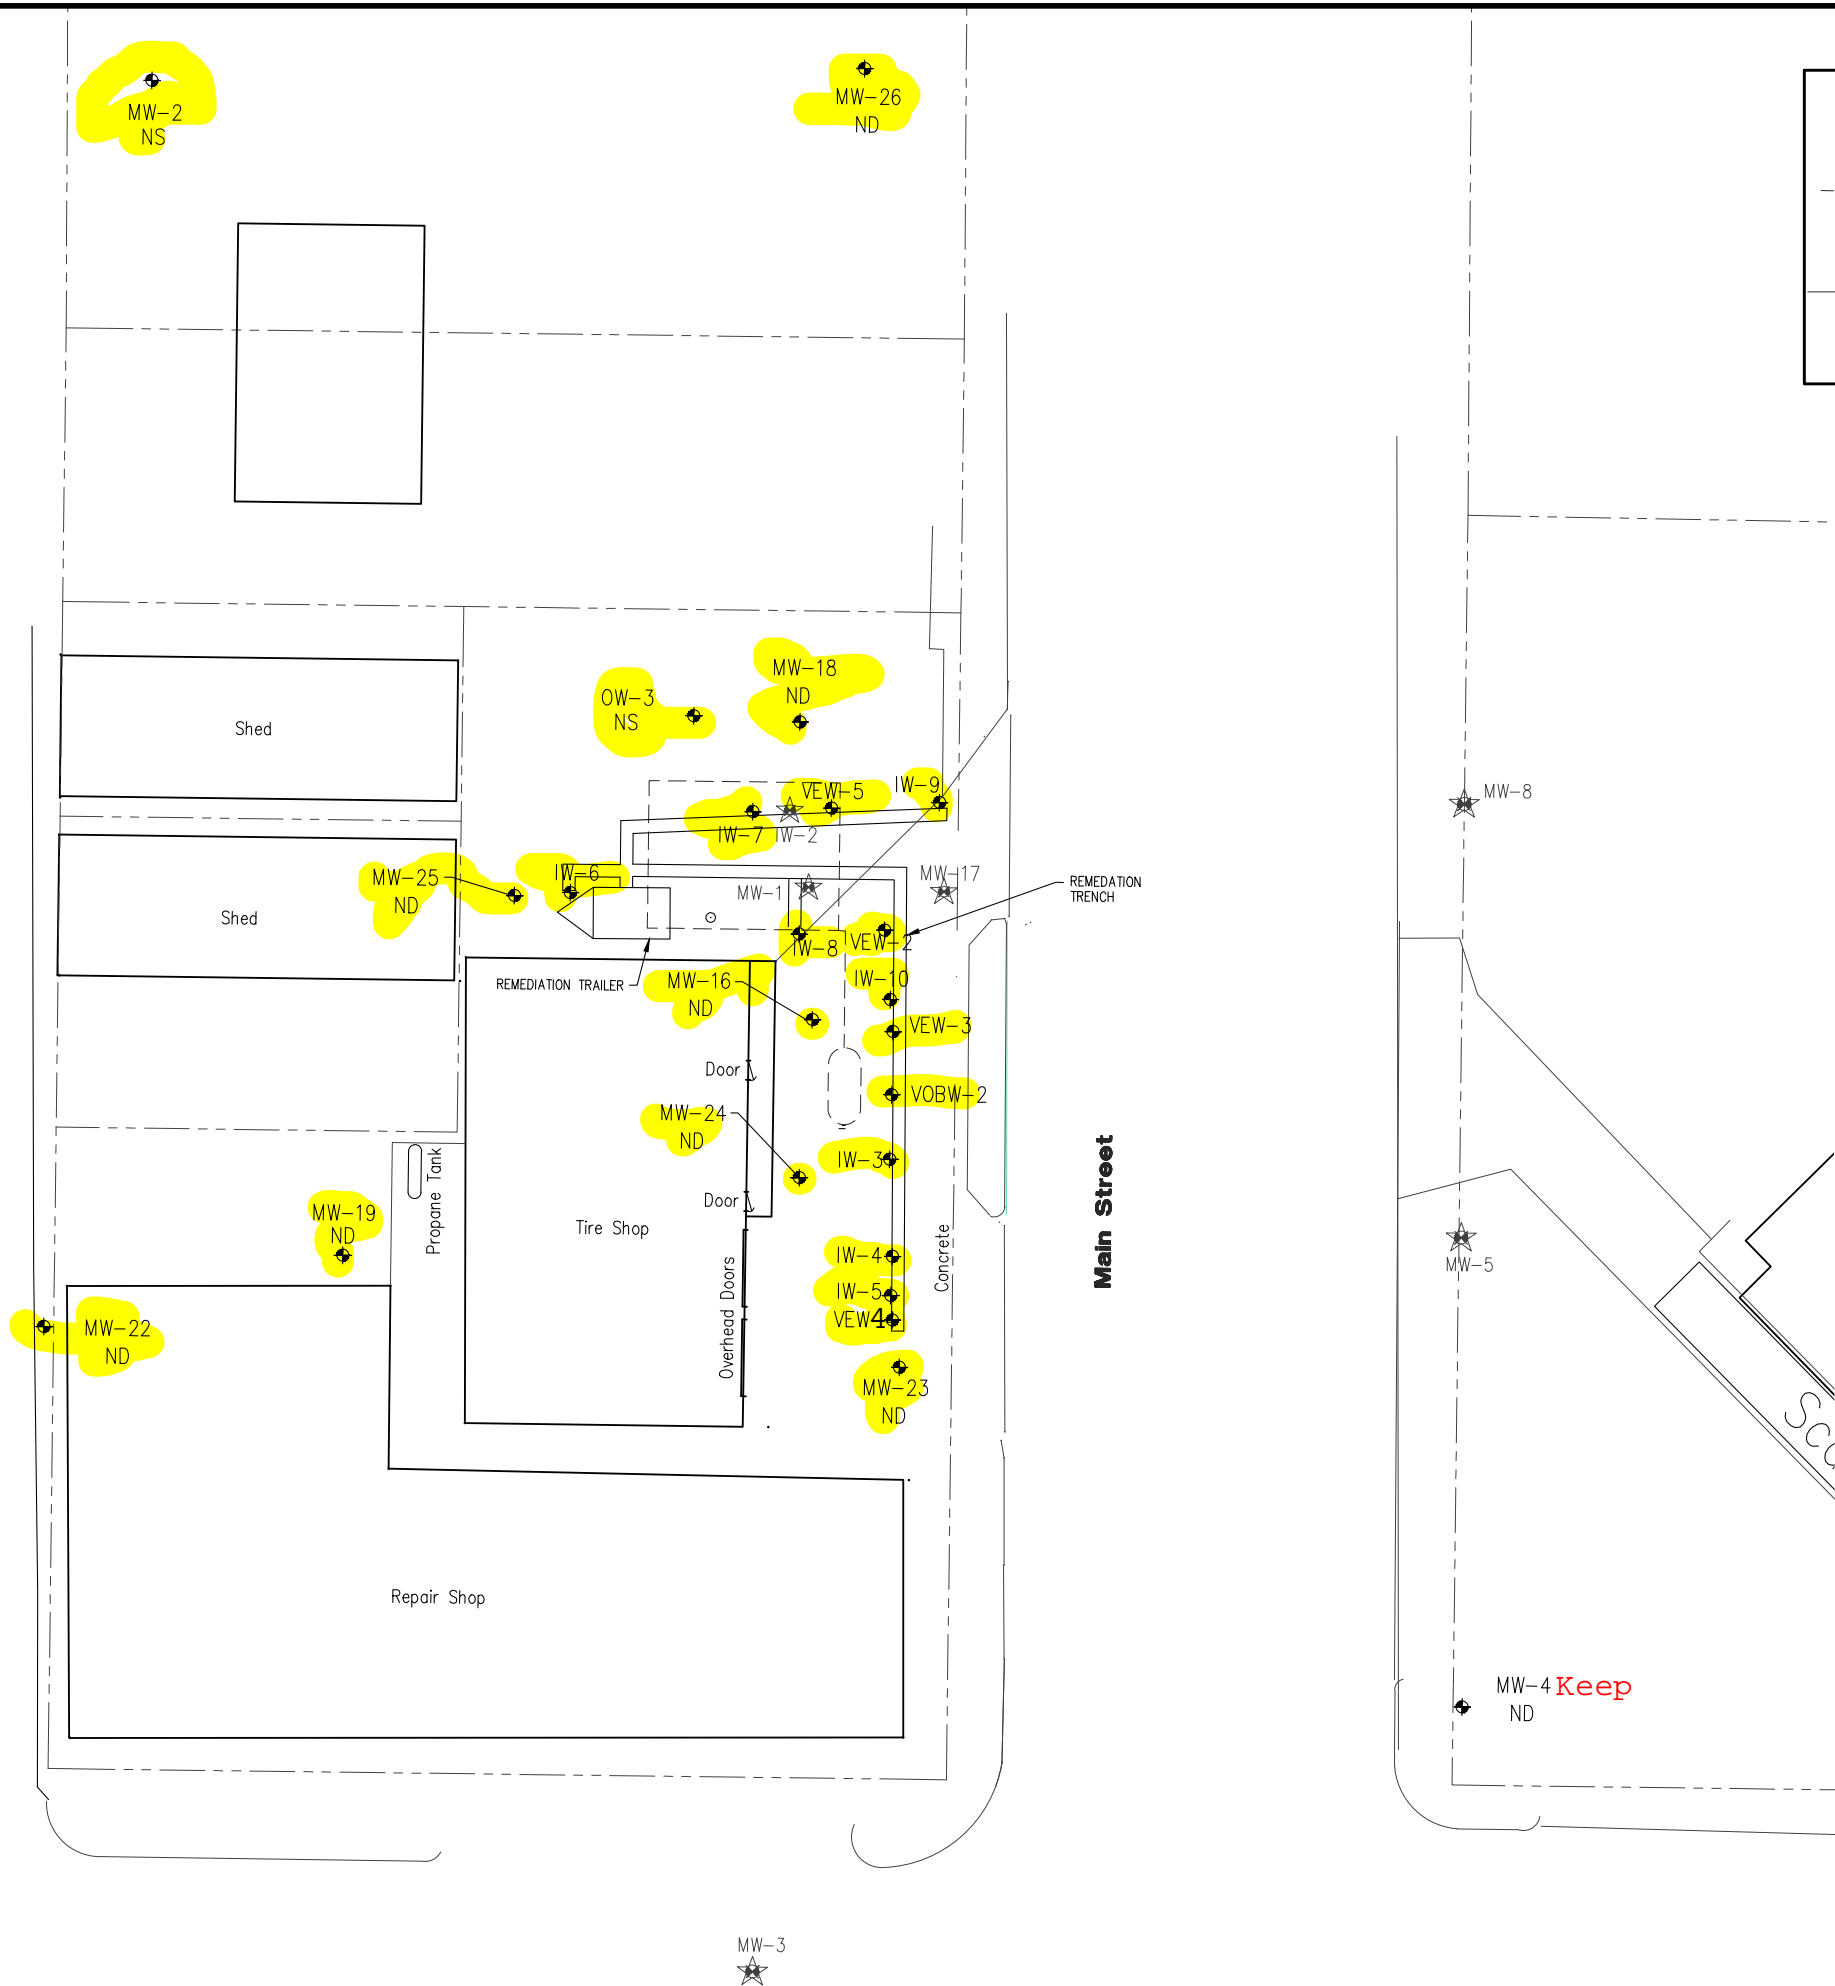
**Sampling Date:
December 6, 2022**

NOTE:
 REMEDIAL WELLS AND WELLS LOCATED SOUTH OF RAILROAD STREET WERE NOT GAUGED OR SAMPLED
 PWS-2 = ND;
 PWS-2 IS LOCATED APPROXIMATELY 1000 FEET NE OF THE SITE
