INSPECTION REPORT

Date: 06-19-2007Operator: Encore Operating Co.Address: P.O.Box 27710City/St: Denver CO 80227Phone: 303-595-9251License: 33069Location: NE/4 except SE SE NE also
parts of NW/4 Sec 26-9-21WLease: Cox - CCounty: GrahamReason for investigation: Request Herb Deines and Sanita DeanProblem: Abandoned well

Operating Co # 33069
Cox C Lease
NE/4 Except for the SE SE NE Sec.26-9-21W
Graham County

A Lease inspection conducted on **June 19, 2007**, to check for compliance with State Rules & Regulations regarding the Conservation of Crude Oil & Natural

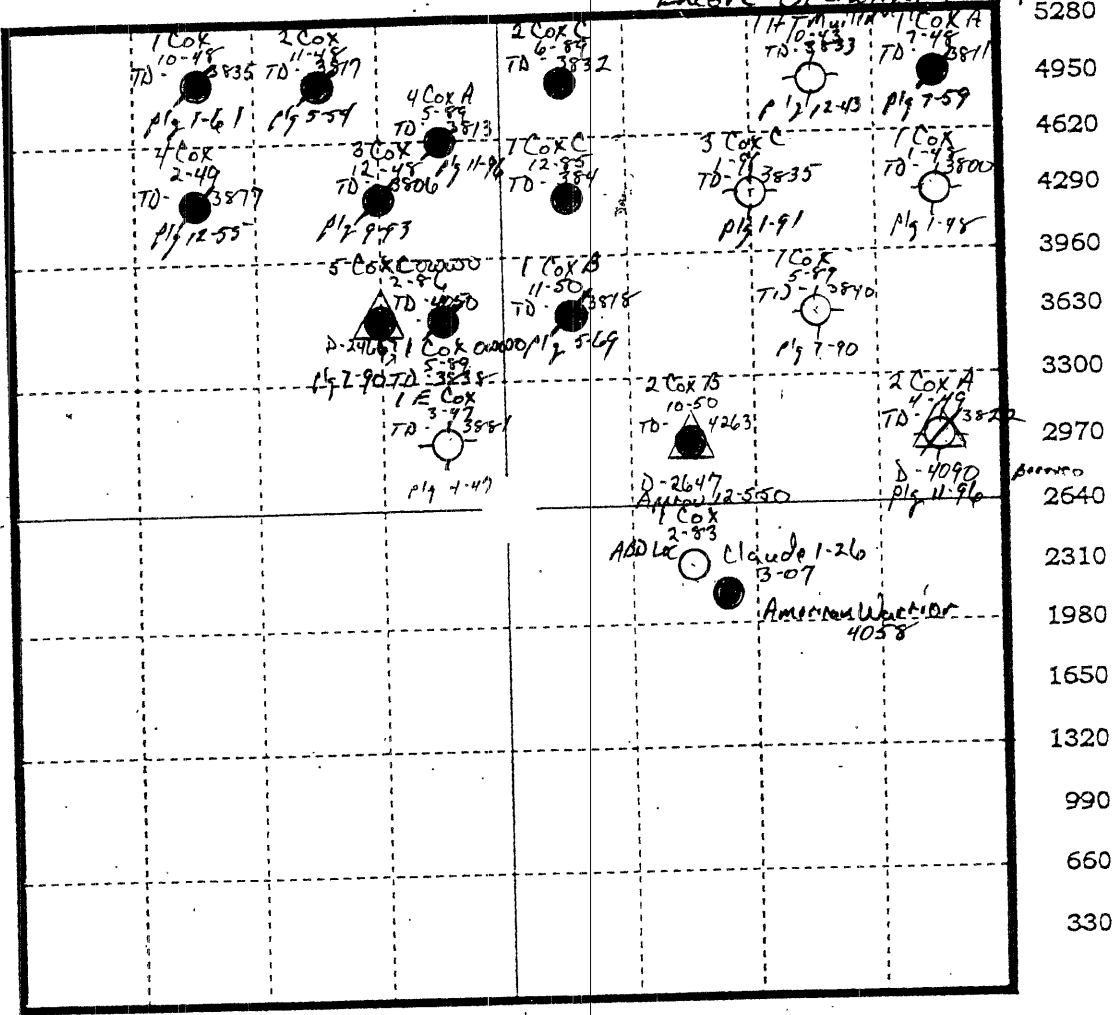
KCC LEASE SURVEY PLAT

LEASE Cox,
Section 26, Township 9

COUNTY Graham, Range 21

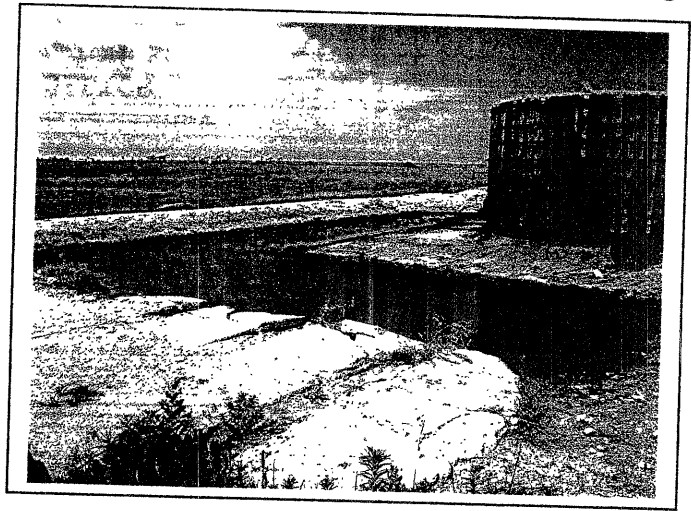
The Cox tank battery site found oil & brine inside the TB dike area, discharge was reported to District Office.

- The above said is in violation of K.A.R.82-3-111 and will be turned over to Rich Williams TA coordinator for tracking purposes. The above said is also in violation of K.A.R.82-3-126 violation letters will be sent.

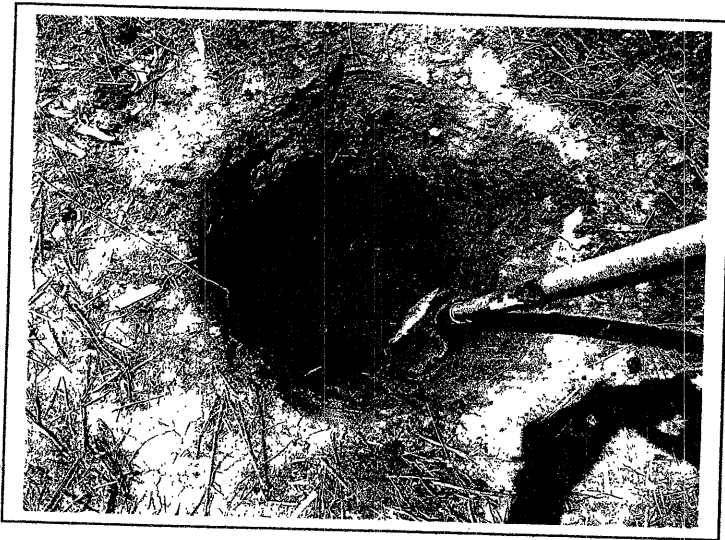
The Cox B # 2 well Docket D-2647 located in the SE SW NE was found cut off and buried two feet down. A 6 second drop was found to fluids. No TA was found on file. GPS location 099.62991 & 39.24267. 2998 FSL & 1750 FEL

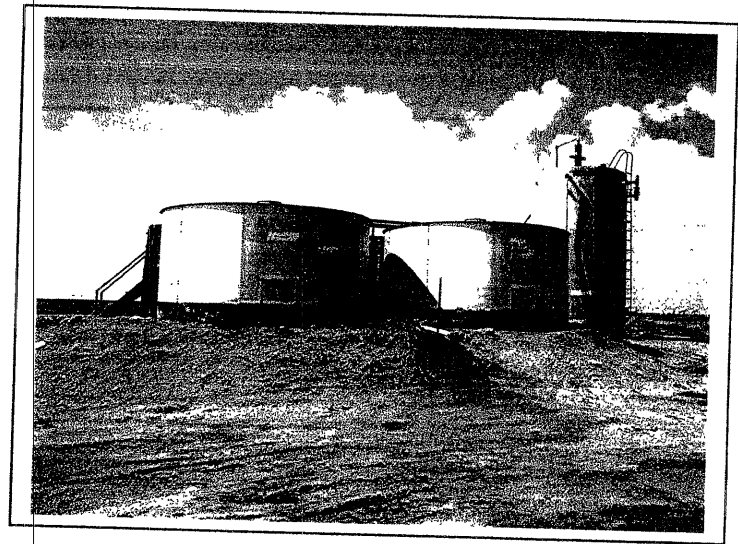
The Cox TB site has no lease sign an Encore sticker was found stuck on a storage tank. Tanks are located in the SE SE NW
