CORRECTION(S) to WATER WELL COMPLETION RECORD Form WWC-5 (to rectify lacking or incorrect information)

WATER WELL RECORD Form WWC-5

MW-16

SHAMROCK SERVICE
SITE MAP
 612 N. MAIN STREET - SHARON SPRINGS, KANSAS U6-100-00704
This document, and the ideas and designs incorporated herein, are an instrument of professional service, is the property of MILCO and is not to be used in whole or in part, for any other project without the written authorization of © 2009 MILCO.

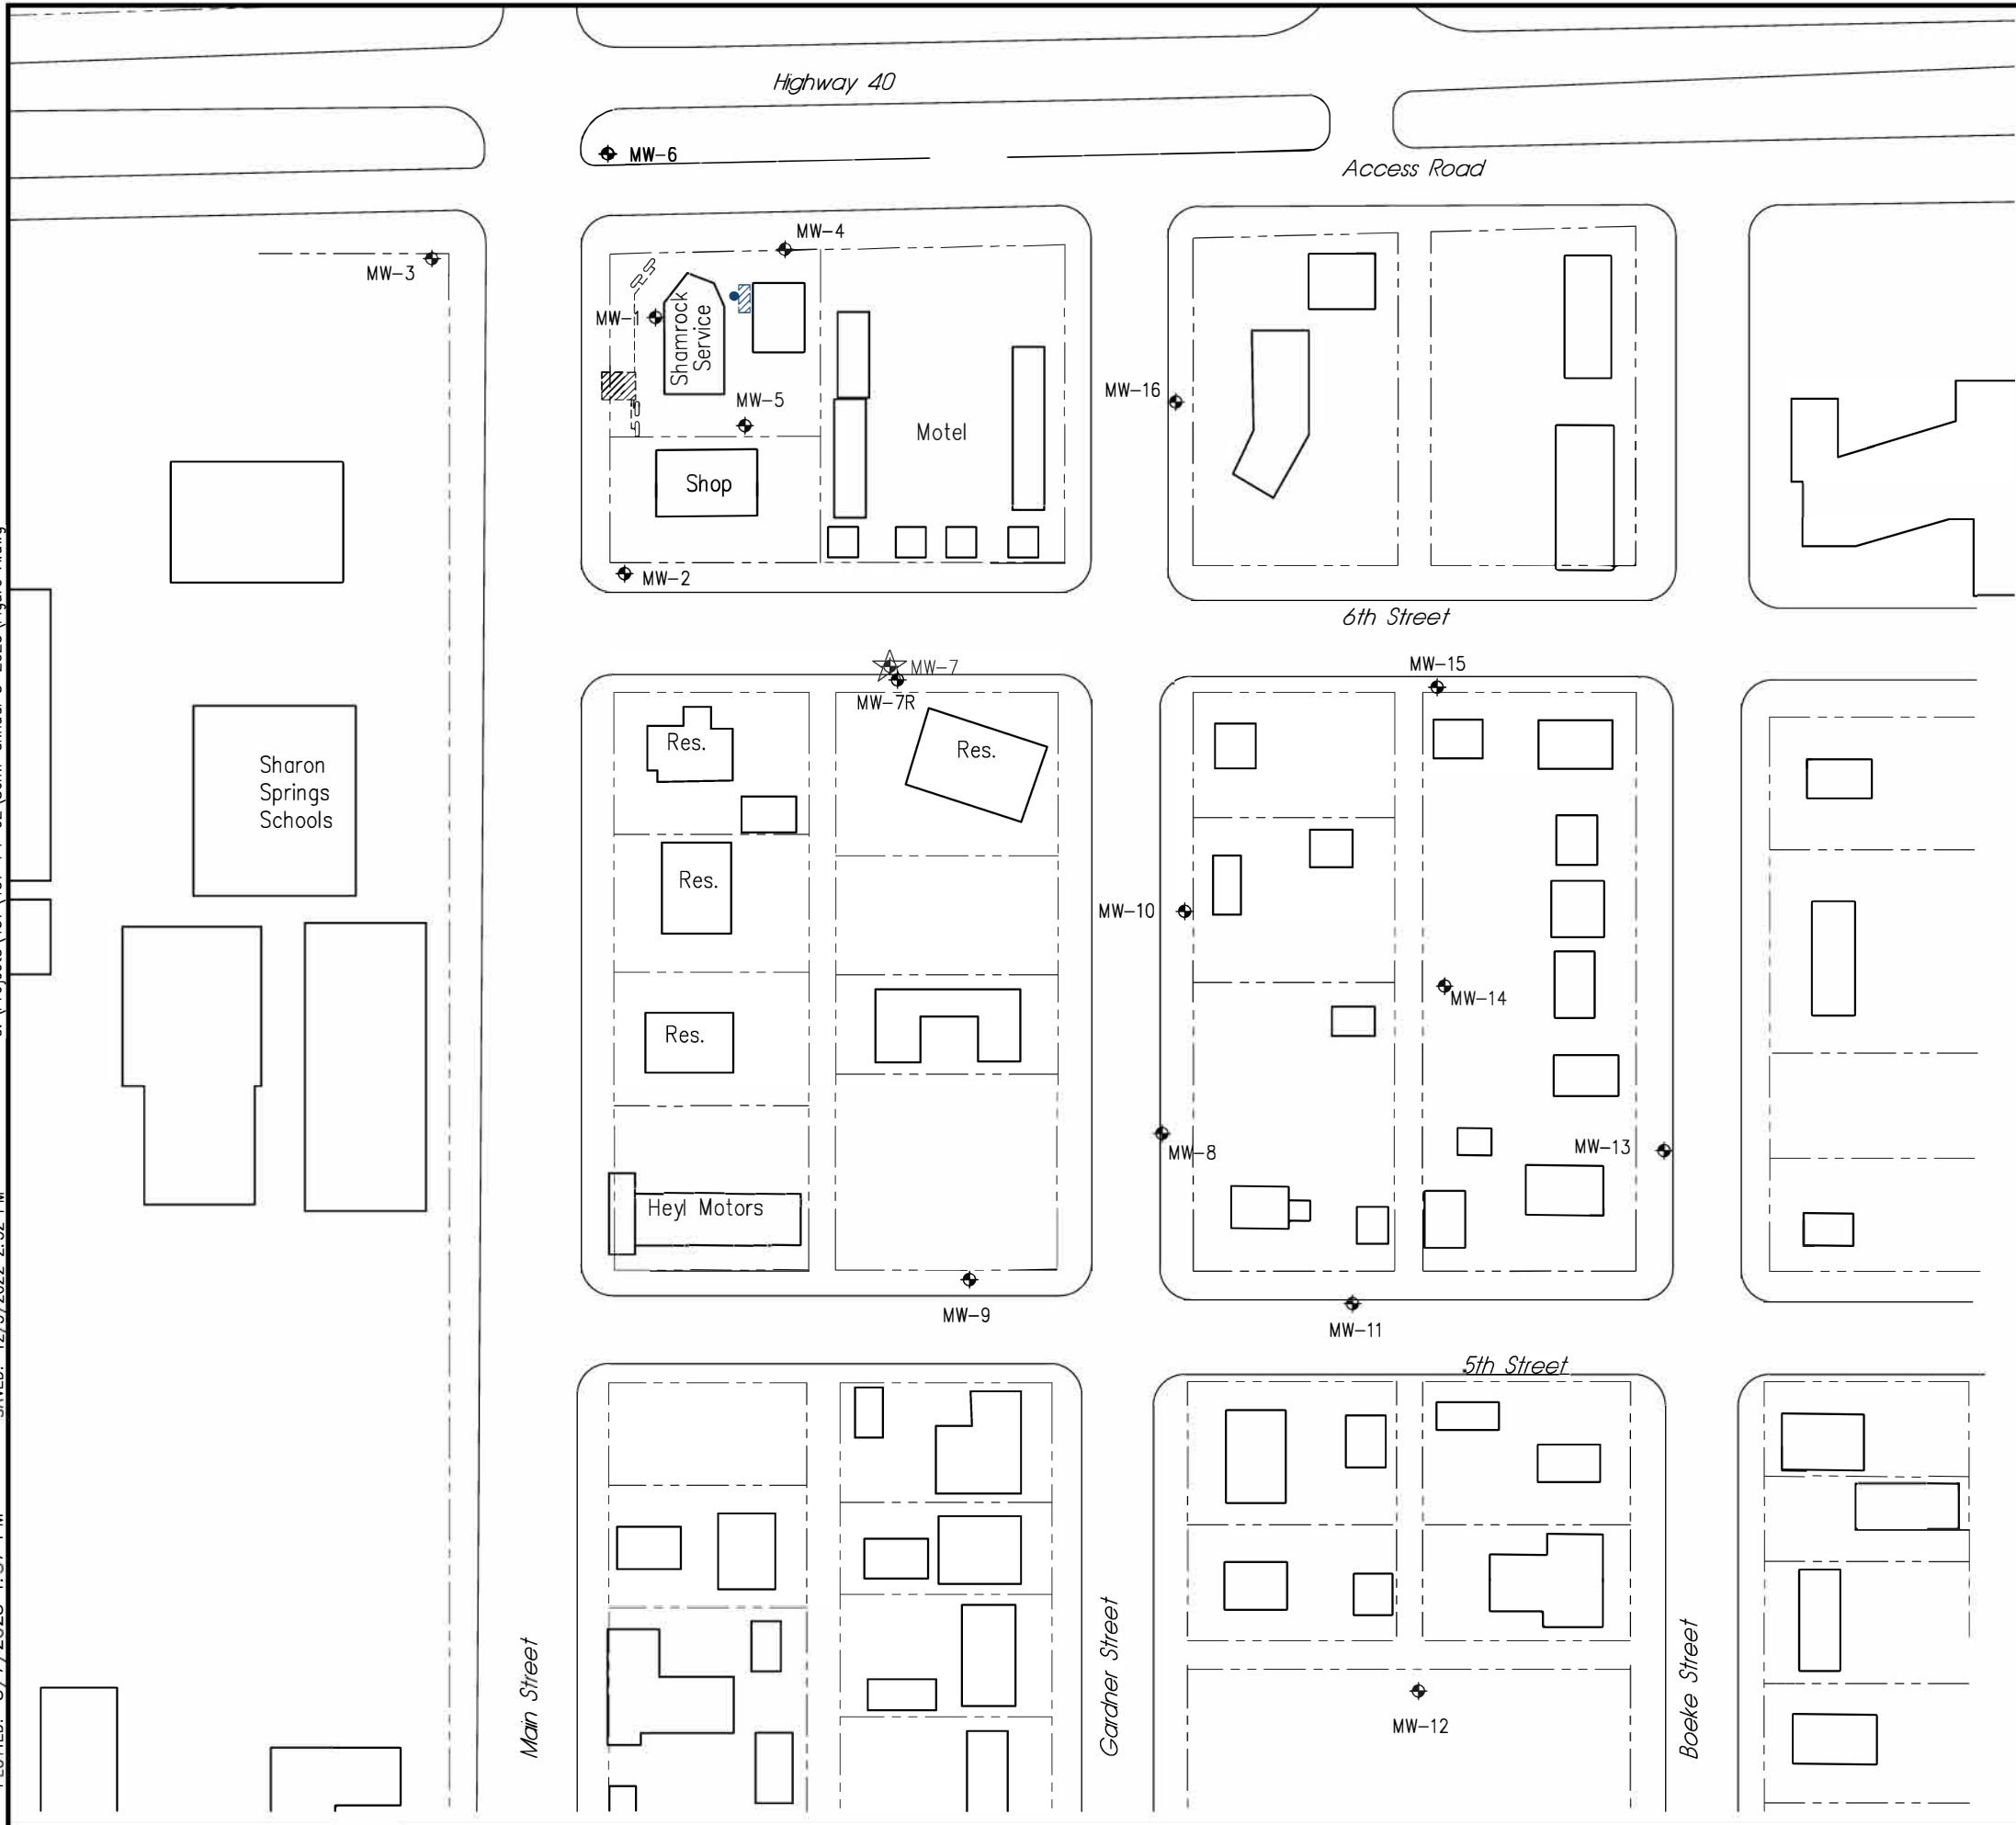
FIGURE A

- MONITORING WELL
- PLUGGED WELL
- FORMER UST BASIN
- FORMER PUMP ISLAND/PRODUCT LINES
