HOME OIL
BTEX ISOCONCENTRATION MAP
SELDEN, KANSAS U6-090-221

FIGURE 4-1

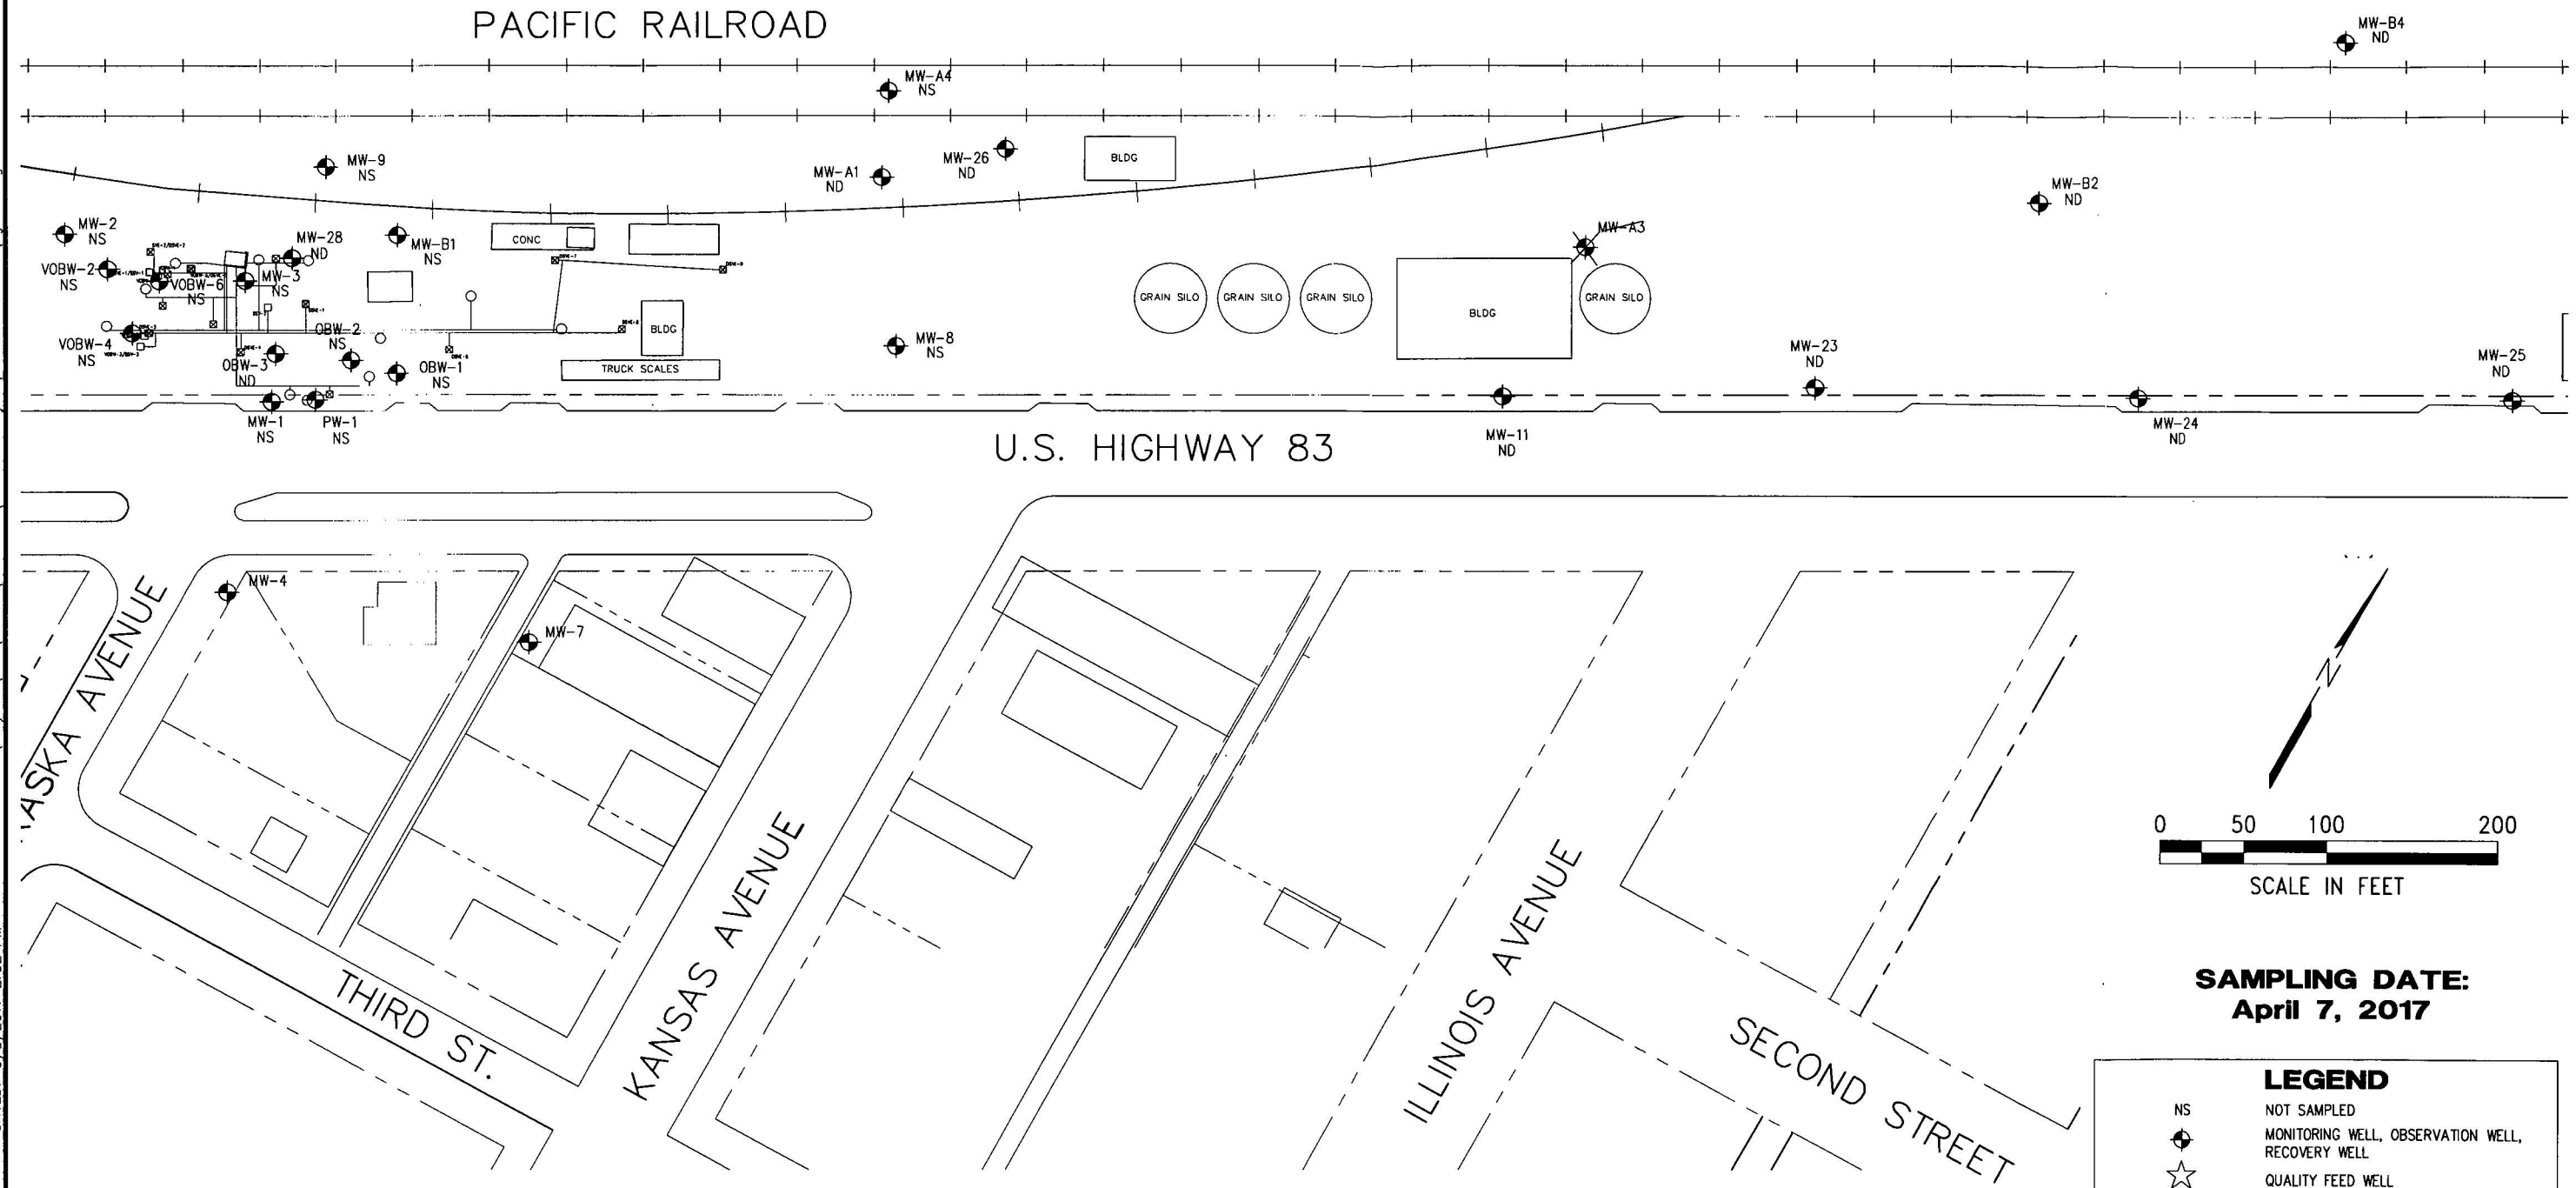
SAMPLING DATE:
April 7, 2017
