WATER WELL PLUGGING RECORD Form WWC-5P

MW-14

HOME OIL
1,2 DICHLOROETHANE ISOCONCENTRATION MAP
 SELDEN, KANSAS U6-090-221

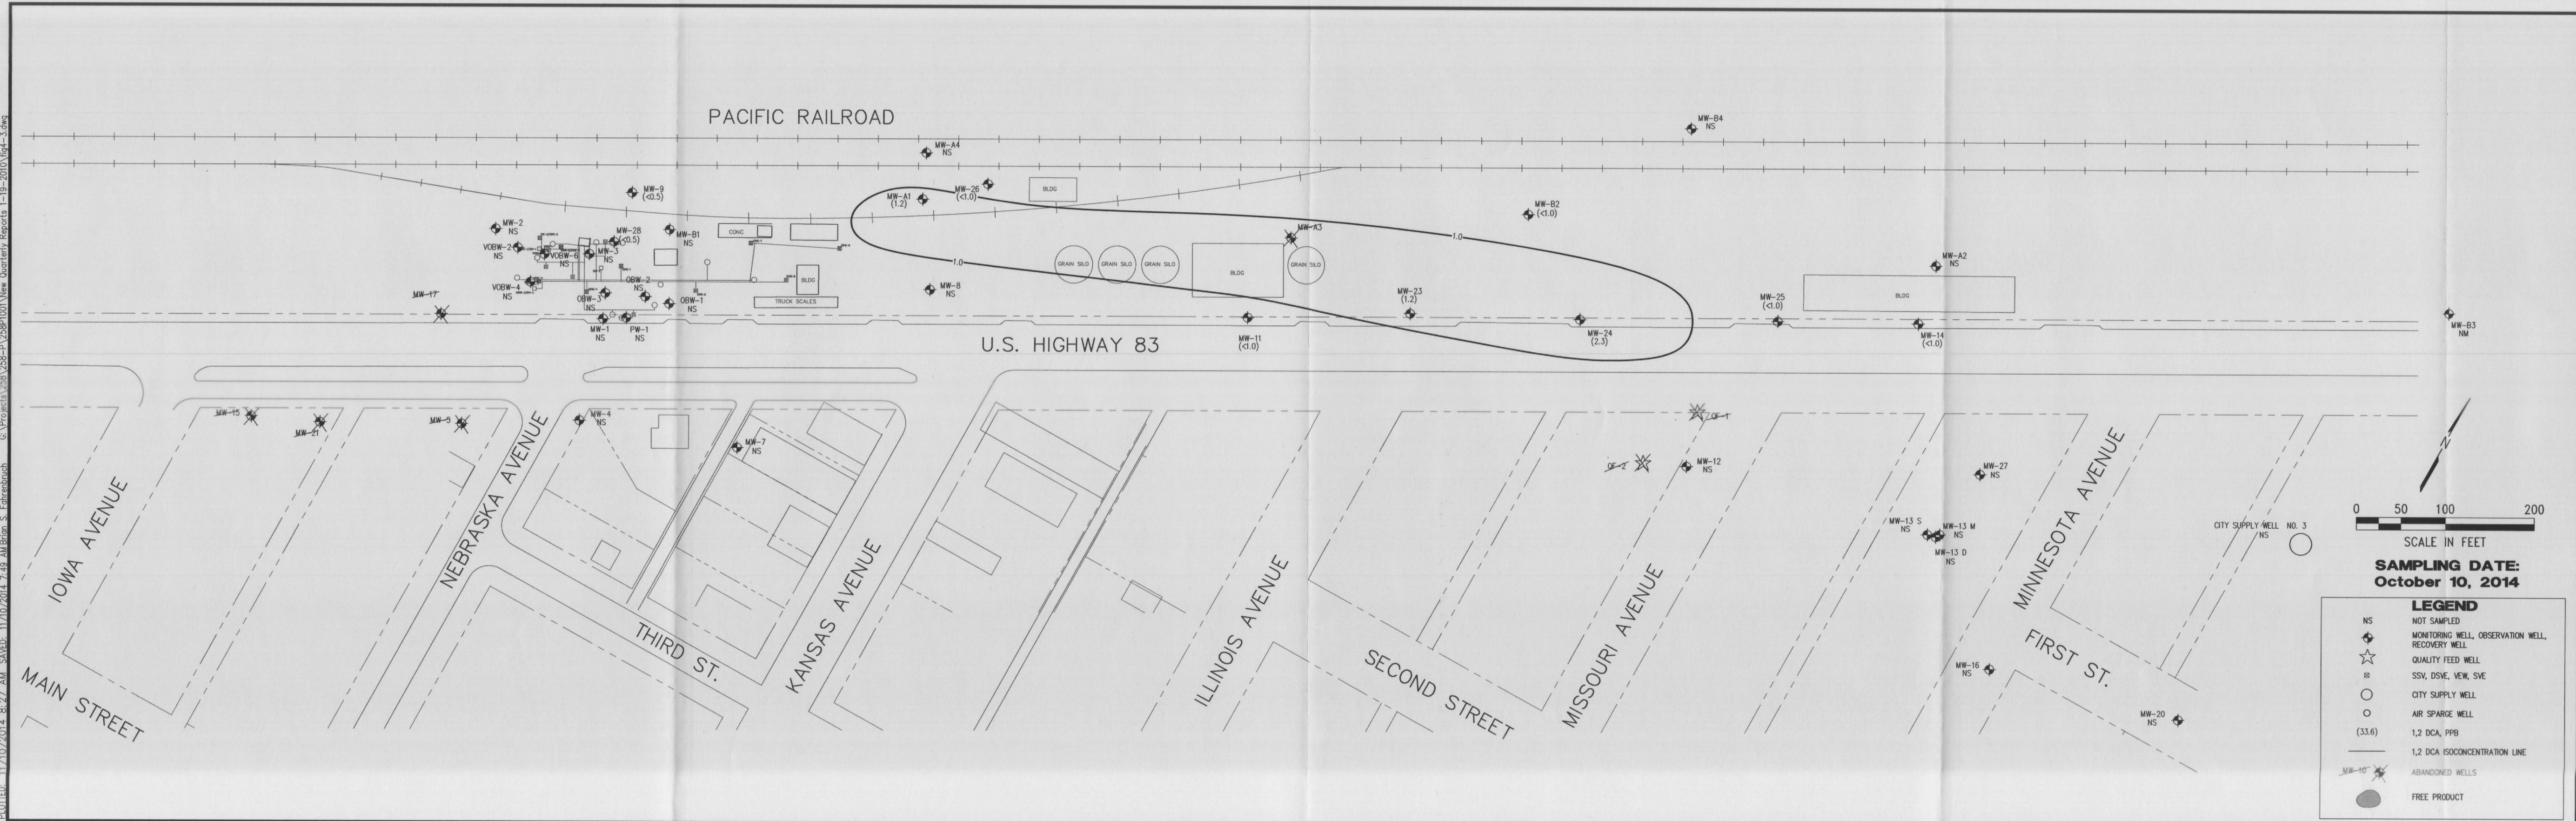
FIGURE 4.3

SCALE IN FEET
SAMPLING DATE:
October 10, 2014
