# Dual Compensated Porosity Log

Pioneer Energy Services

Medicine Lodge KS, South to Sumac RD,  
1 3/4 West, 1/4 NorthEast, South Into

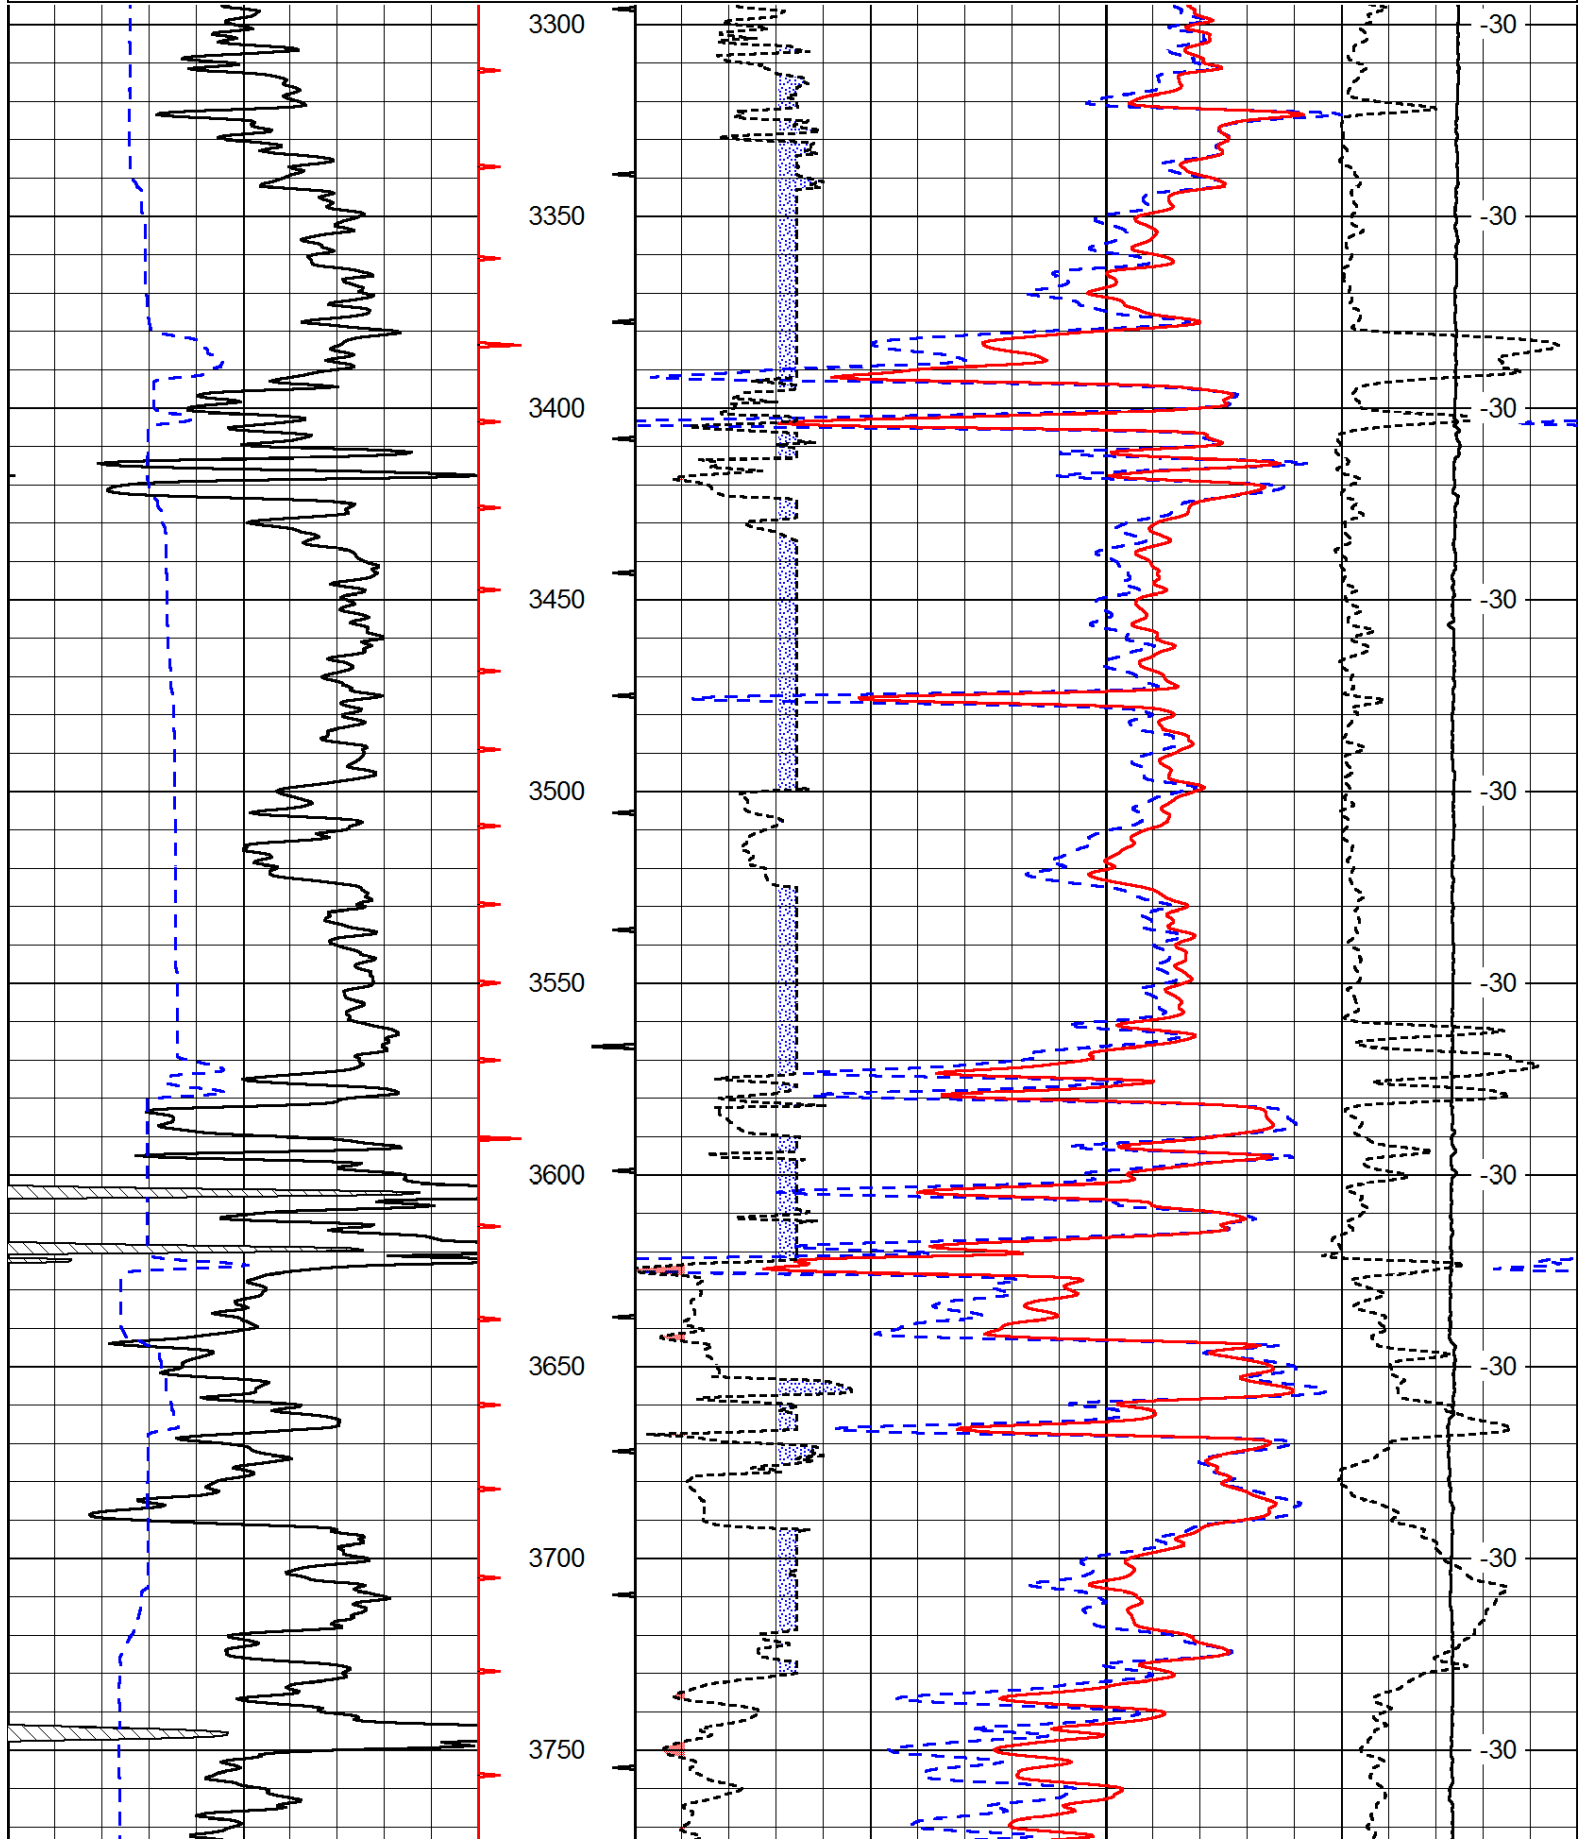
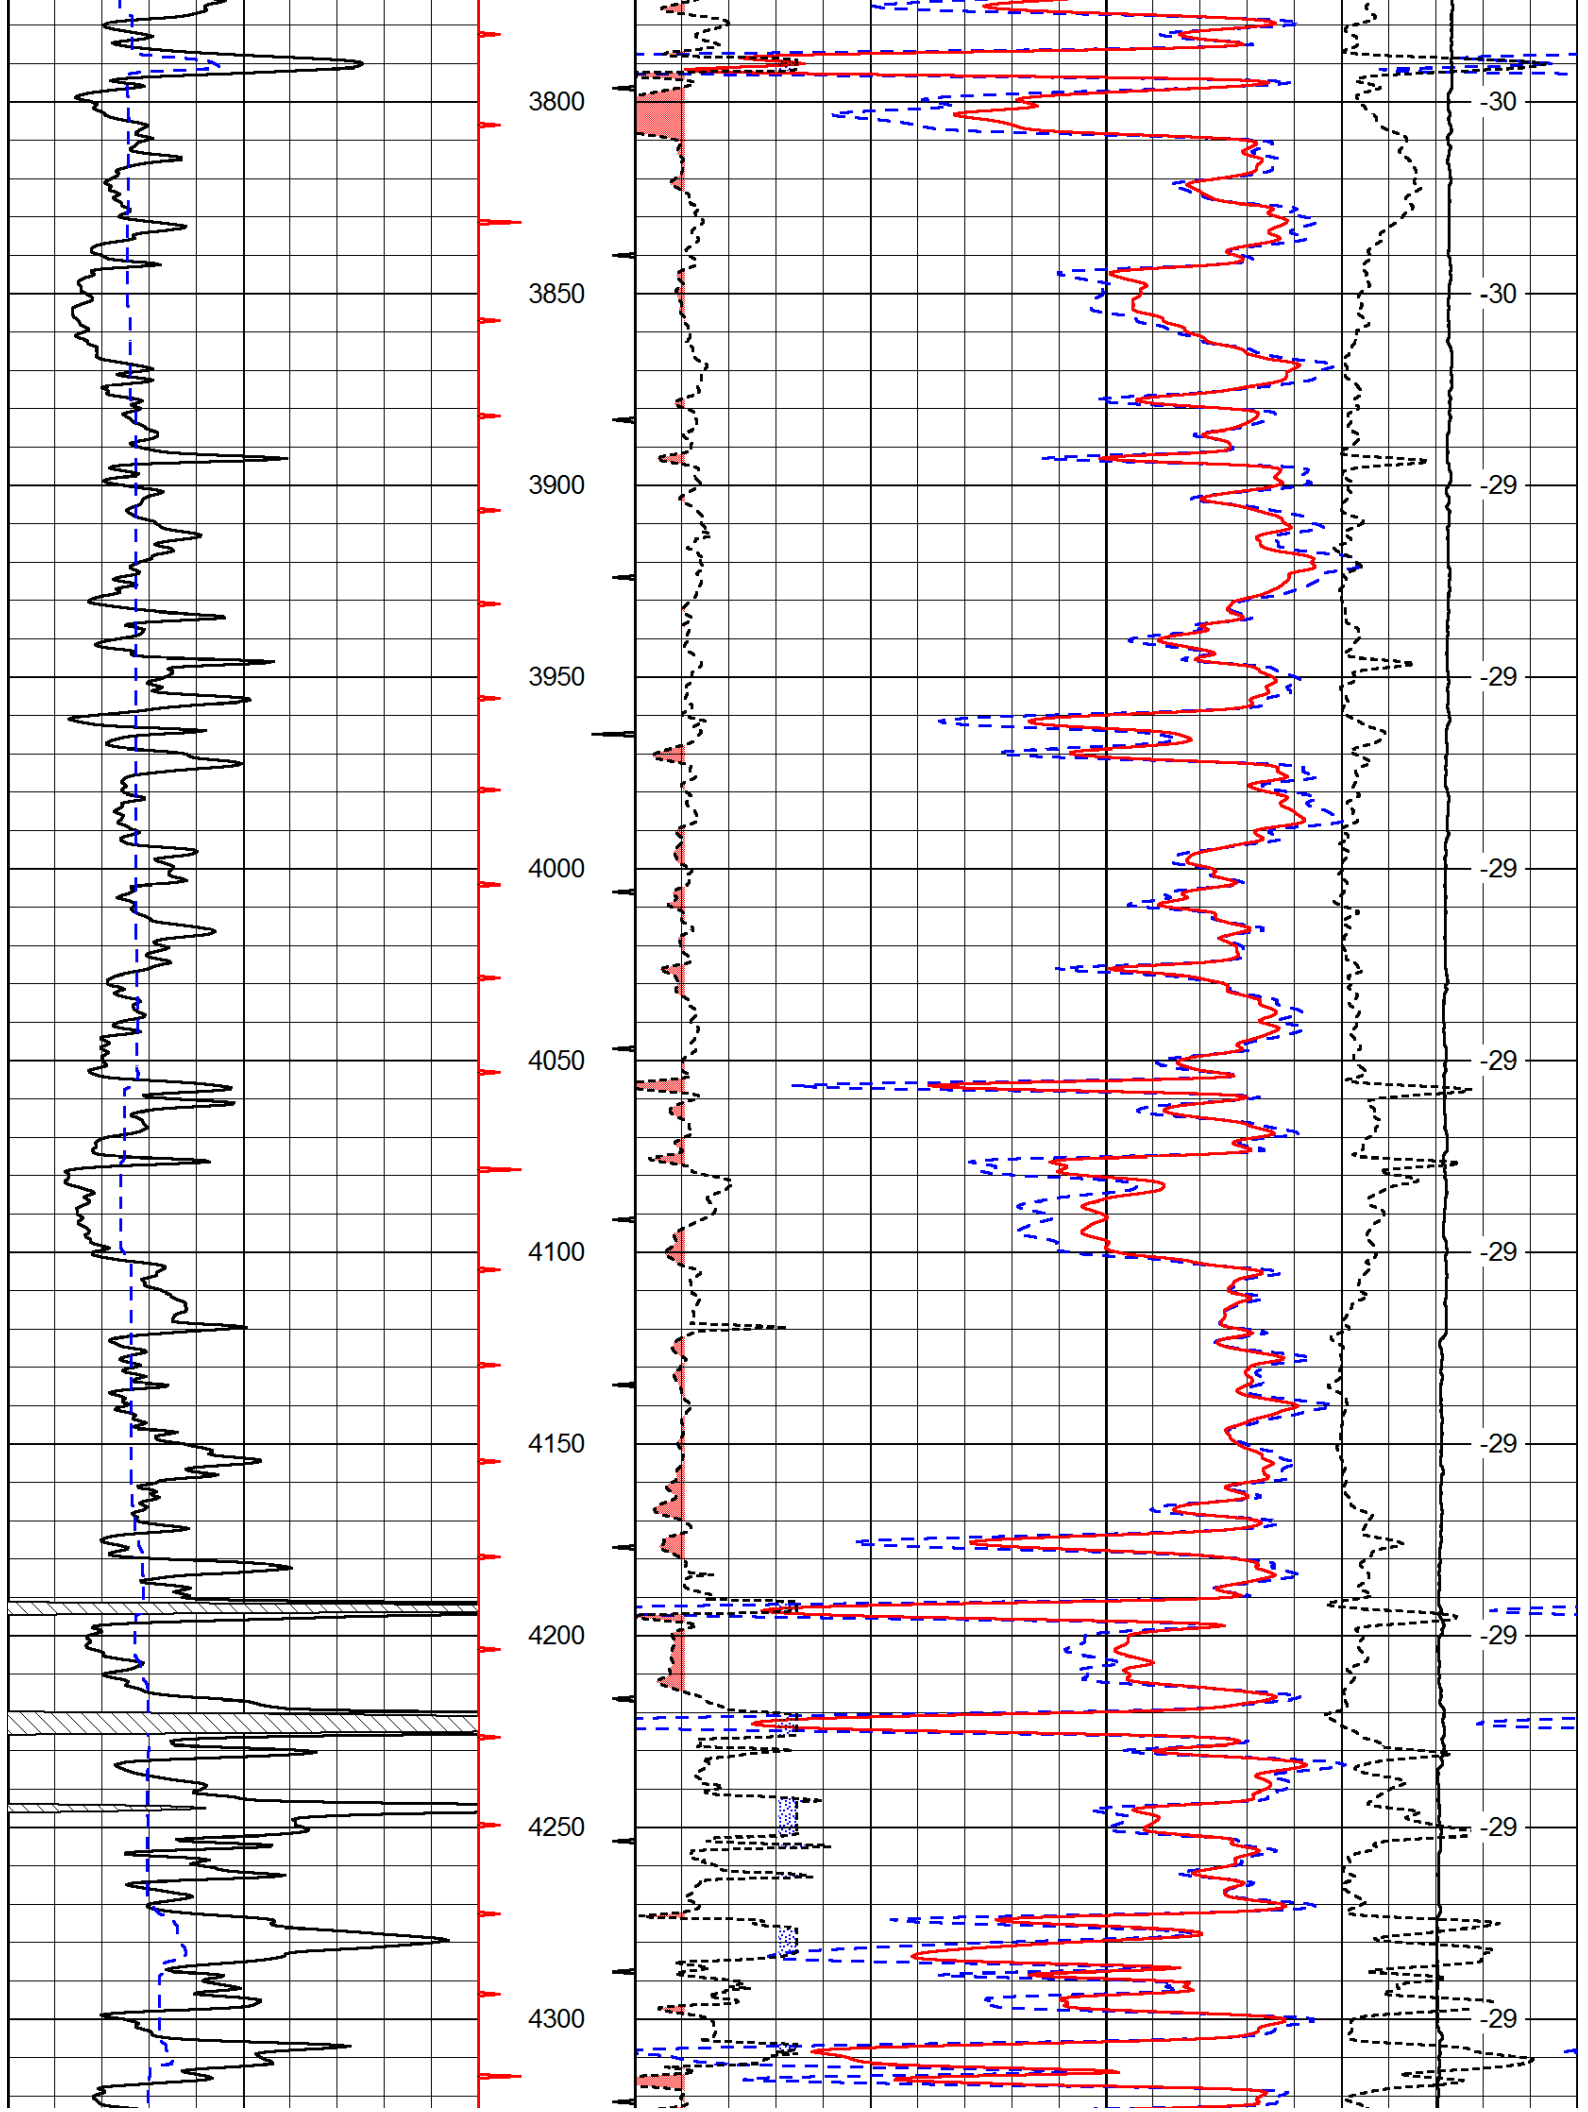
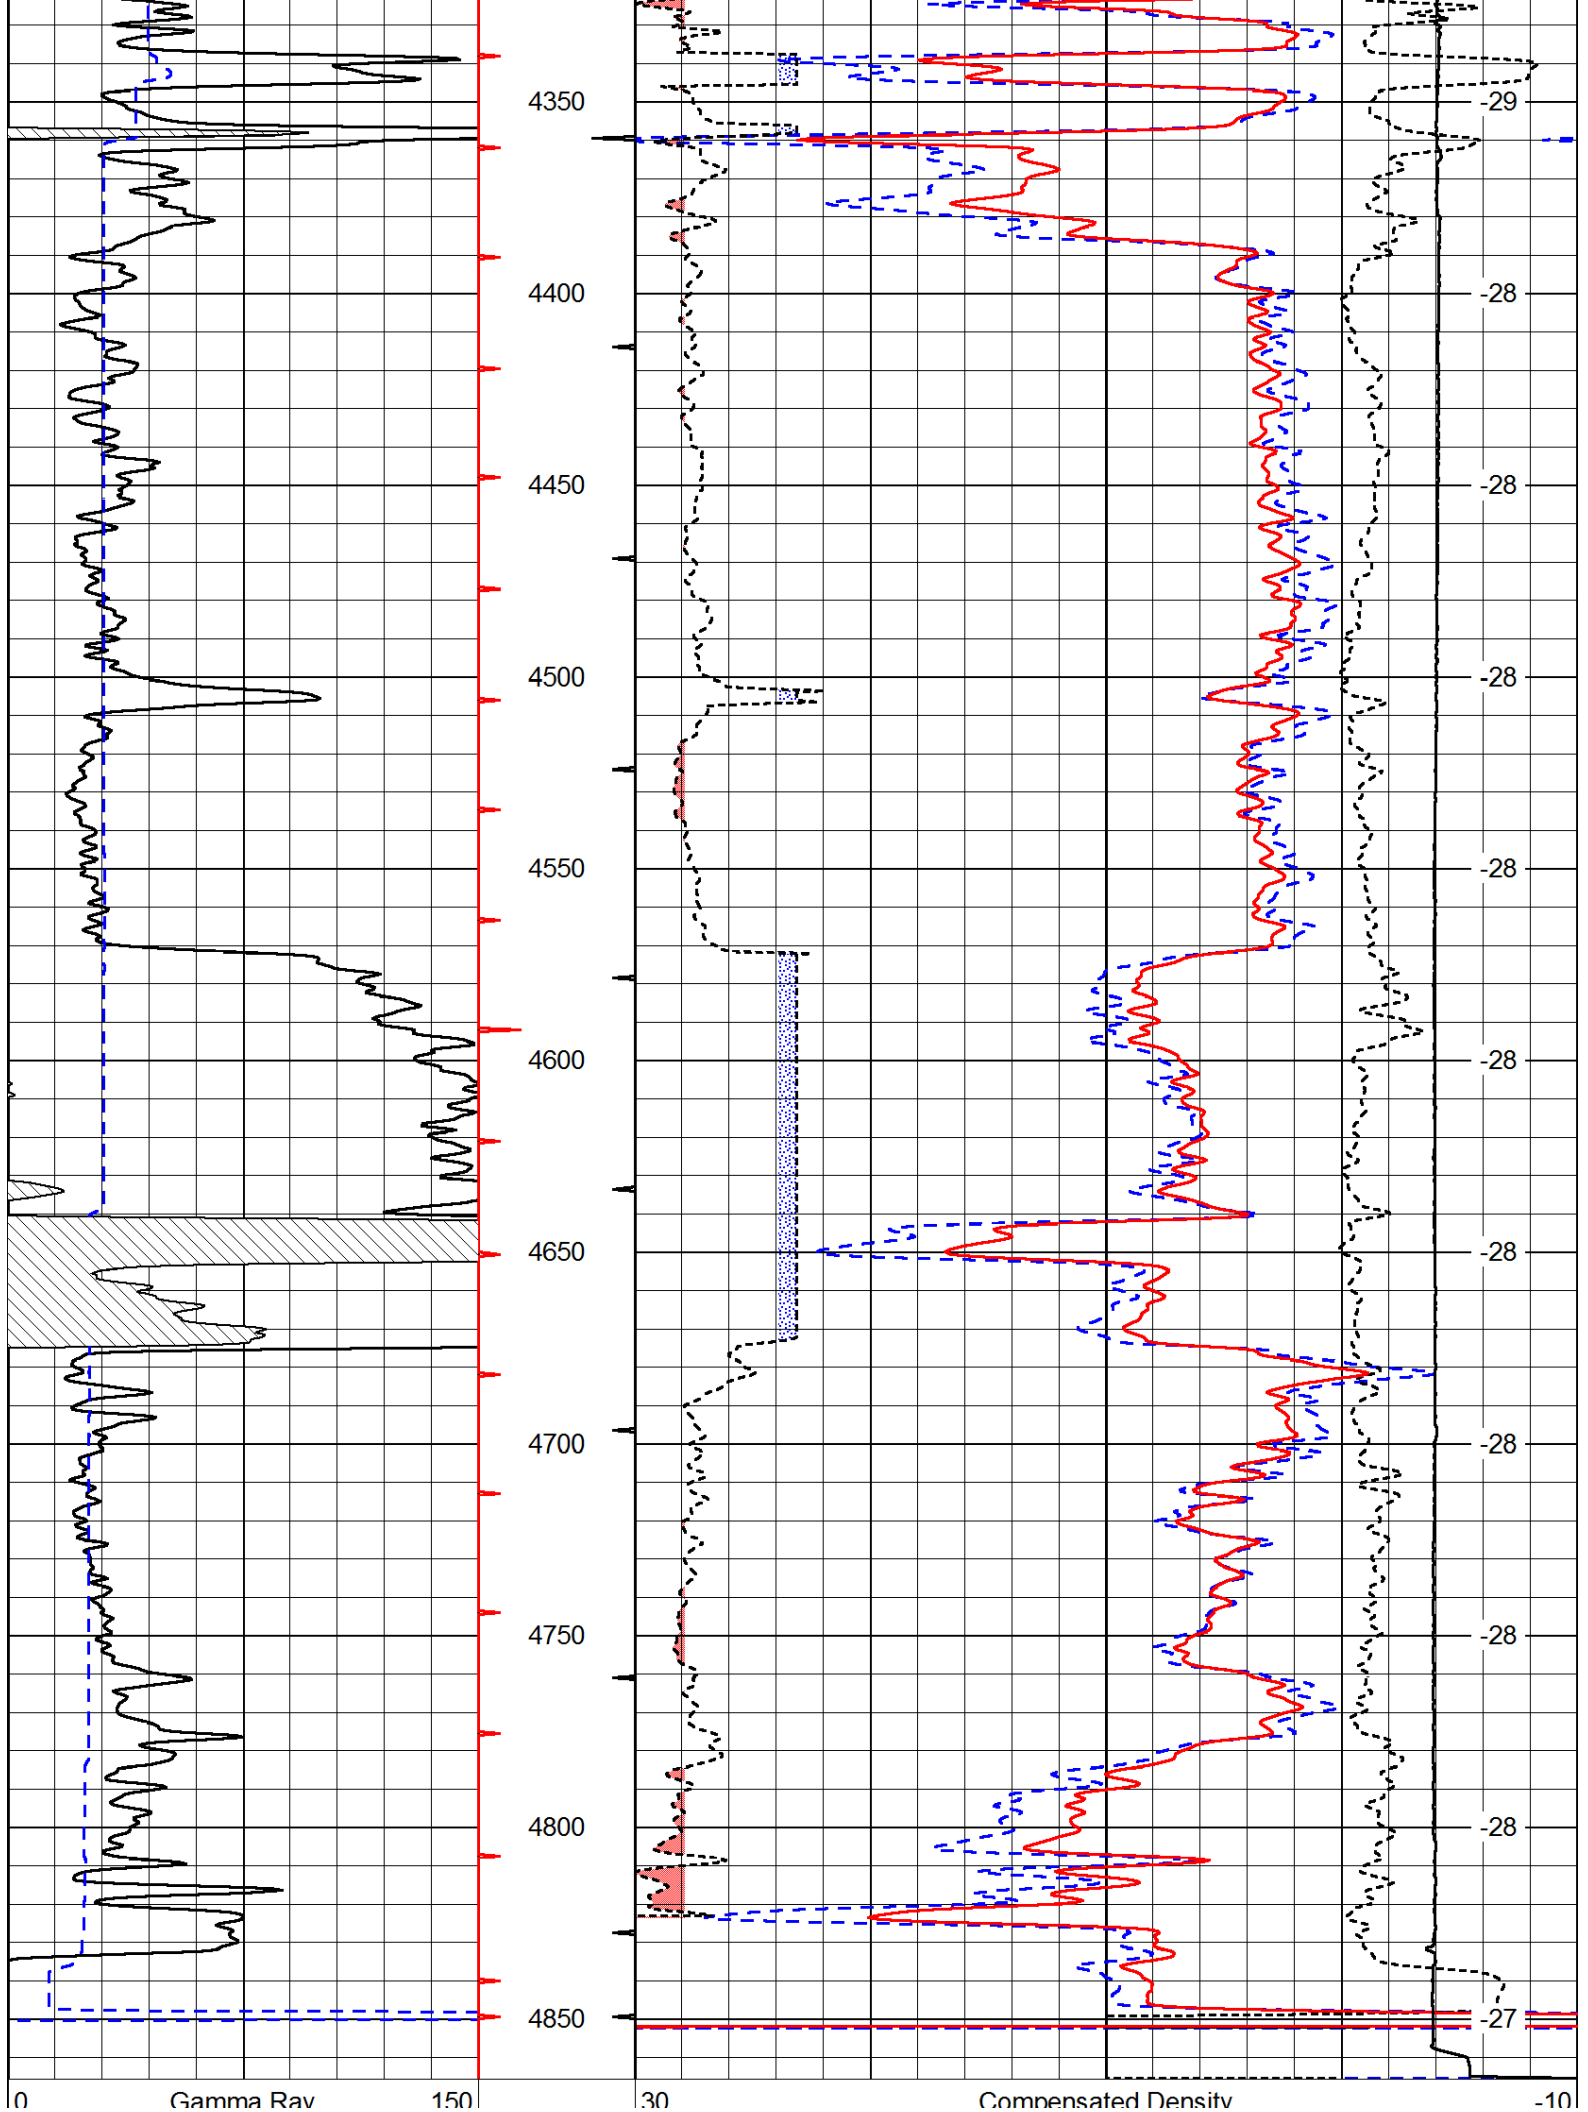
Charted by: Depth in Feet scaled 1:600

| 0 | Gamma Ray | 150 | 30 | Compensated Density | | -10 |
| 6 | Caliper (GAPI) | 16 | 2 | Bulk Density | | 3 |
| | | | 15000 | Line Tension | | 0 |
| | | | 2.625 | DGA | 3.425 | -0.25 |
