# Dual Compensated Porosity Log

Pioneer Energy Services

Medicine Lodge KS, South to Sumac RD,  
1 3/4 West, 1/4 NorthEast, South Into

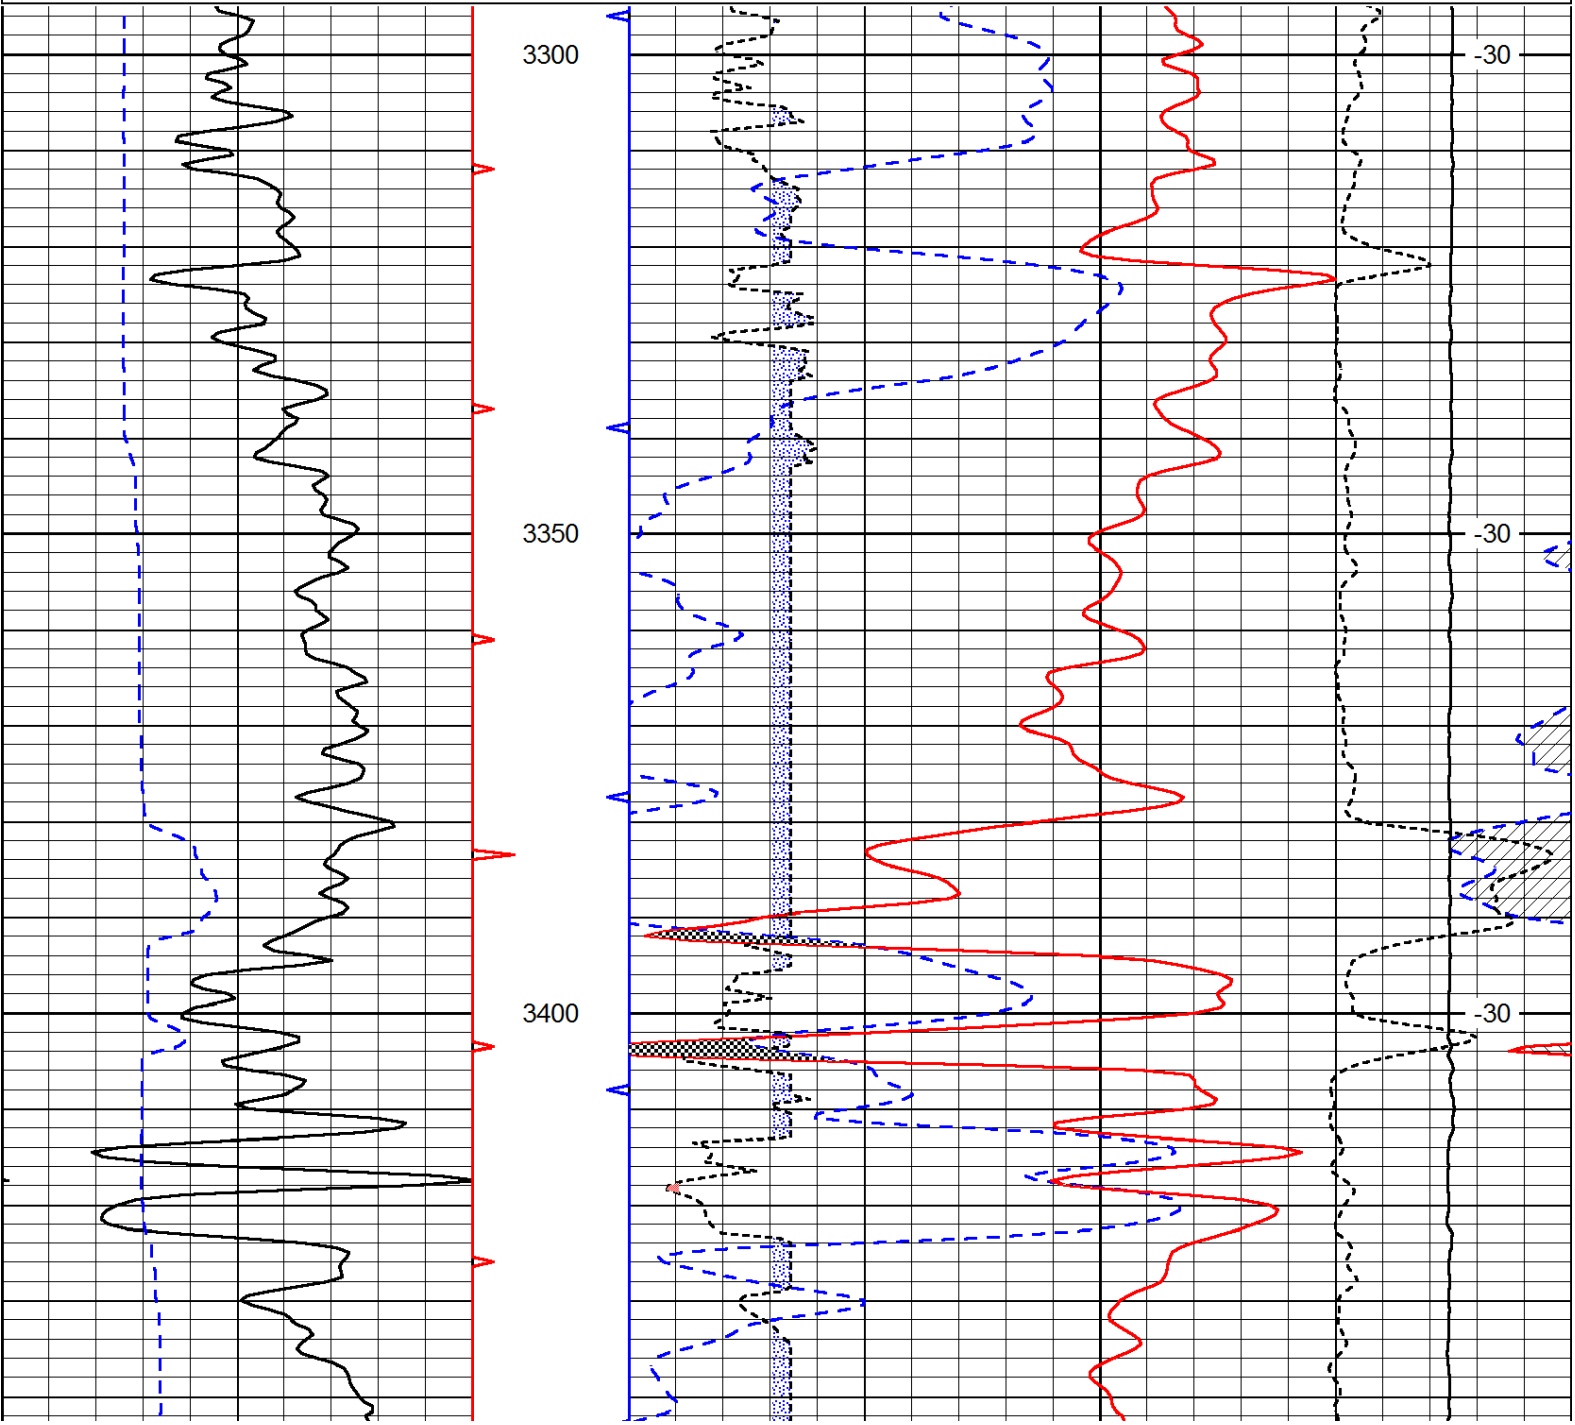
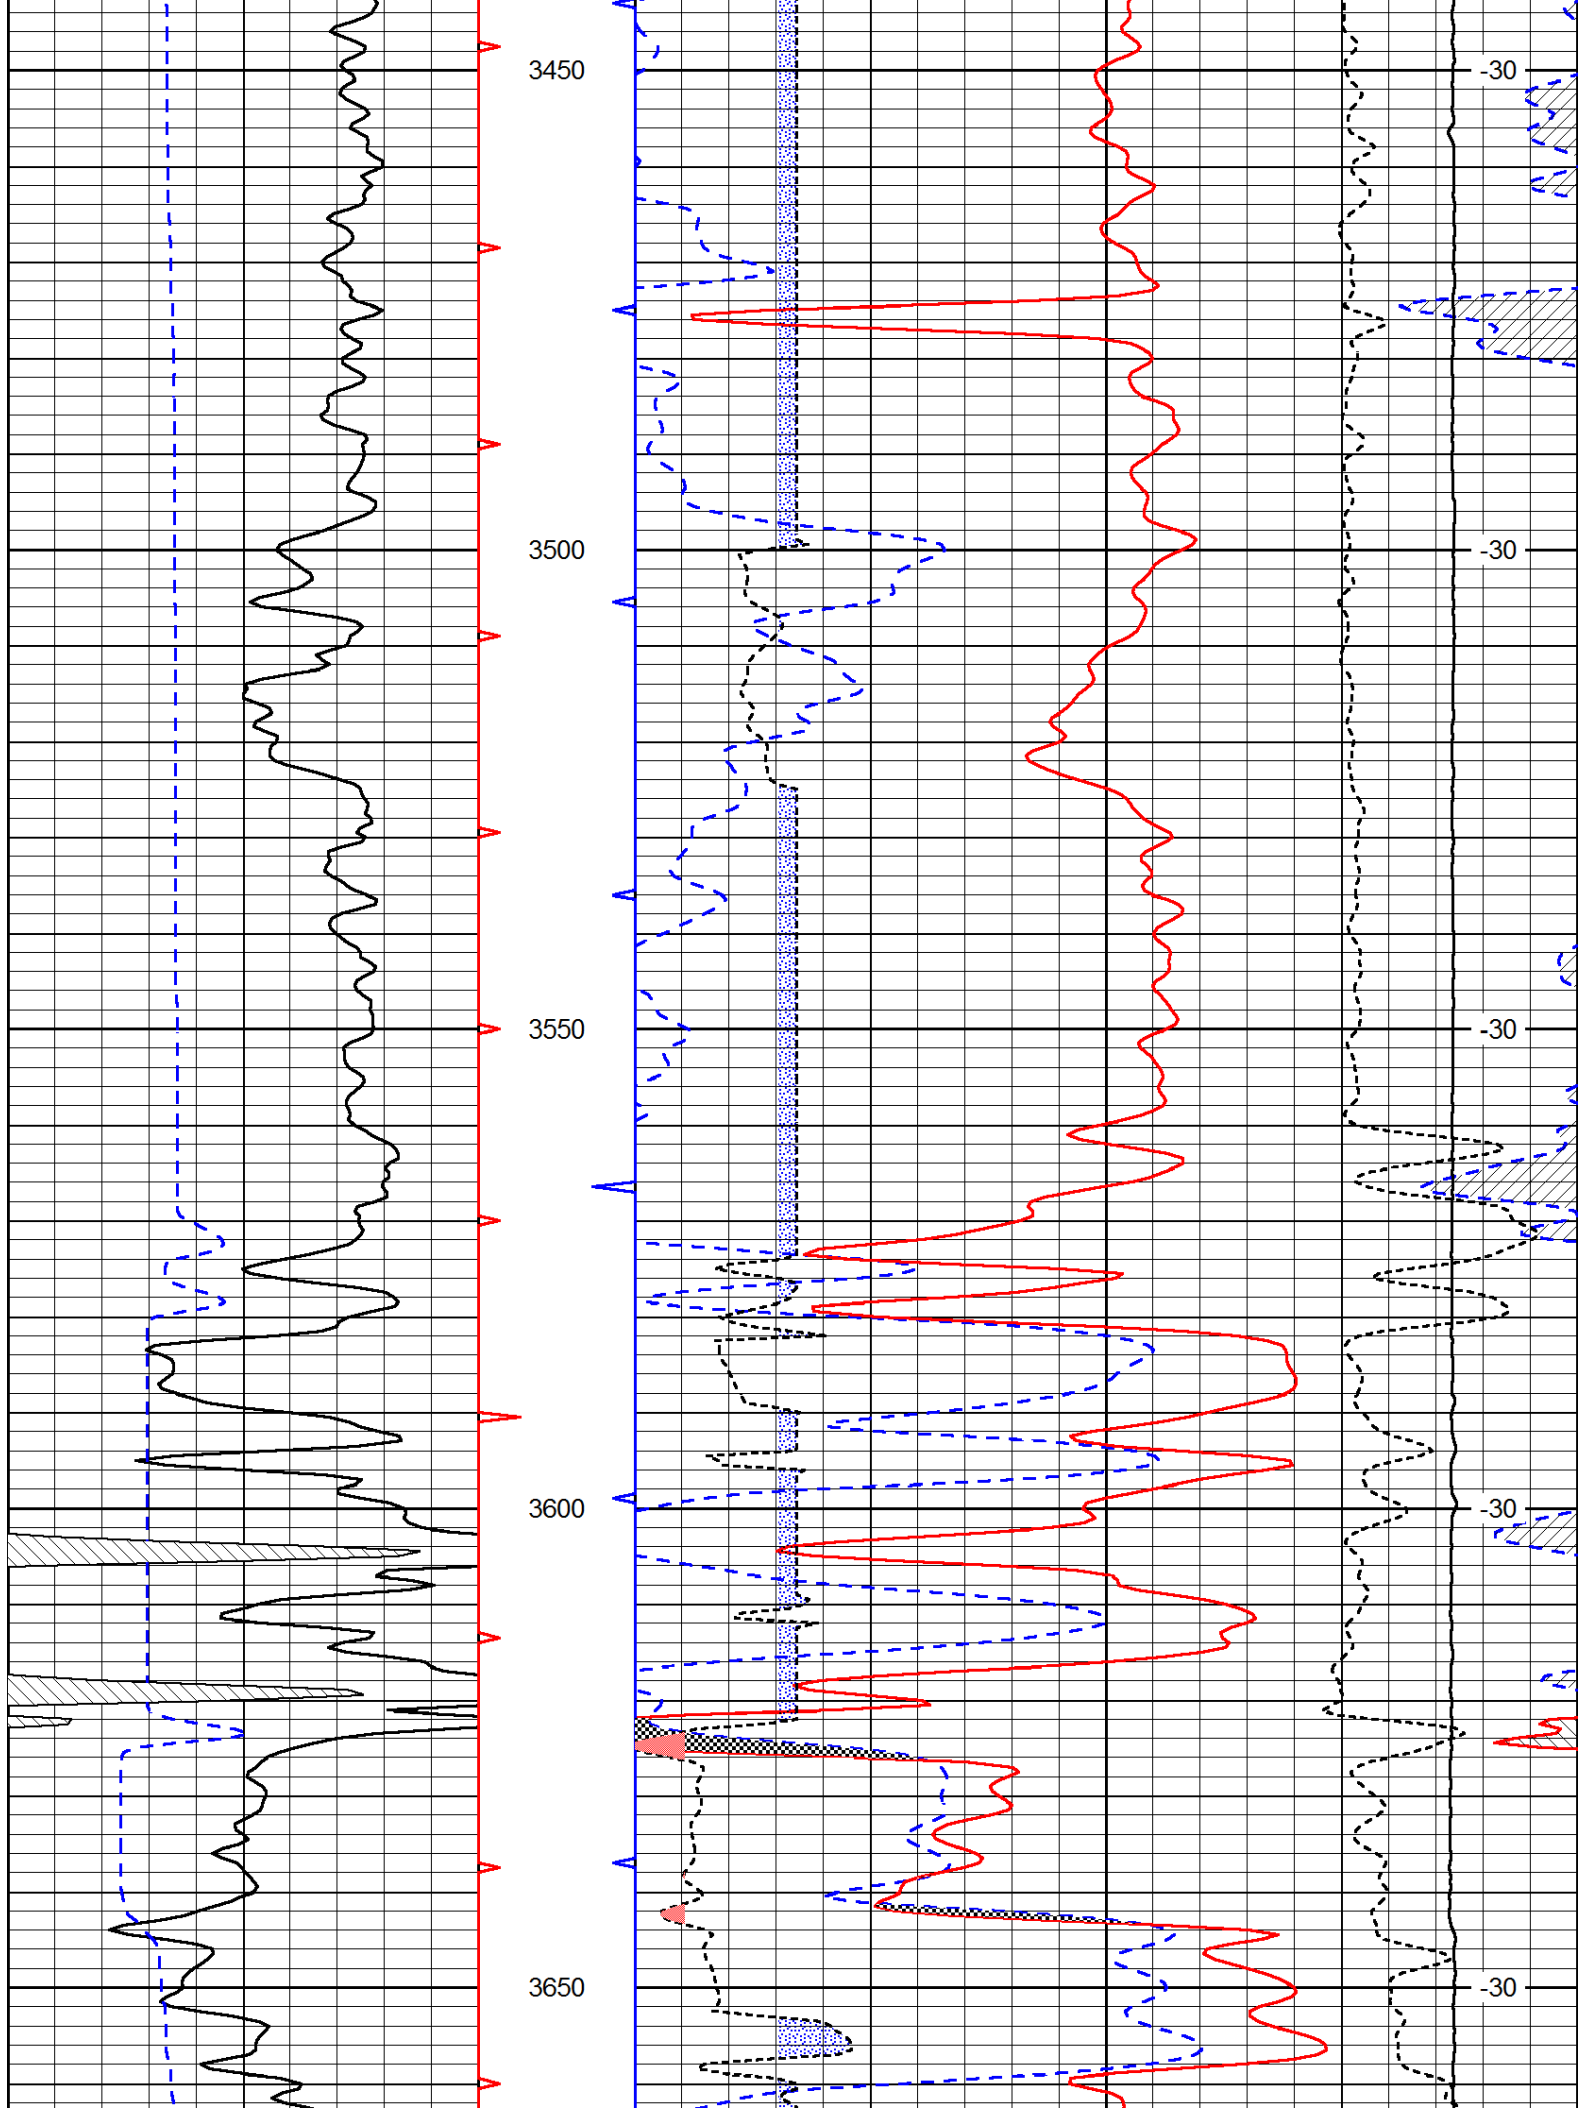
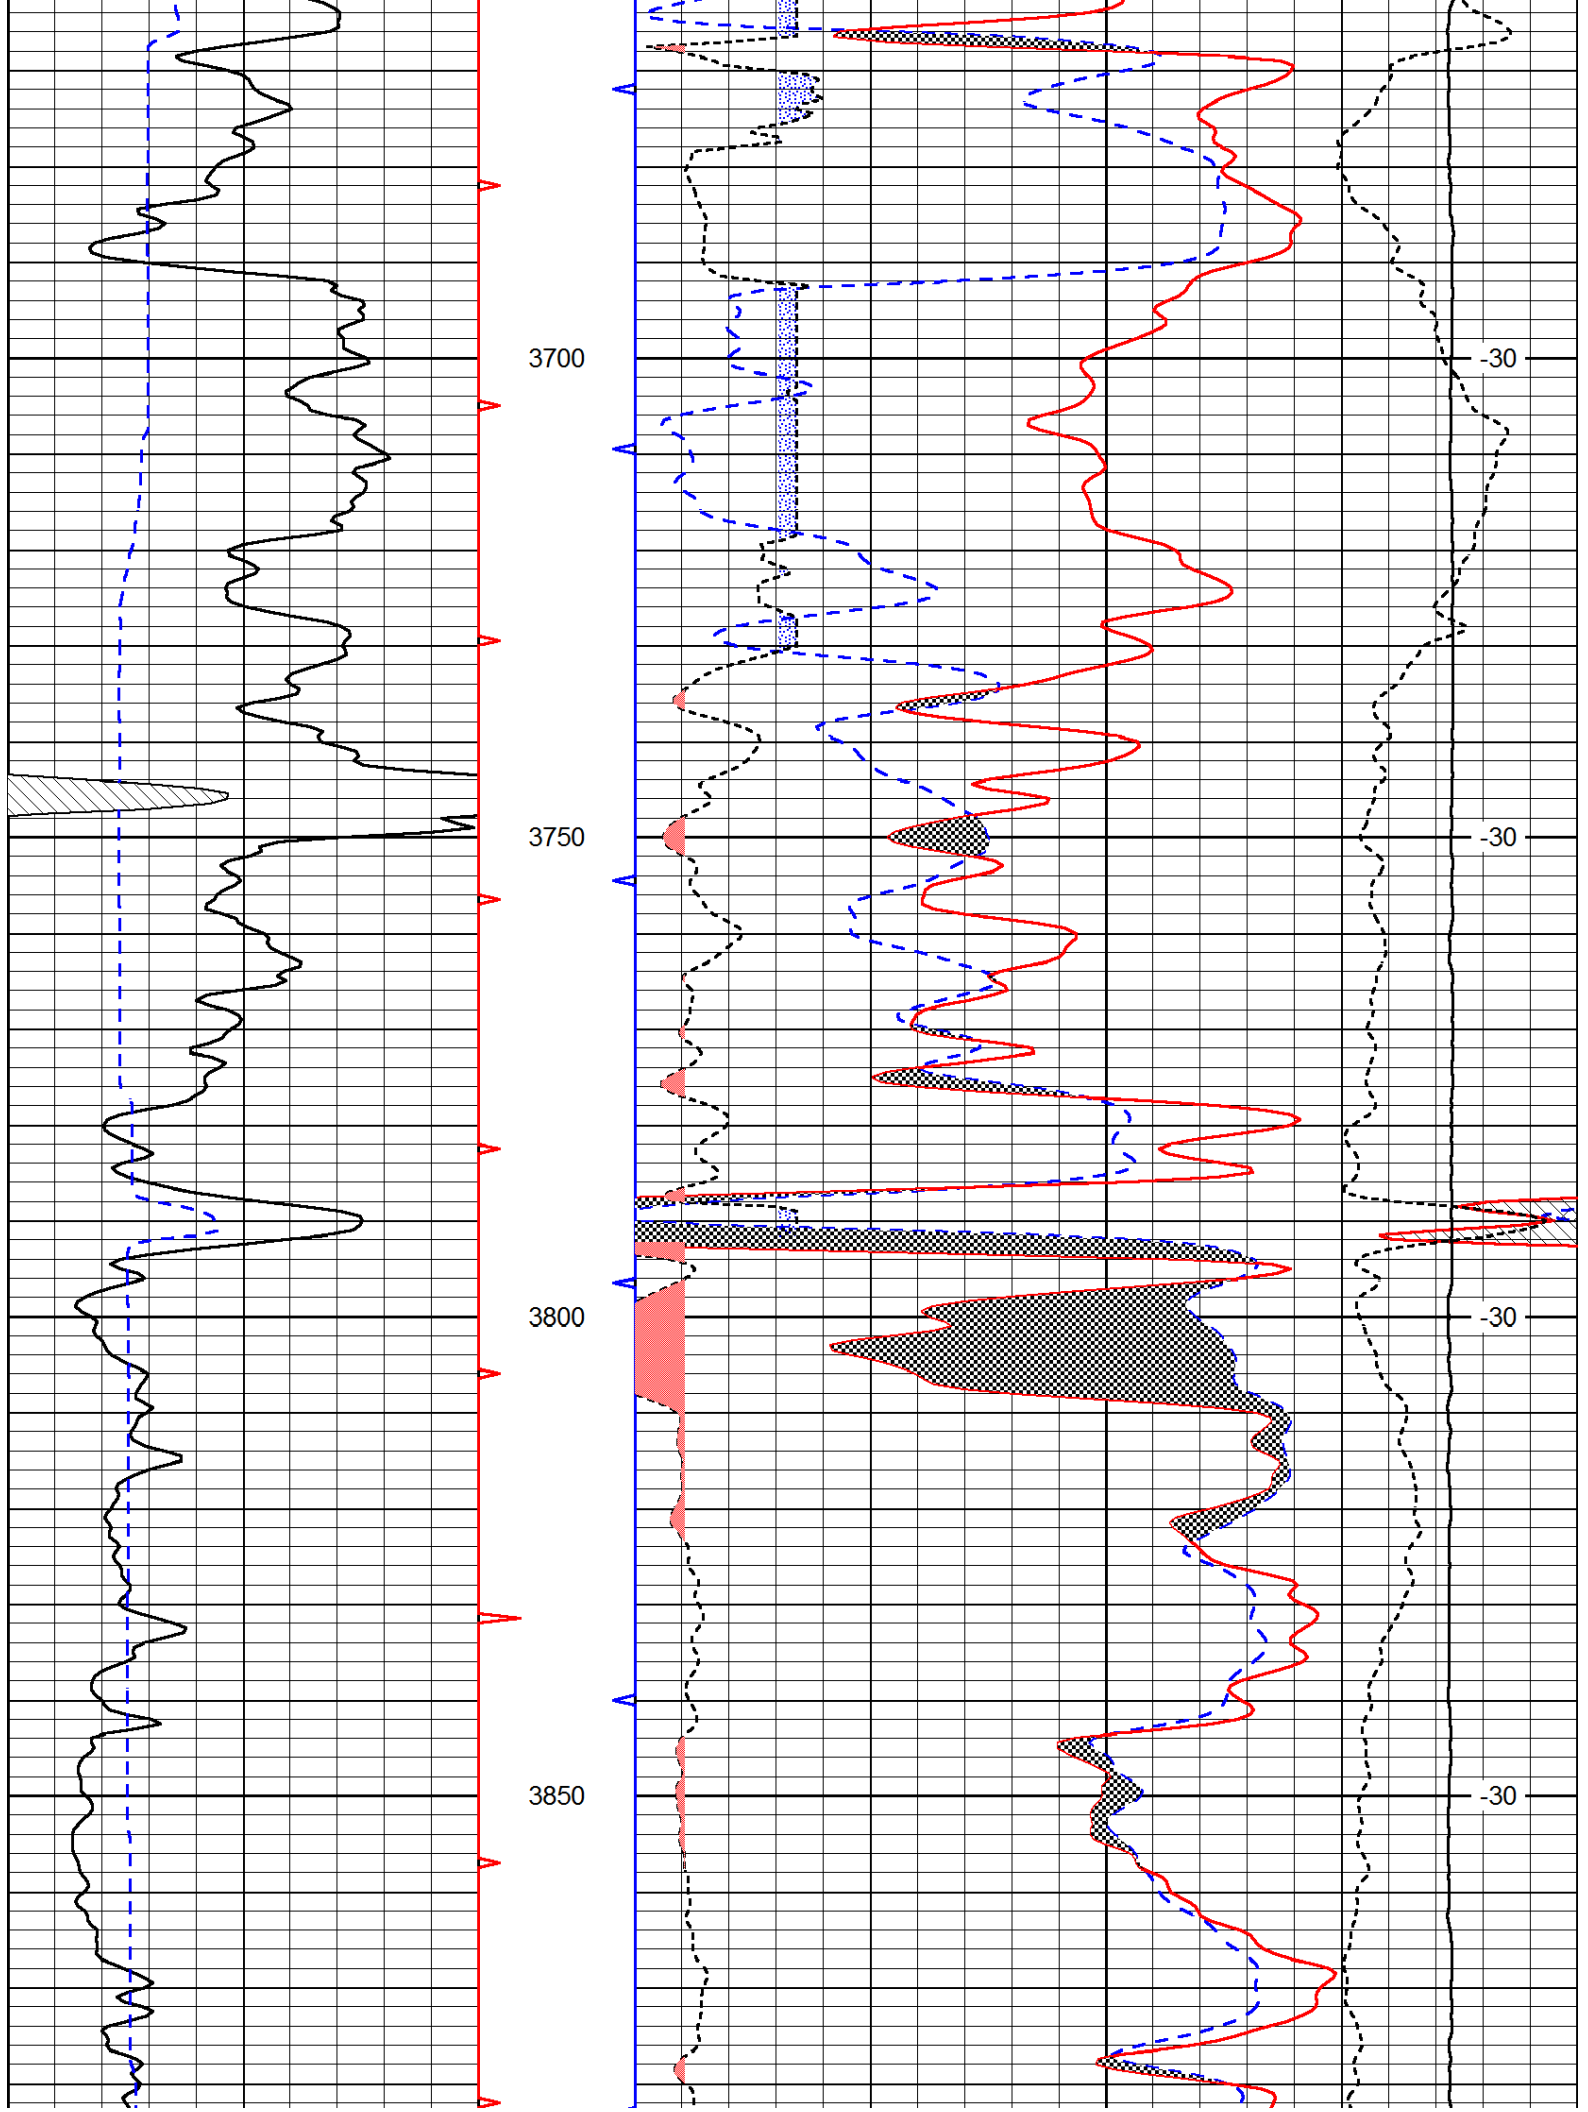
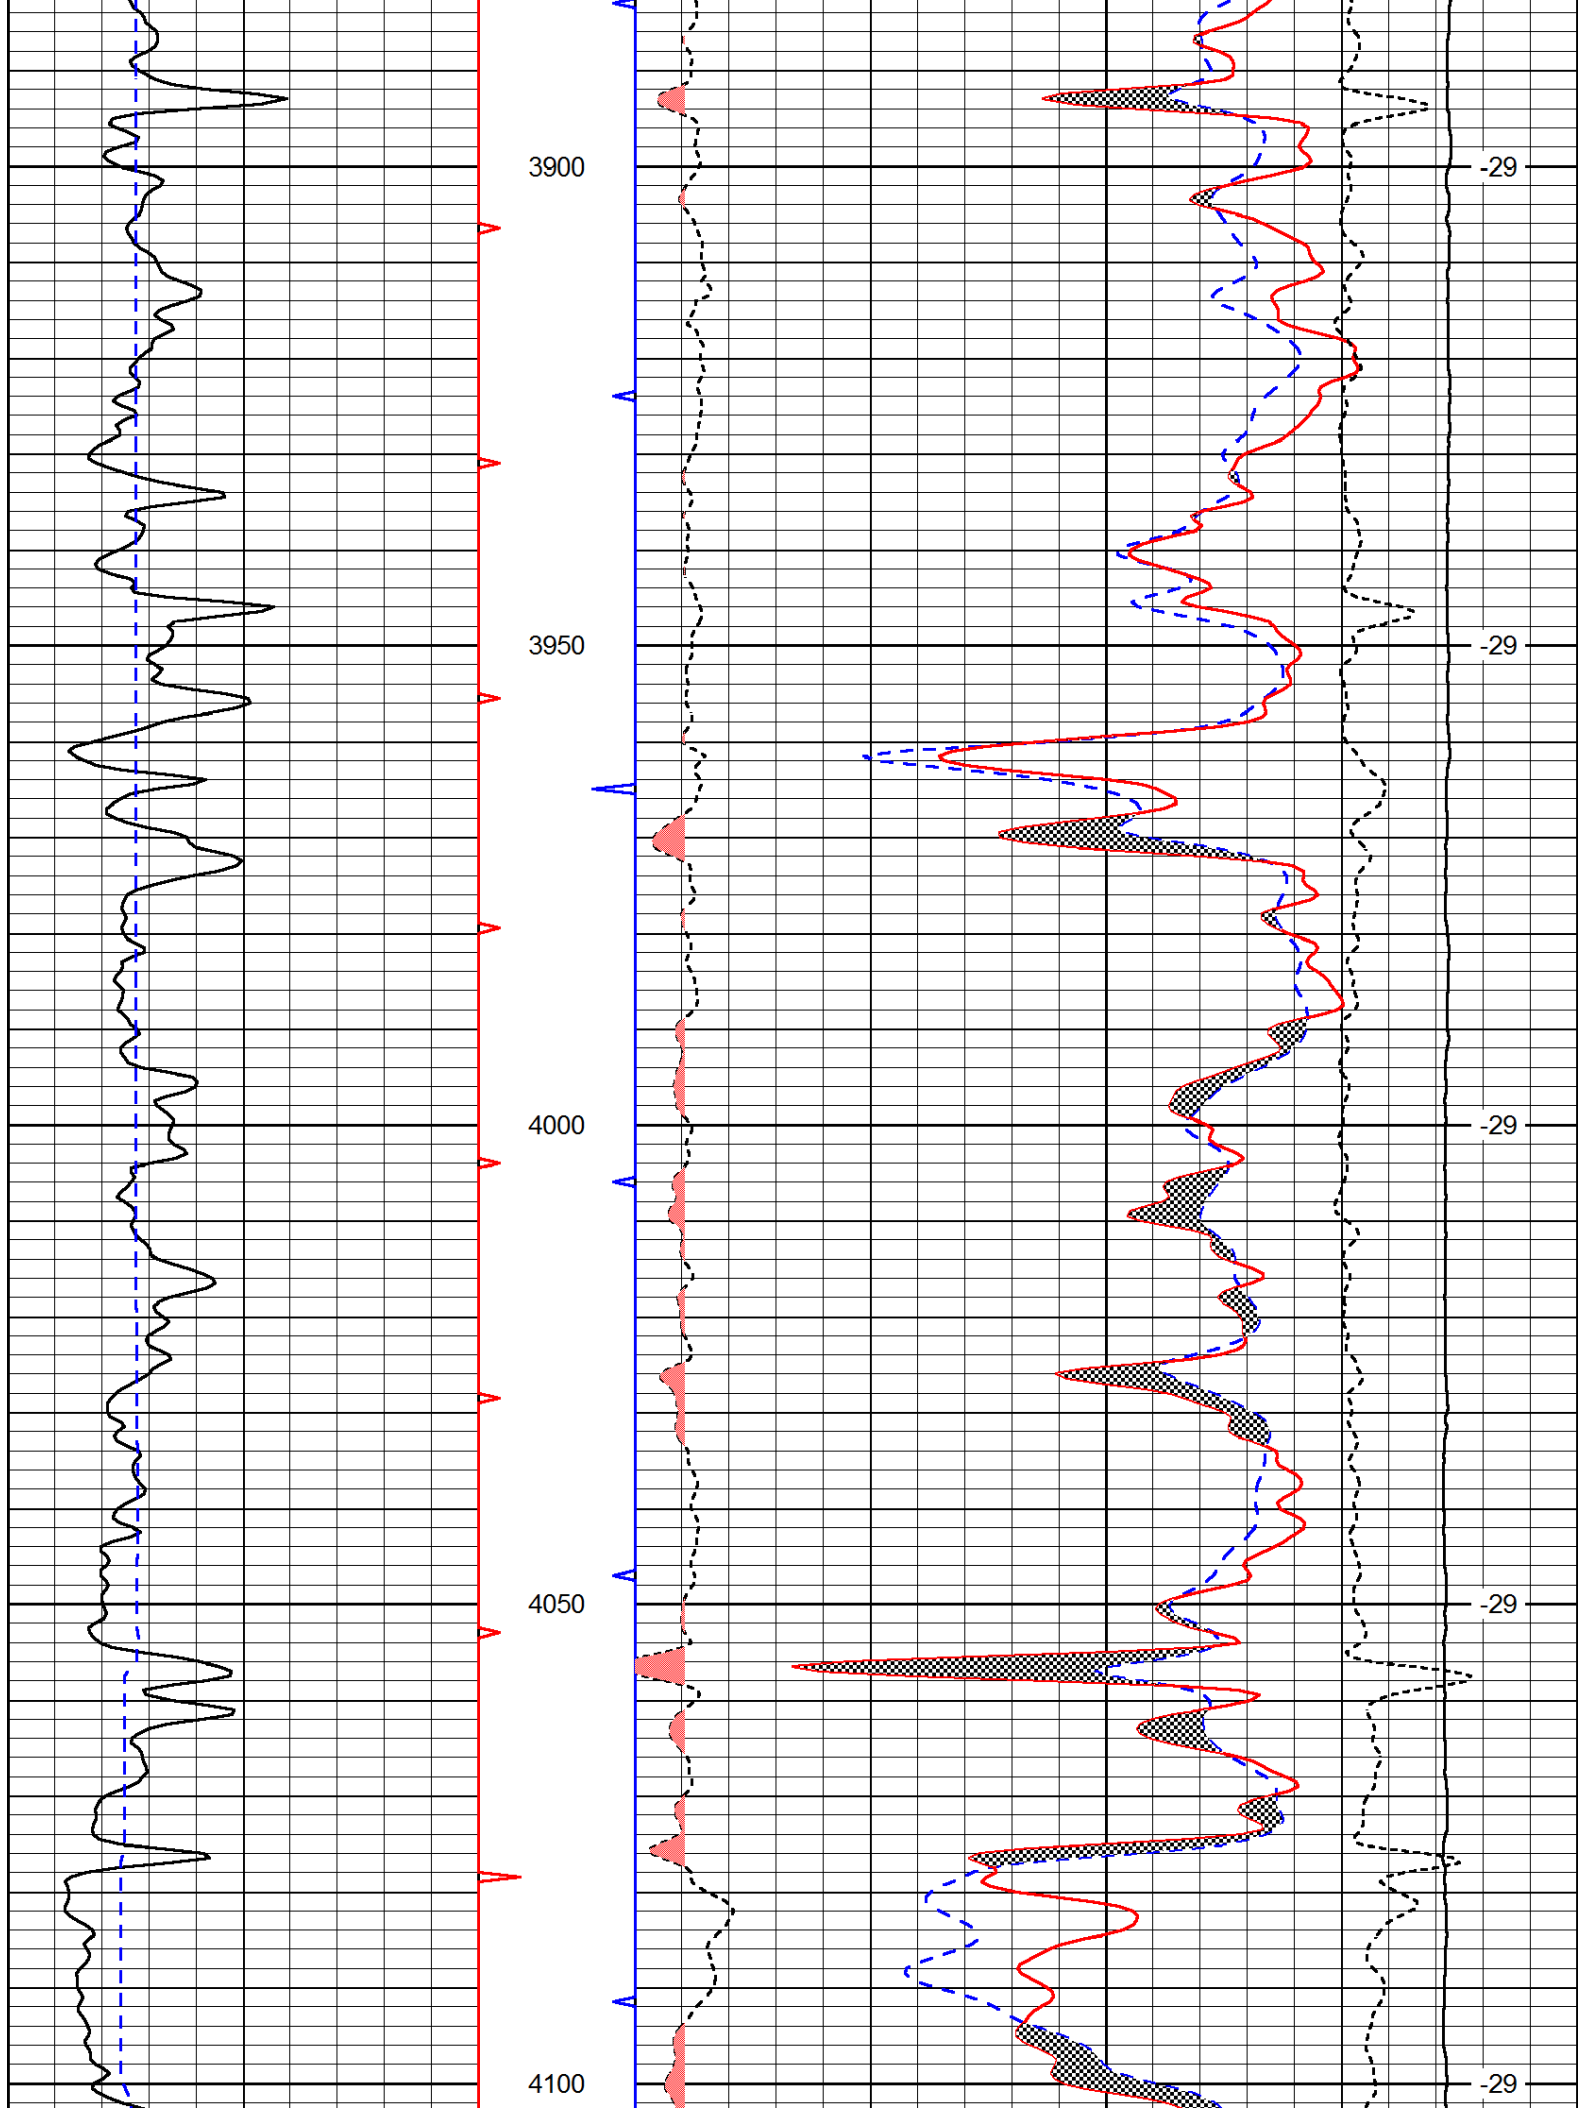
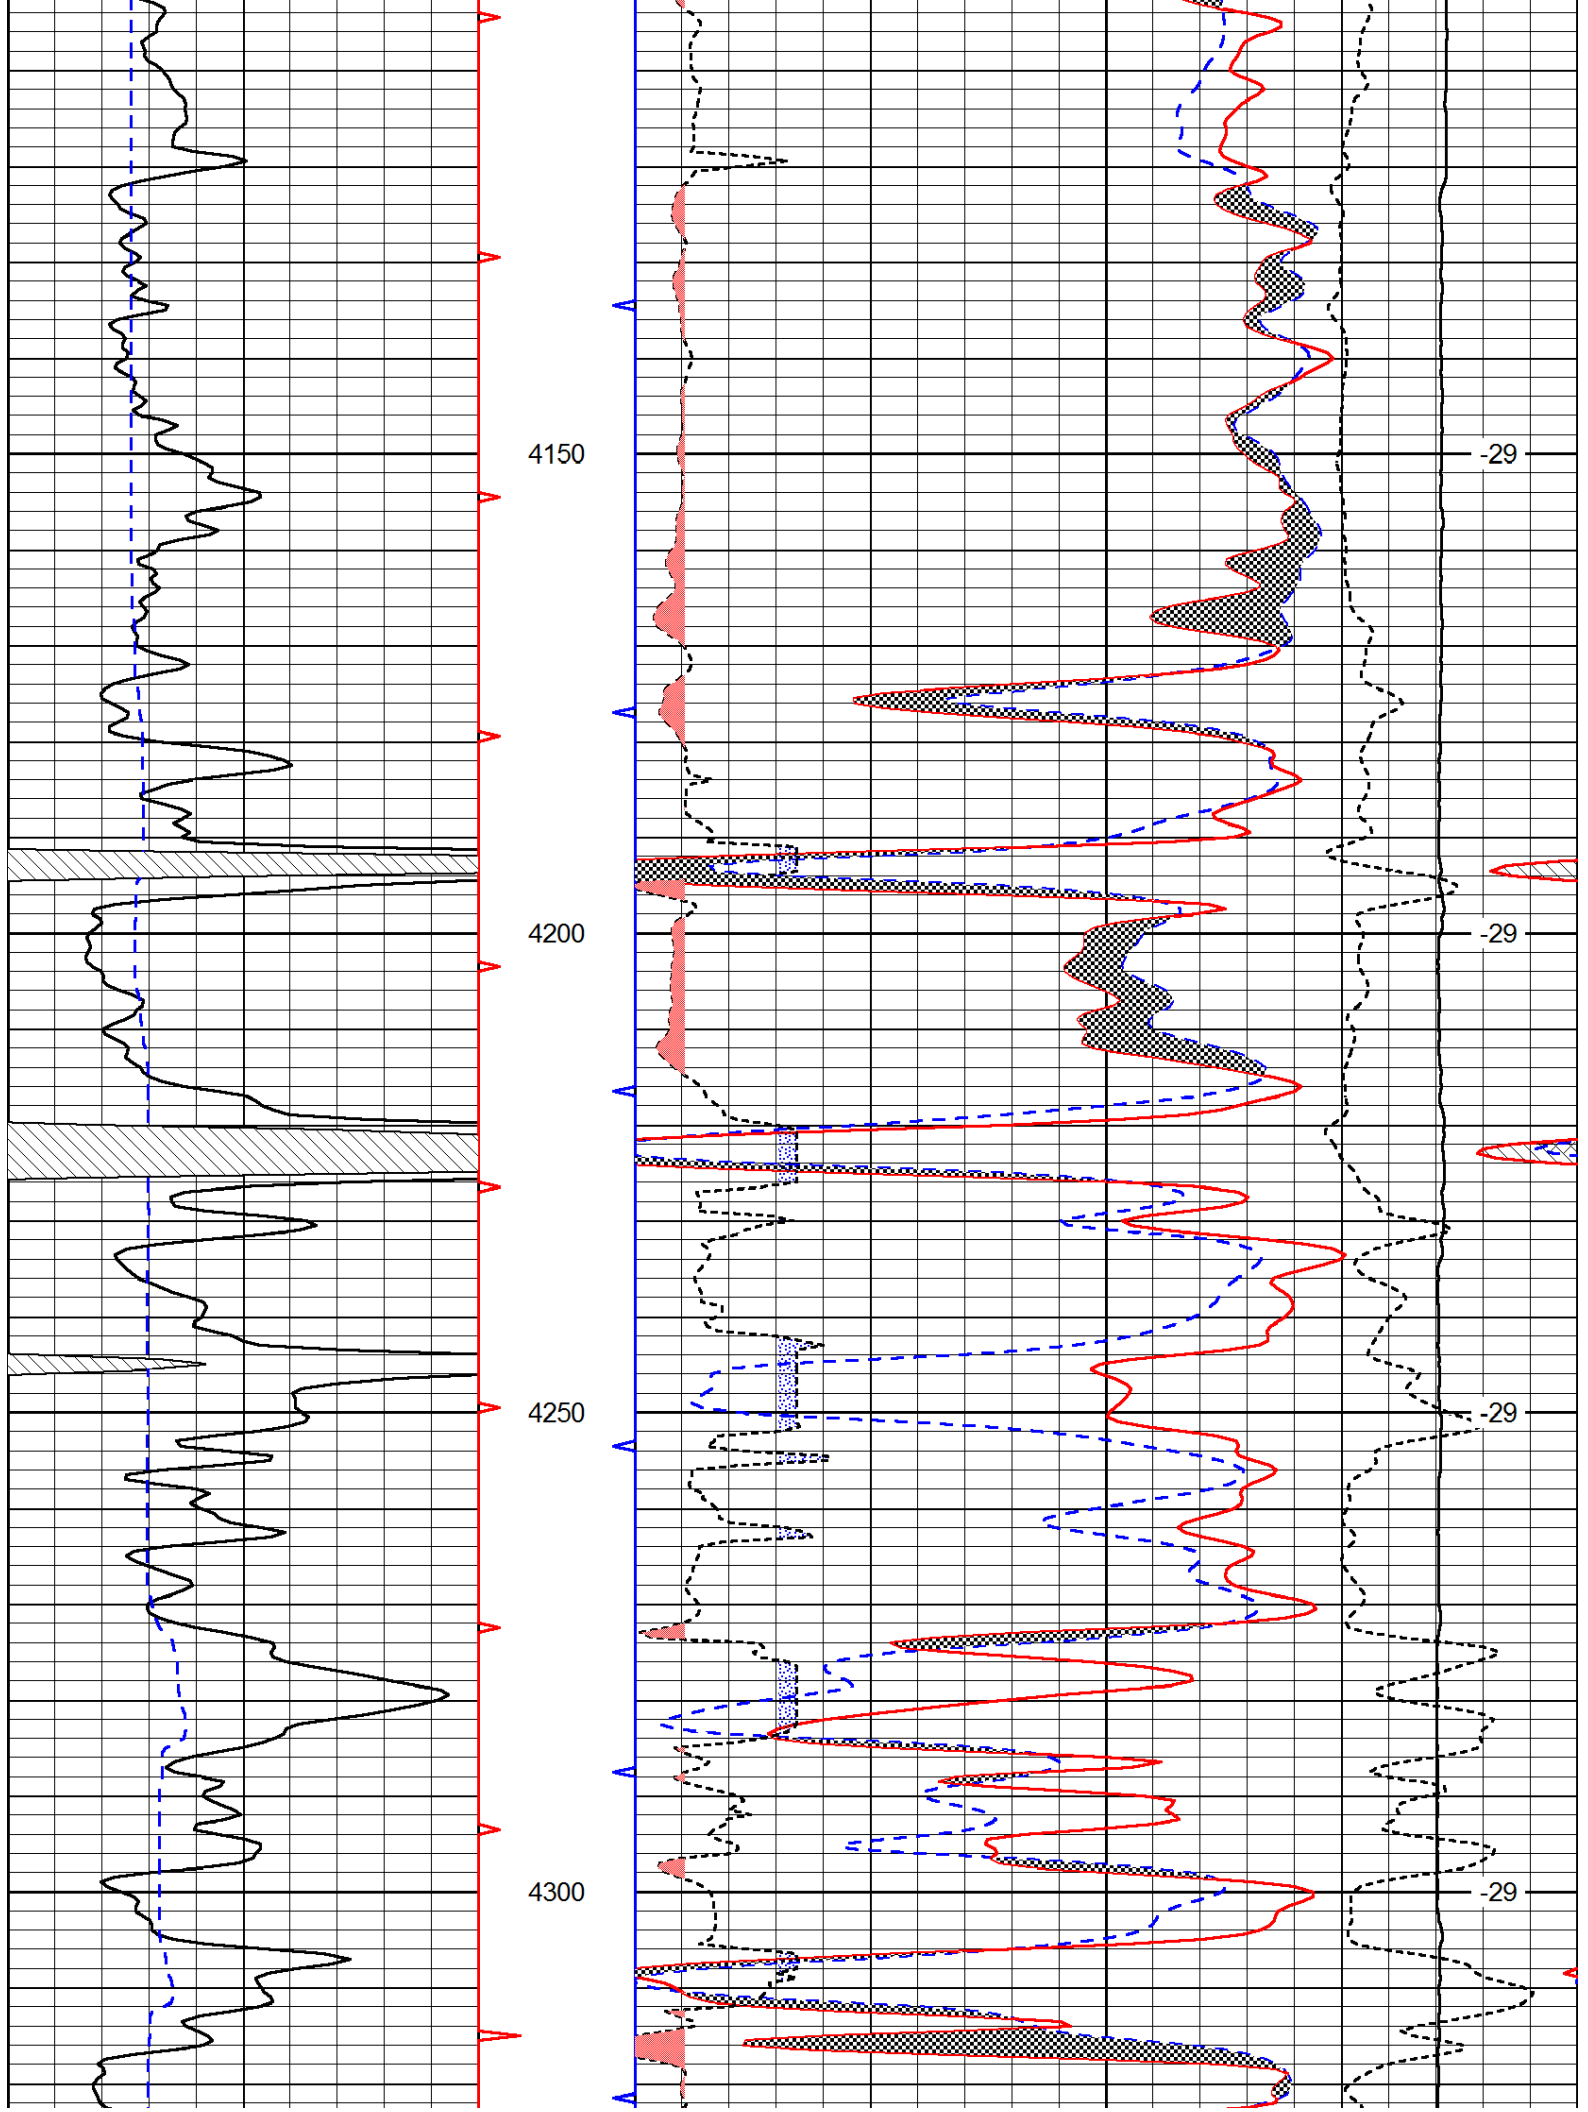
| Charted by: Depth in Feet scaled 1:240 | | | | | | | | | | |

| 0 | | | Gamma Ray | | | | 150 | | | |
| 6 | | | Caliper (GAPI) | | | | 16 | | | |
| 30 | | | Compensated Neutron (Limestone) | | | | -10 | | | |
| 30 | | | Compensated Density (Limestone) | | | | -10 | | | |
| 2.625 | | | DGA | | 3.425 | | -0.25 | | Correction | 0.25 |
| 15000 | | | Line Tension | | | | 0 | | | |
