## Pioneer Energy Services

# Dual Compensated Porosity Log

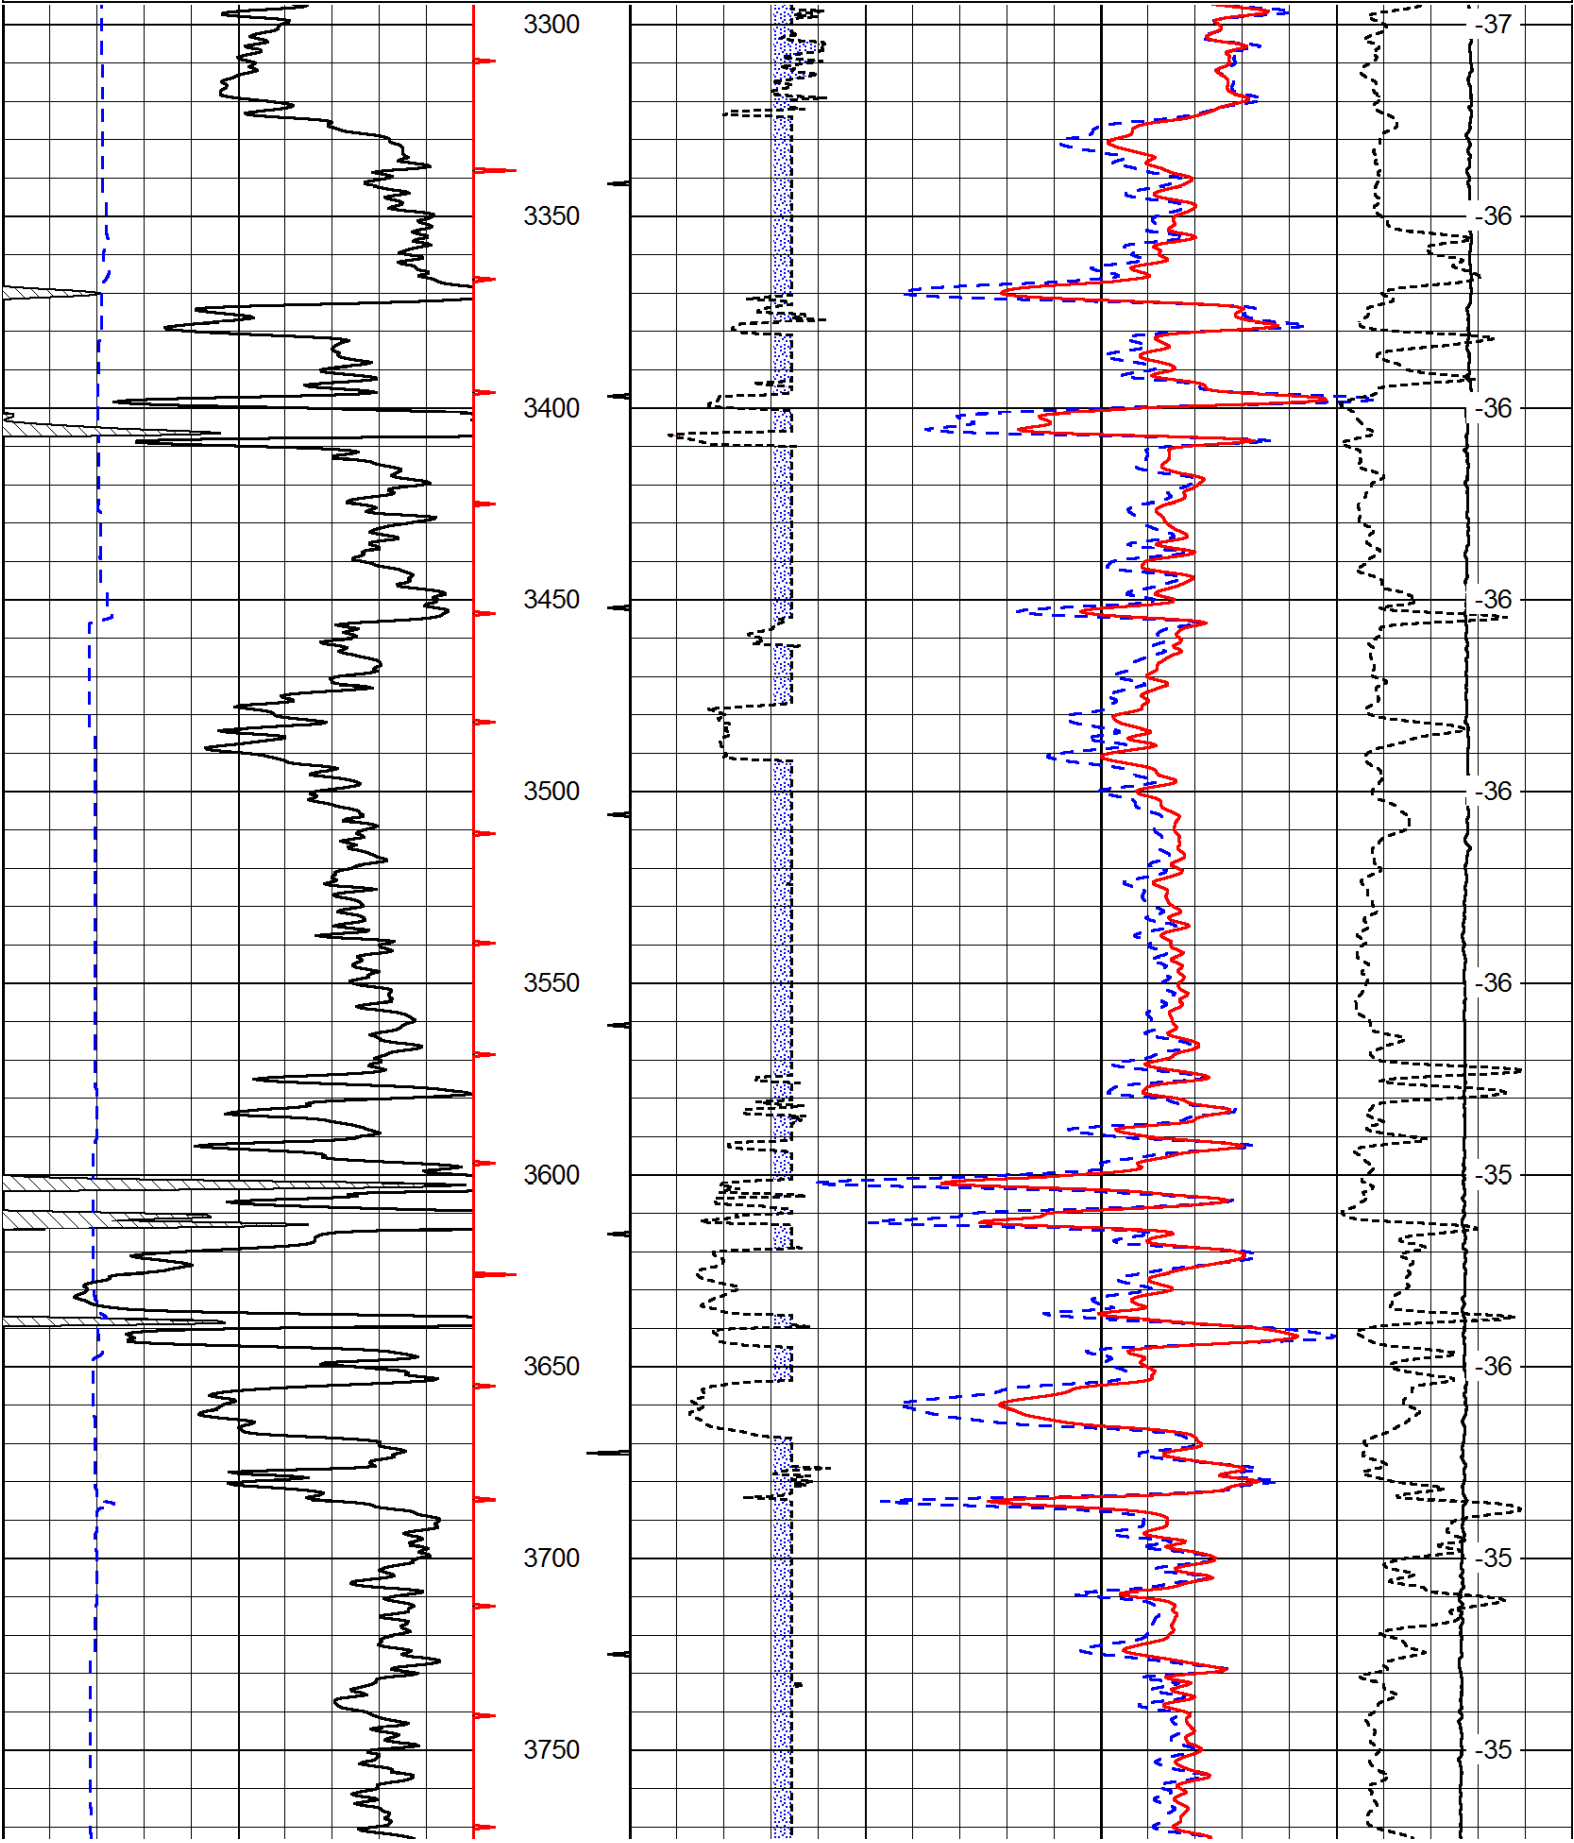
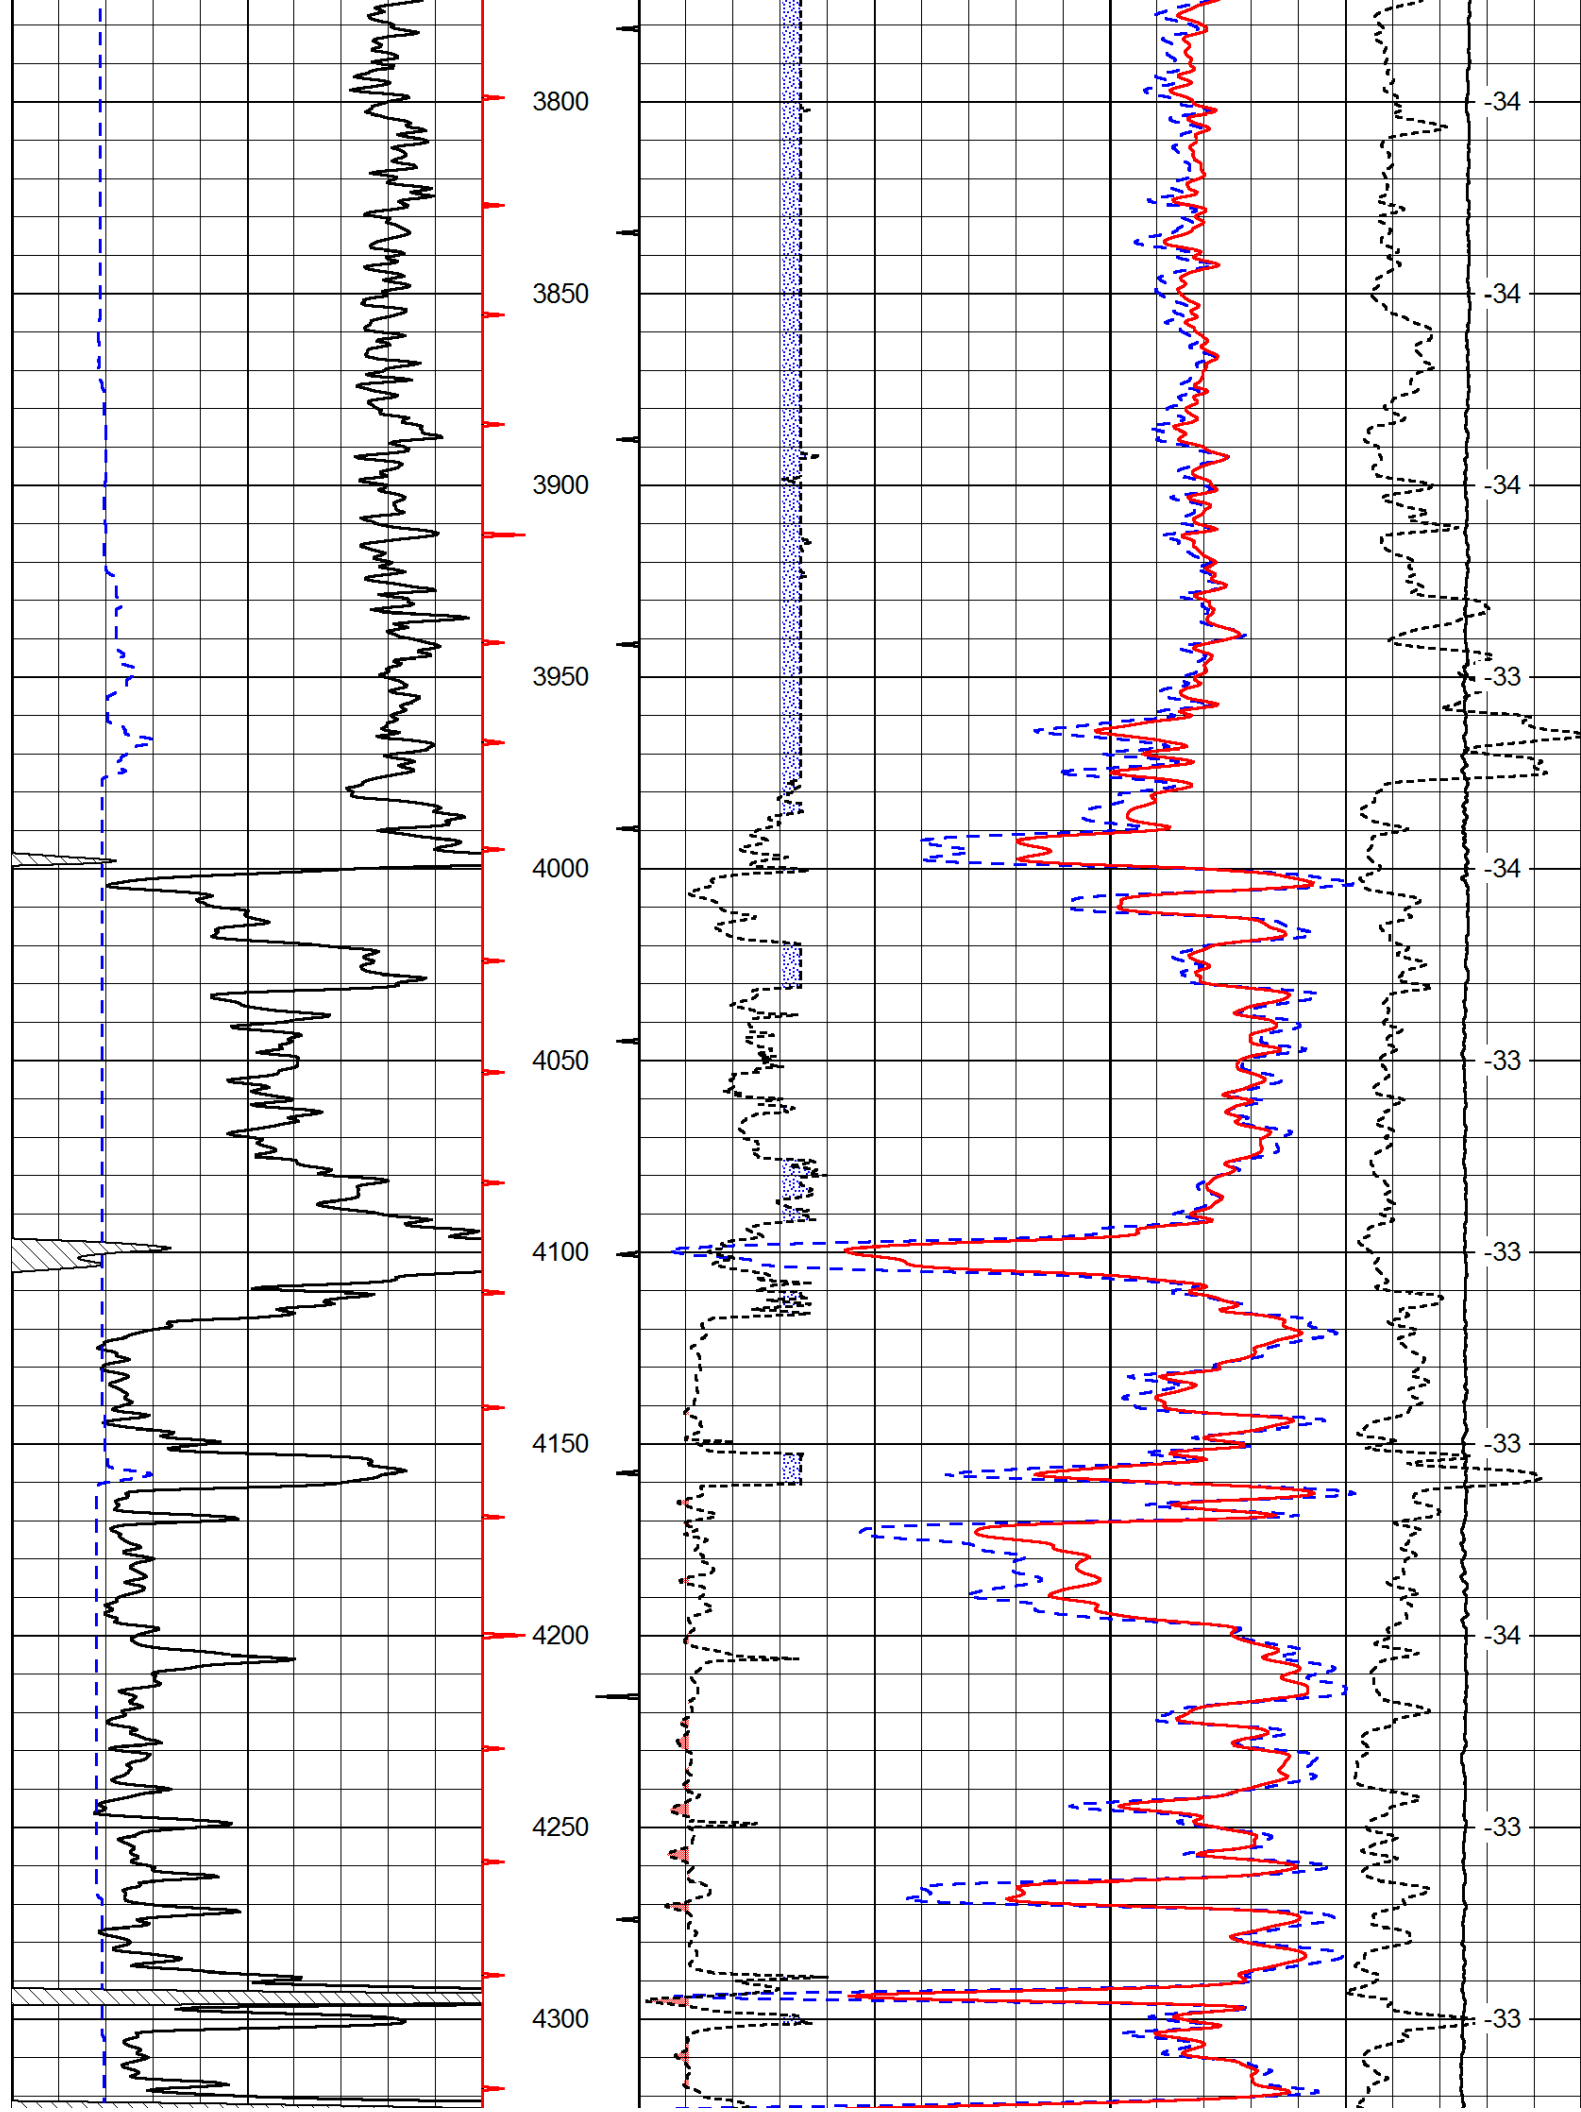
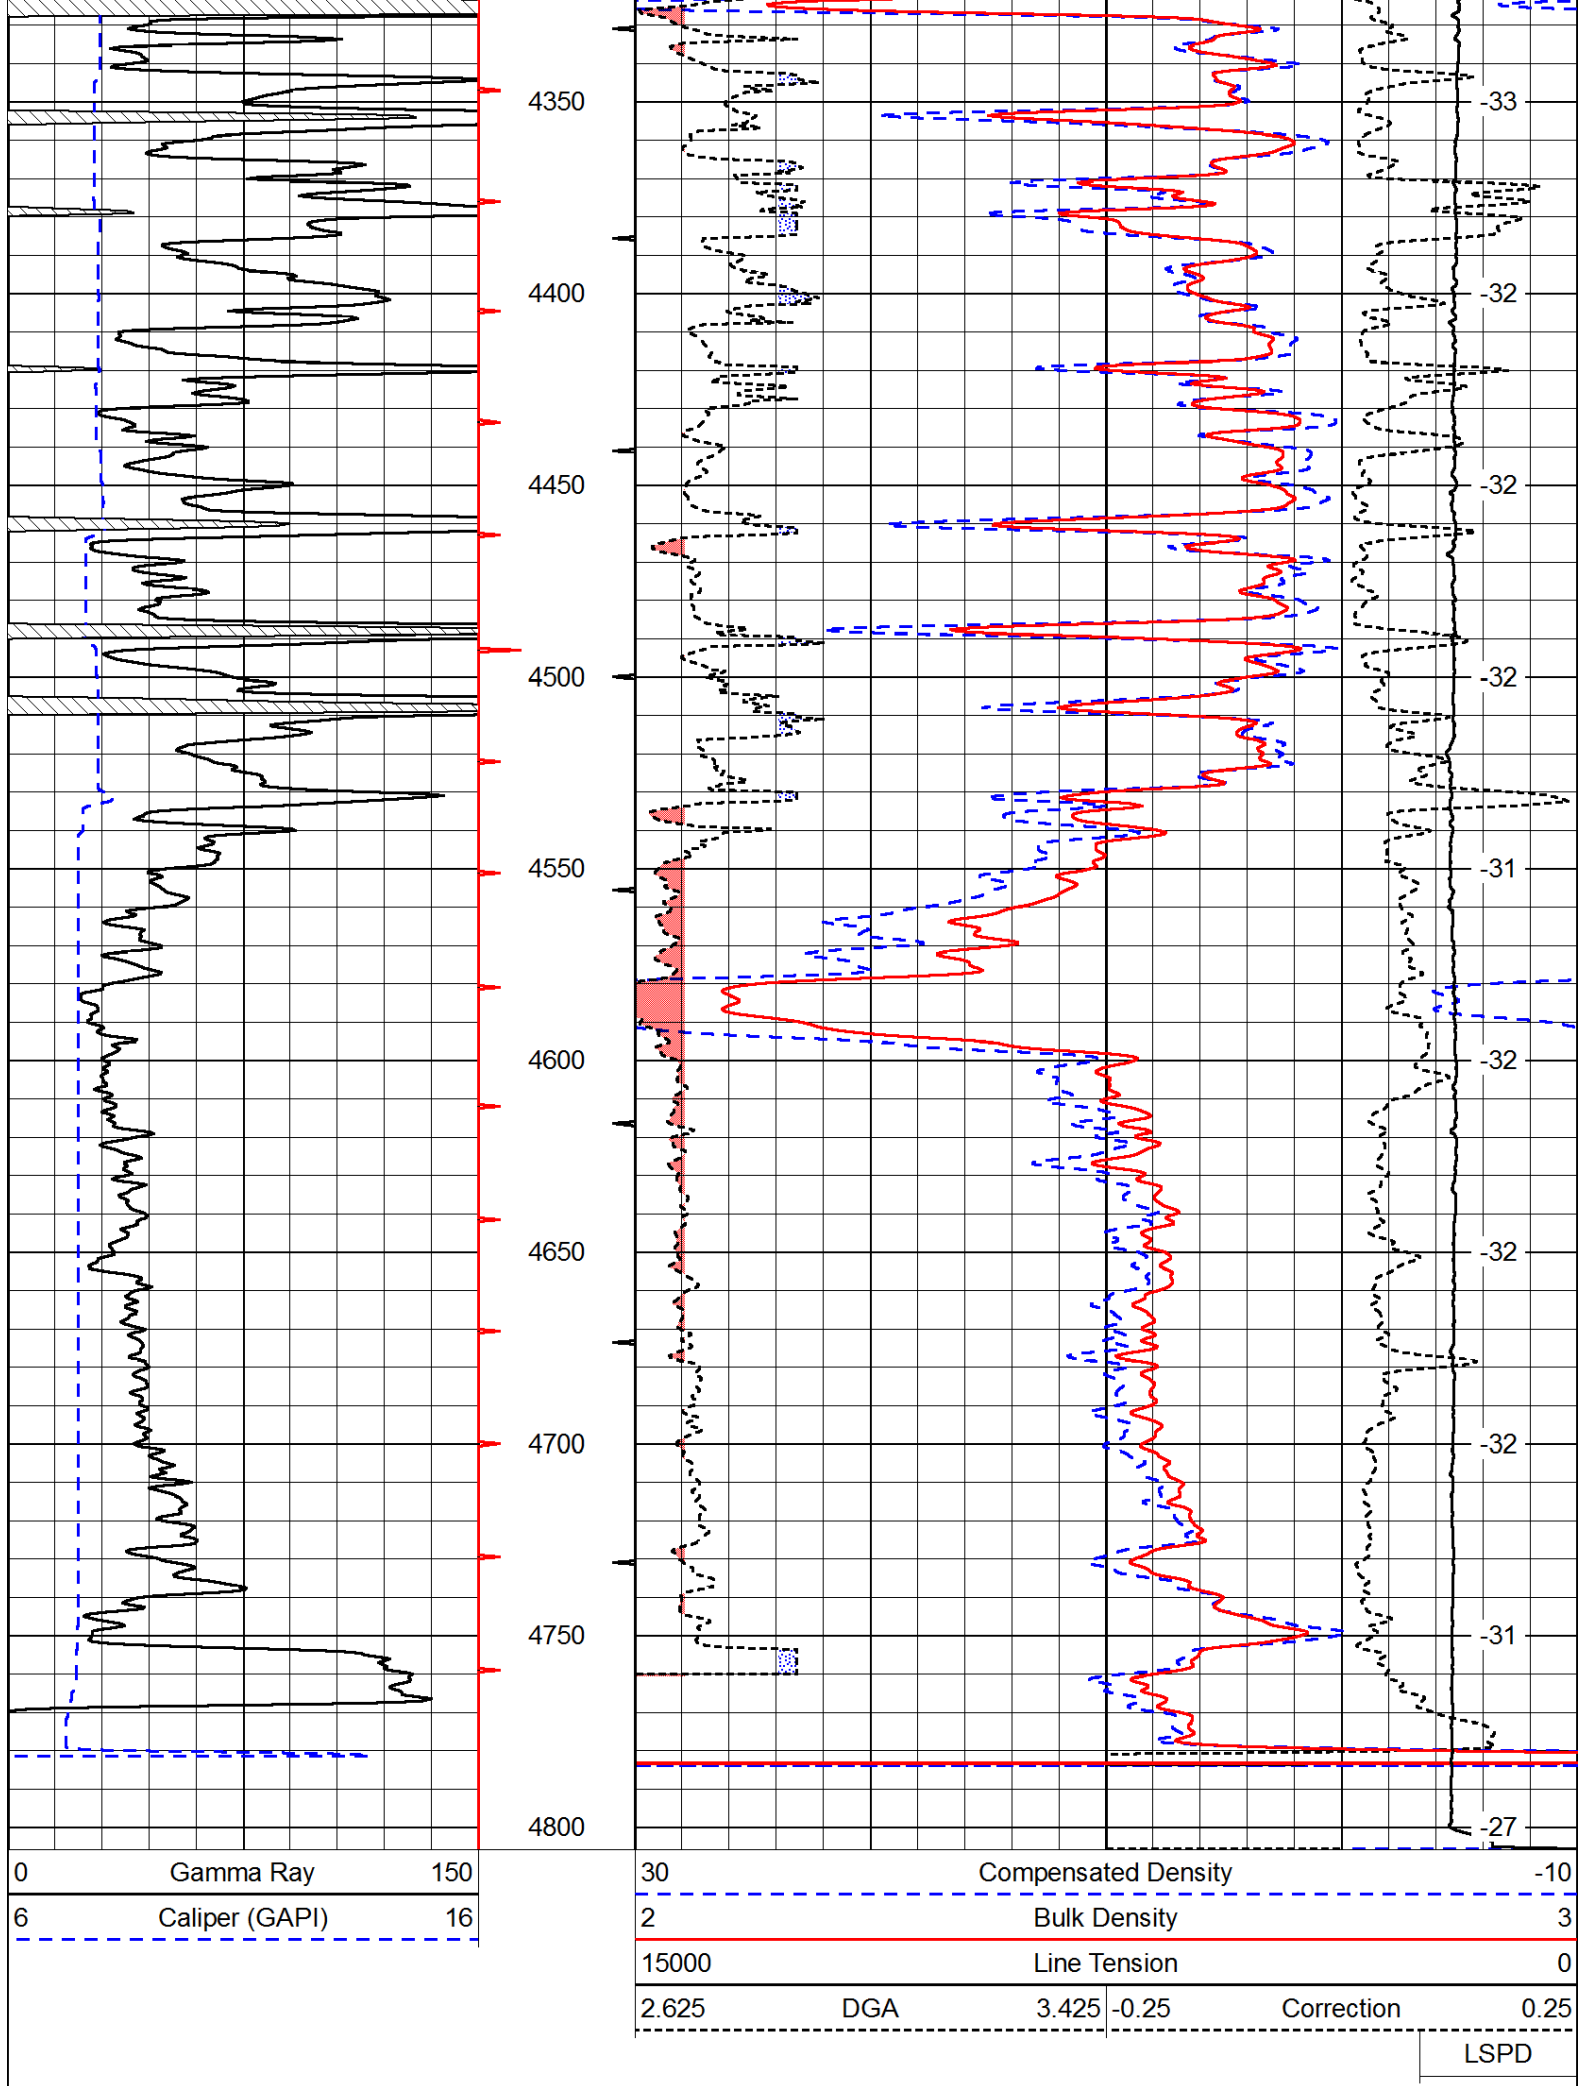
Database File: c:\warrior\data\val\_talbott #8-9\val\_talbott\_8-9hd.db  
Dataset Pathname: dil\vastkml  
Presentation Format: cdl  
Dataset Creation: Sat May 31 13:43:32 2014  
Charted by: Depth in Feet scaled 1:600

| 0 | Gamma Ray | 150 |
| 6 | Caliper (GAPI) | 16 |

| 30 | Compensated Density | | -10 |
| 2 | Bulk Density | | 3 |
| 15000 | Line Tension | | 0 |
| 2.625 | DGA | 3.425 | -0.25 |
