## Pioneer Energy Services

# Dual Compensated Porosity Log

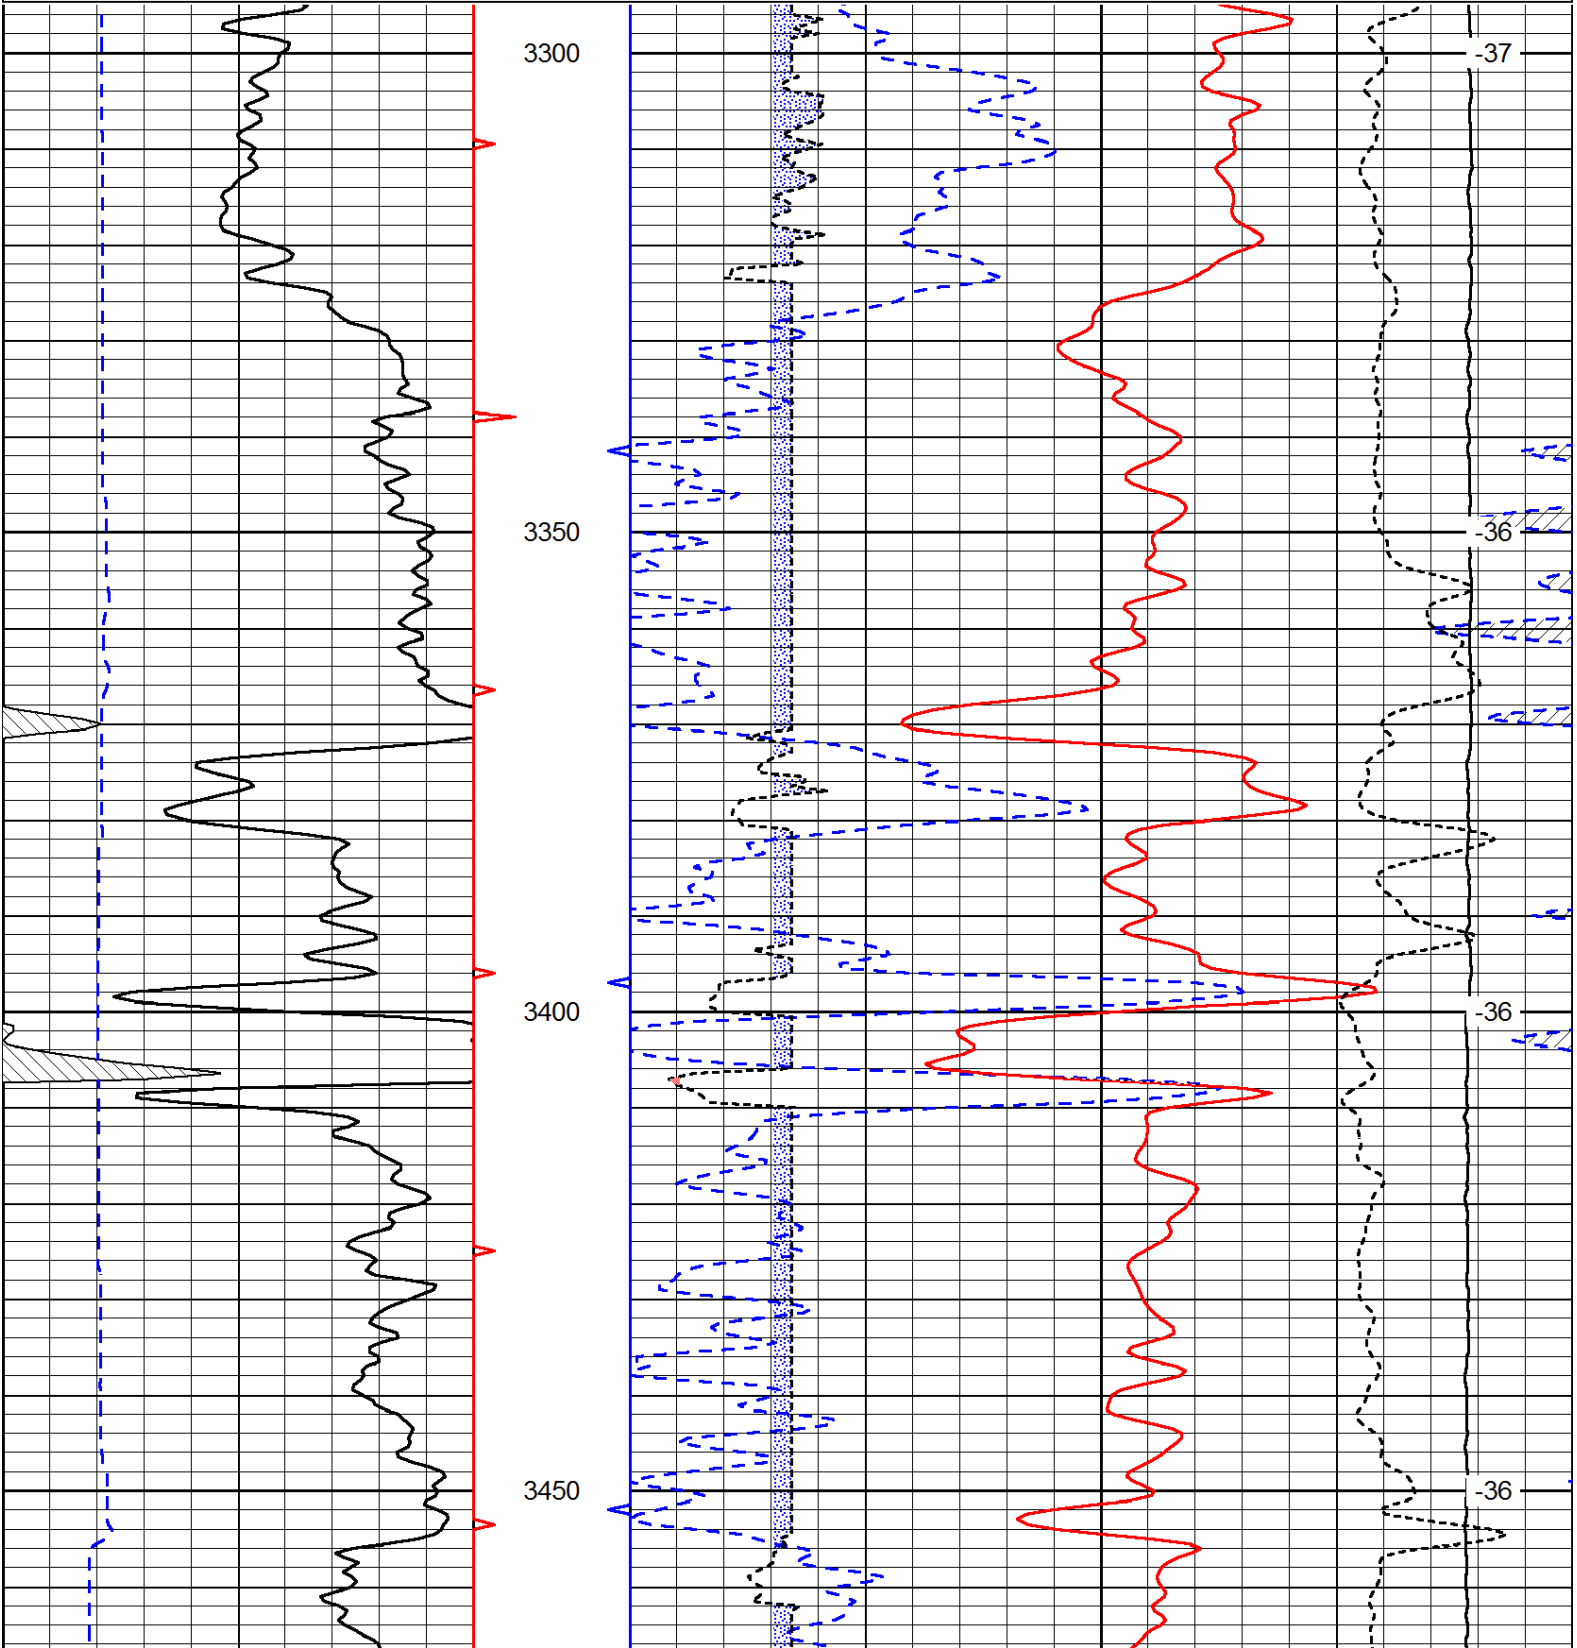
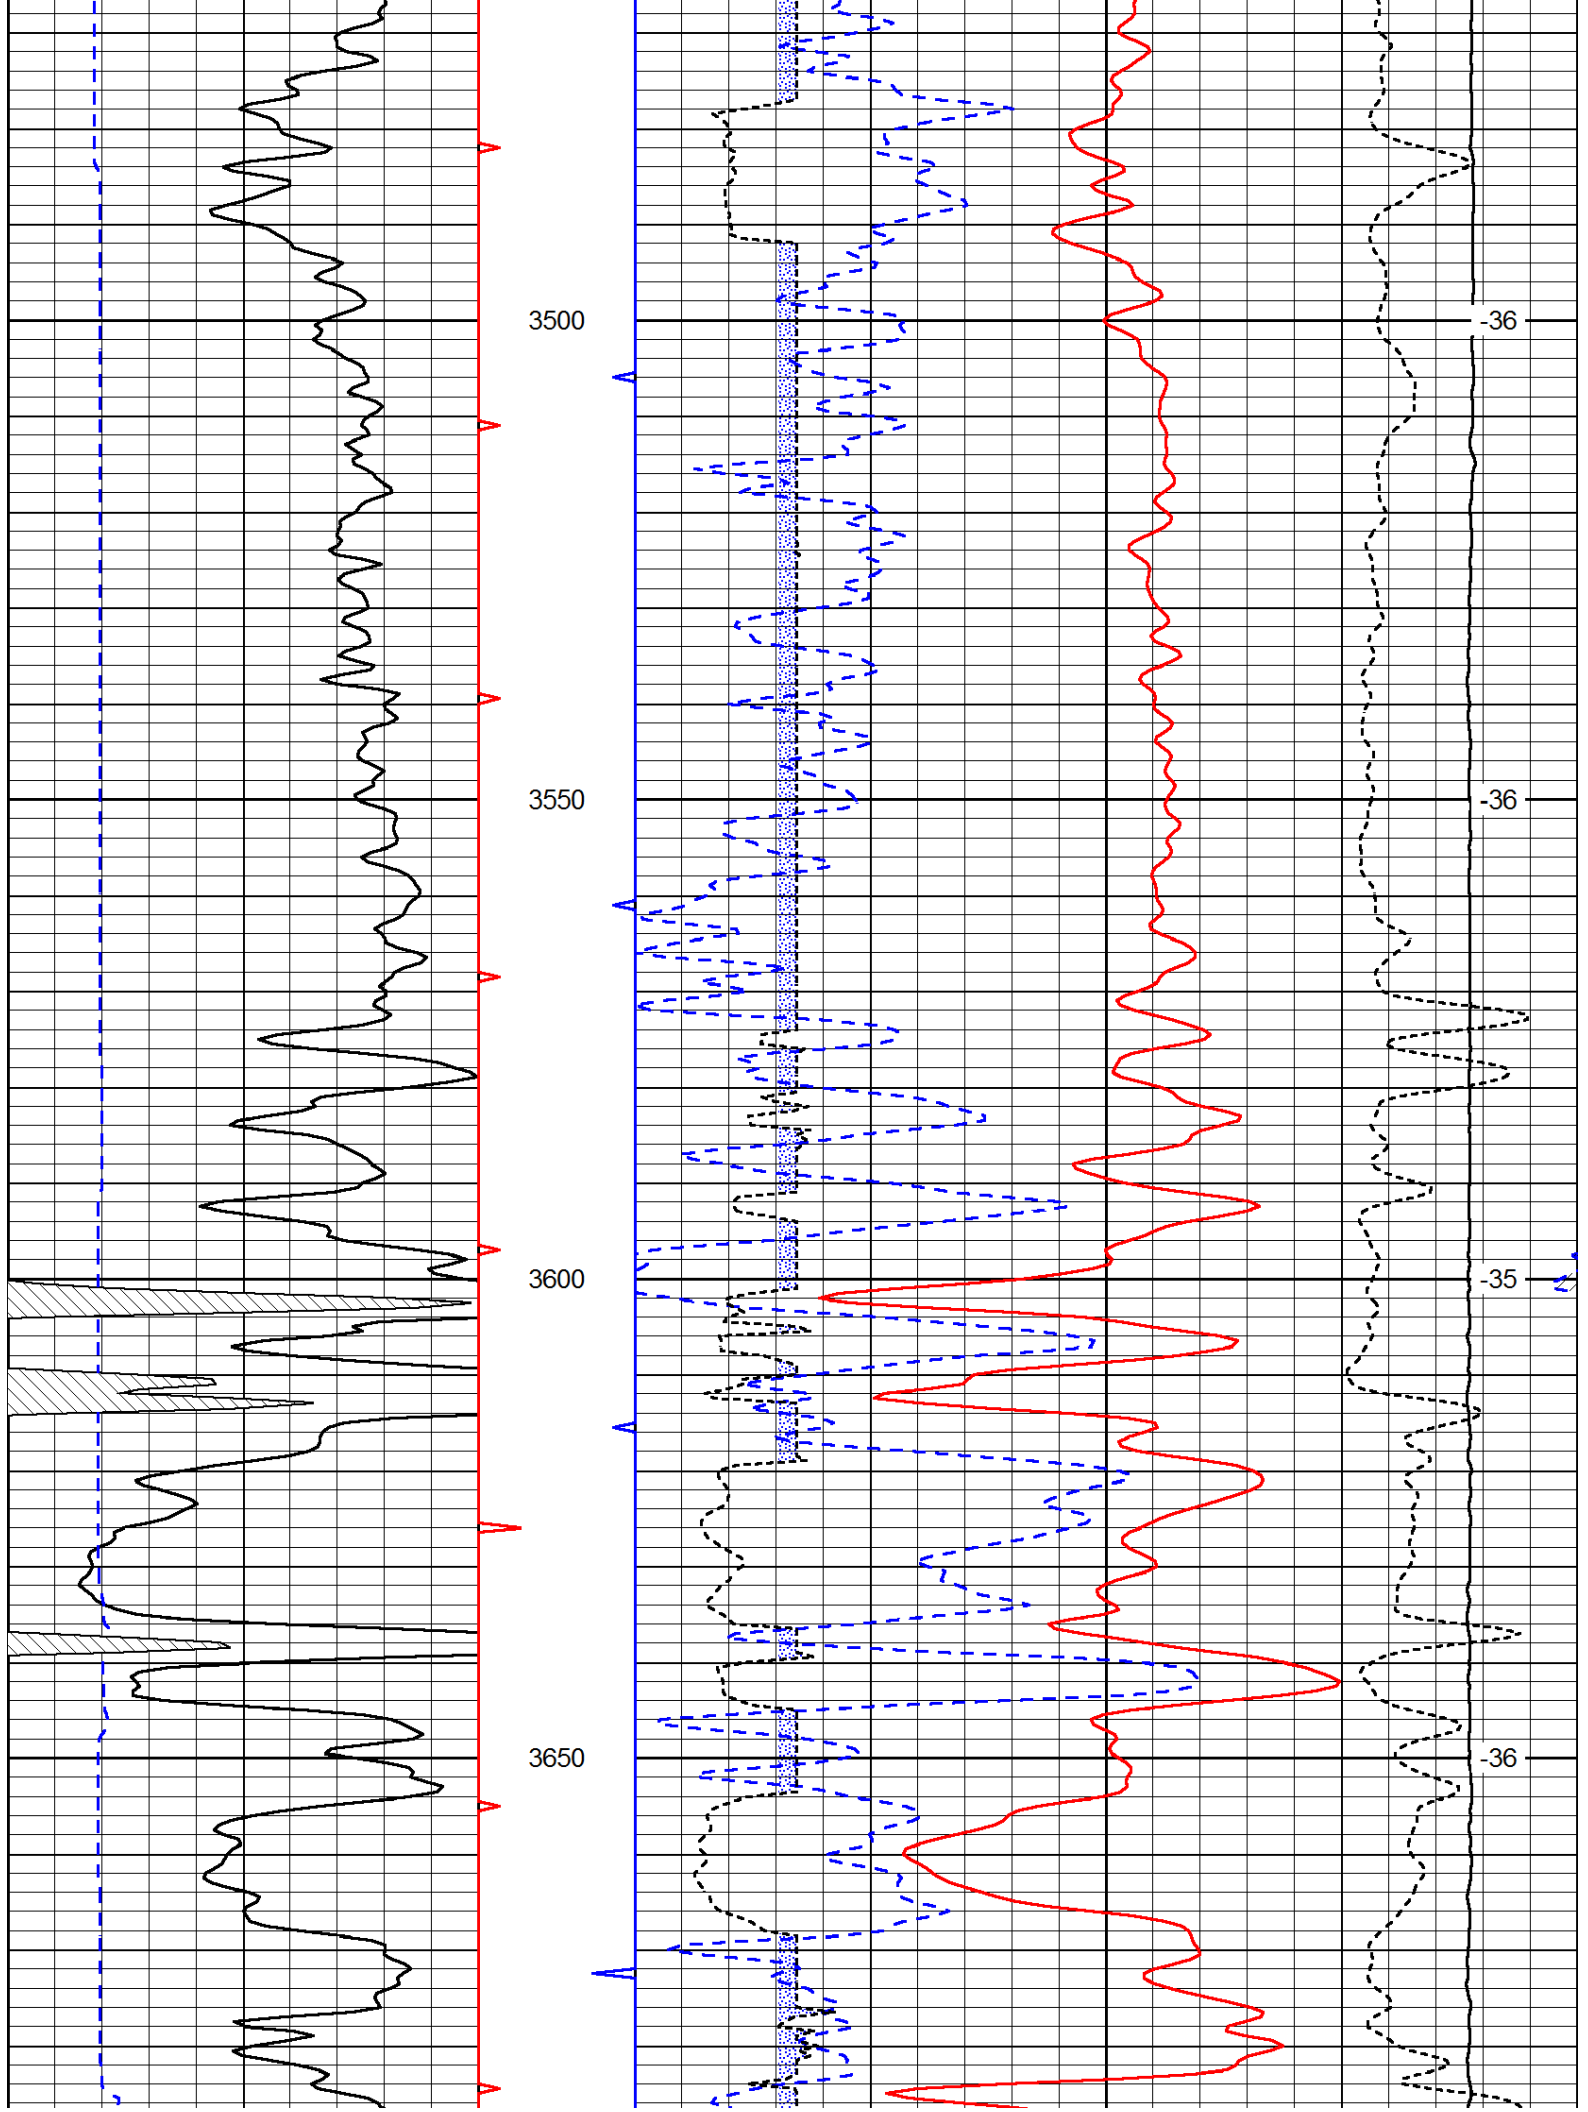
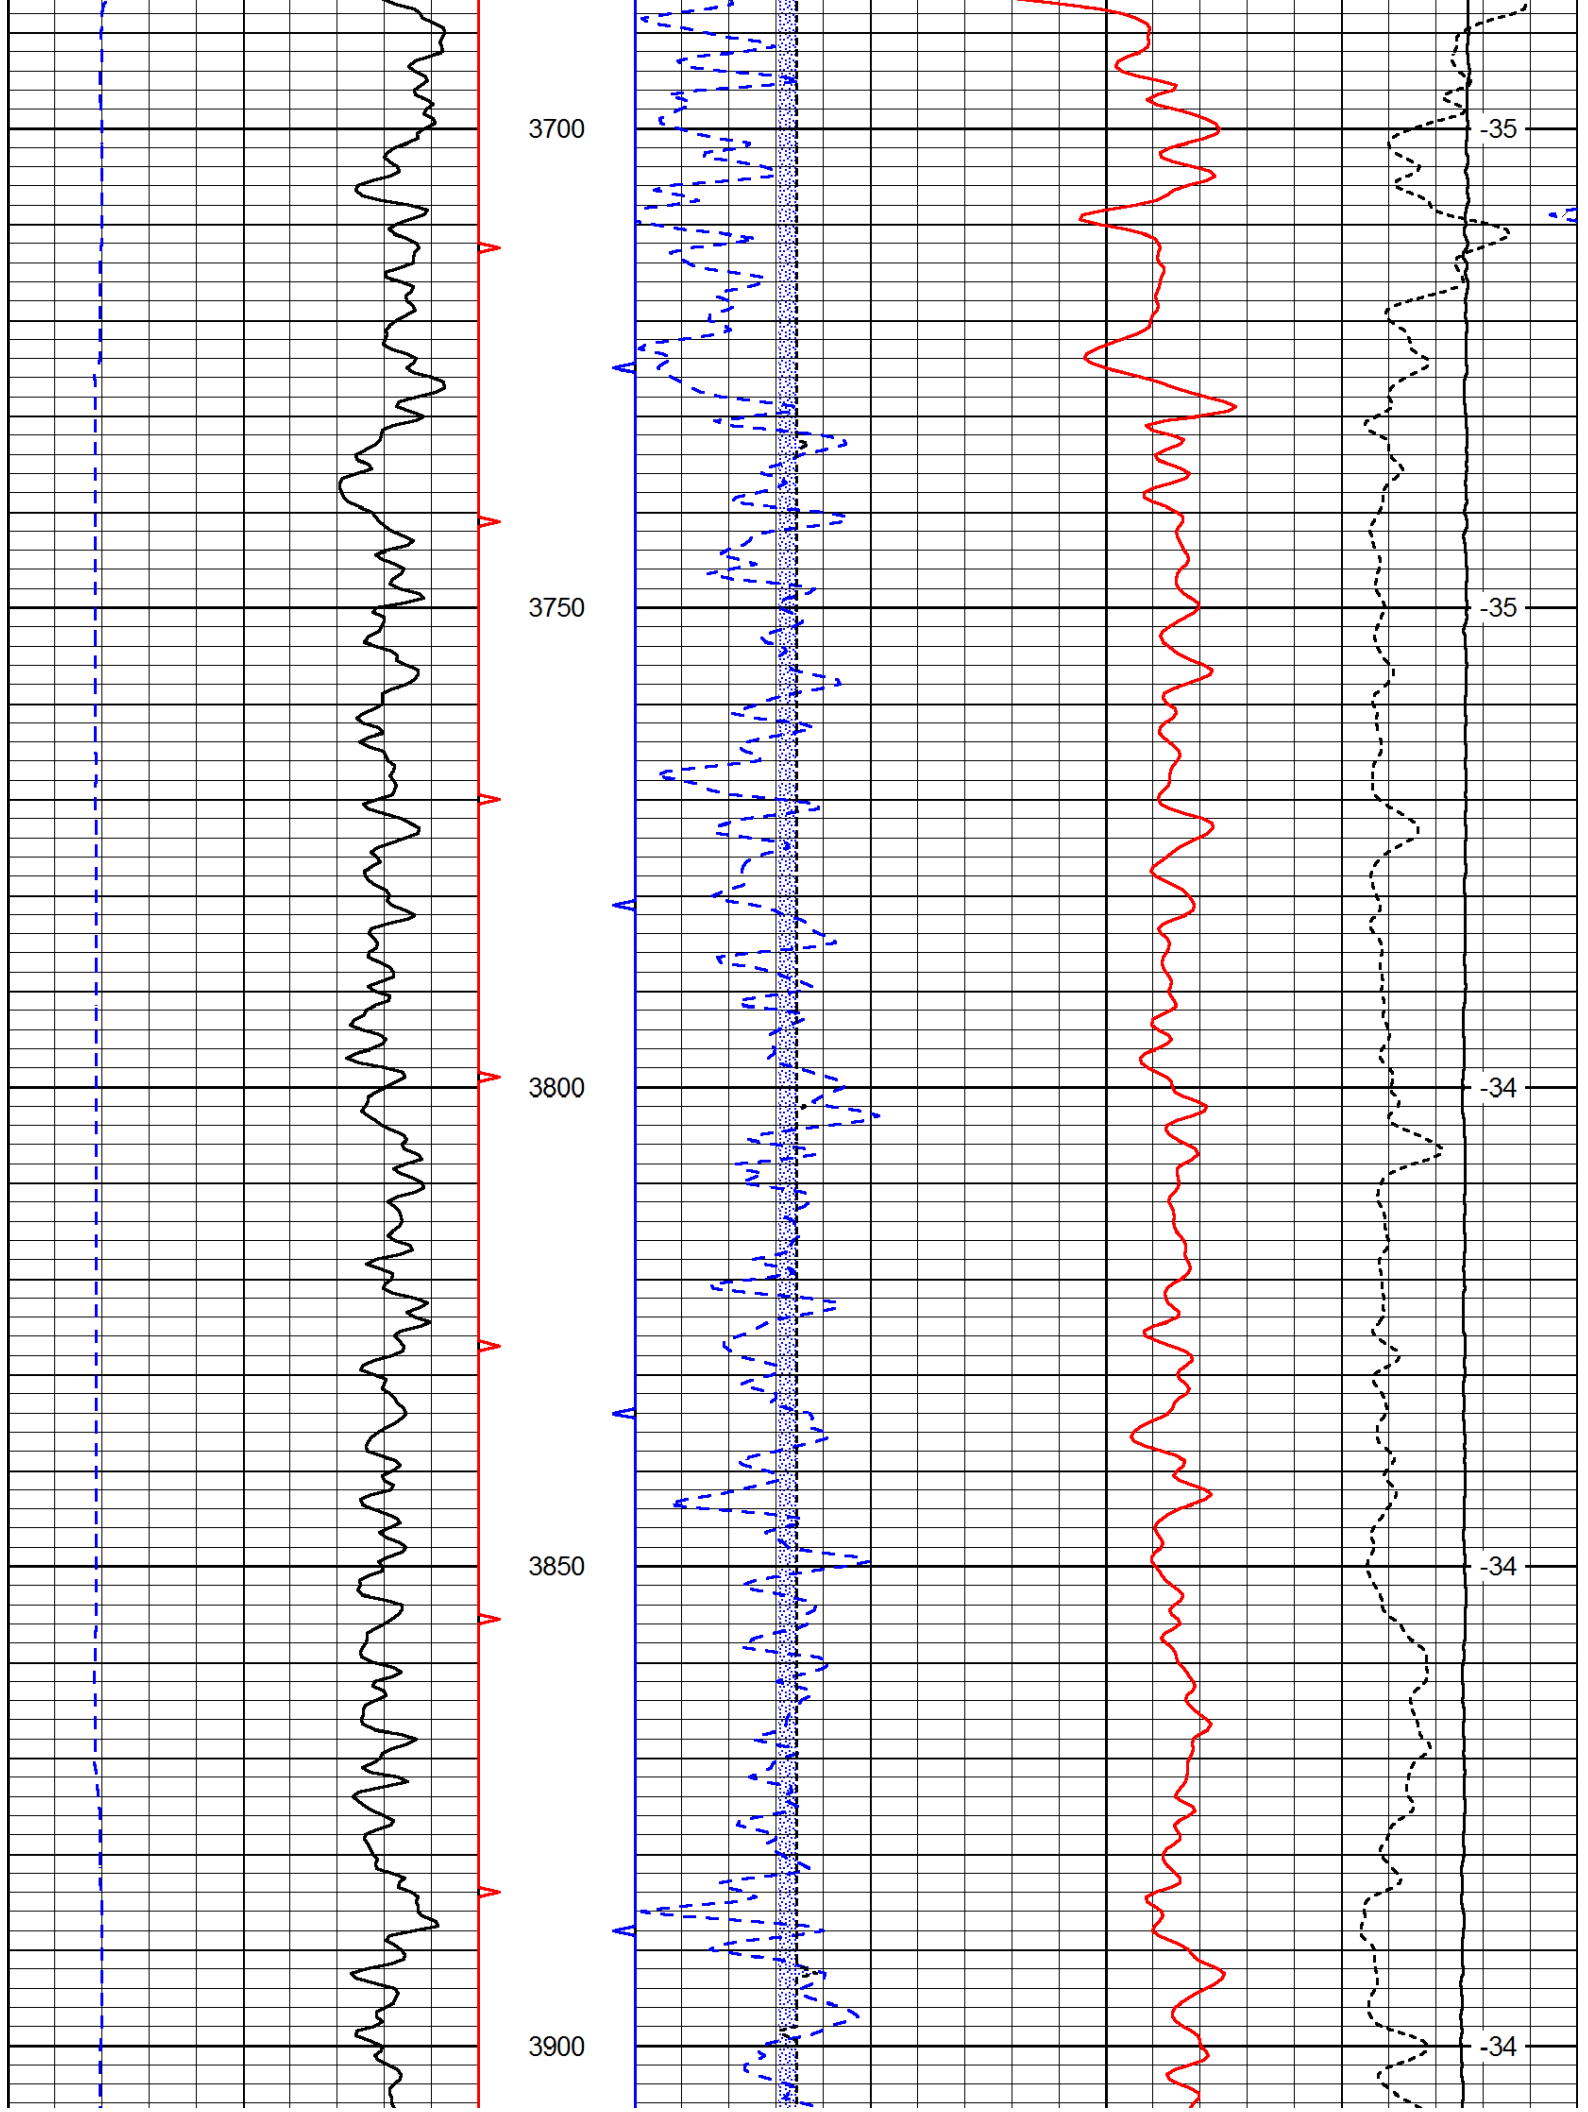
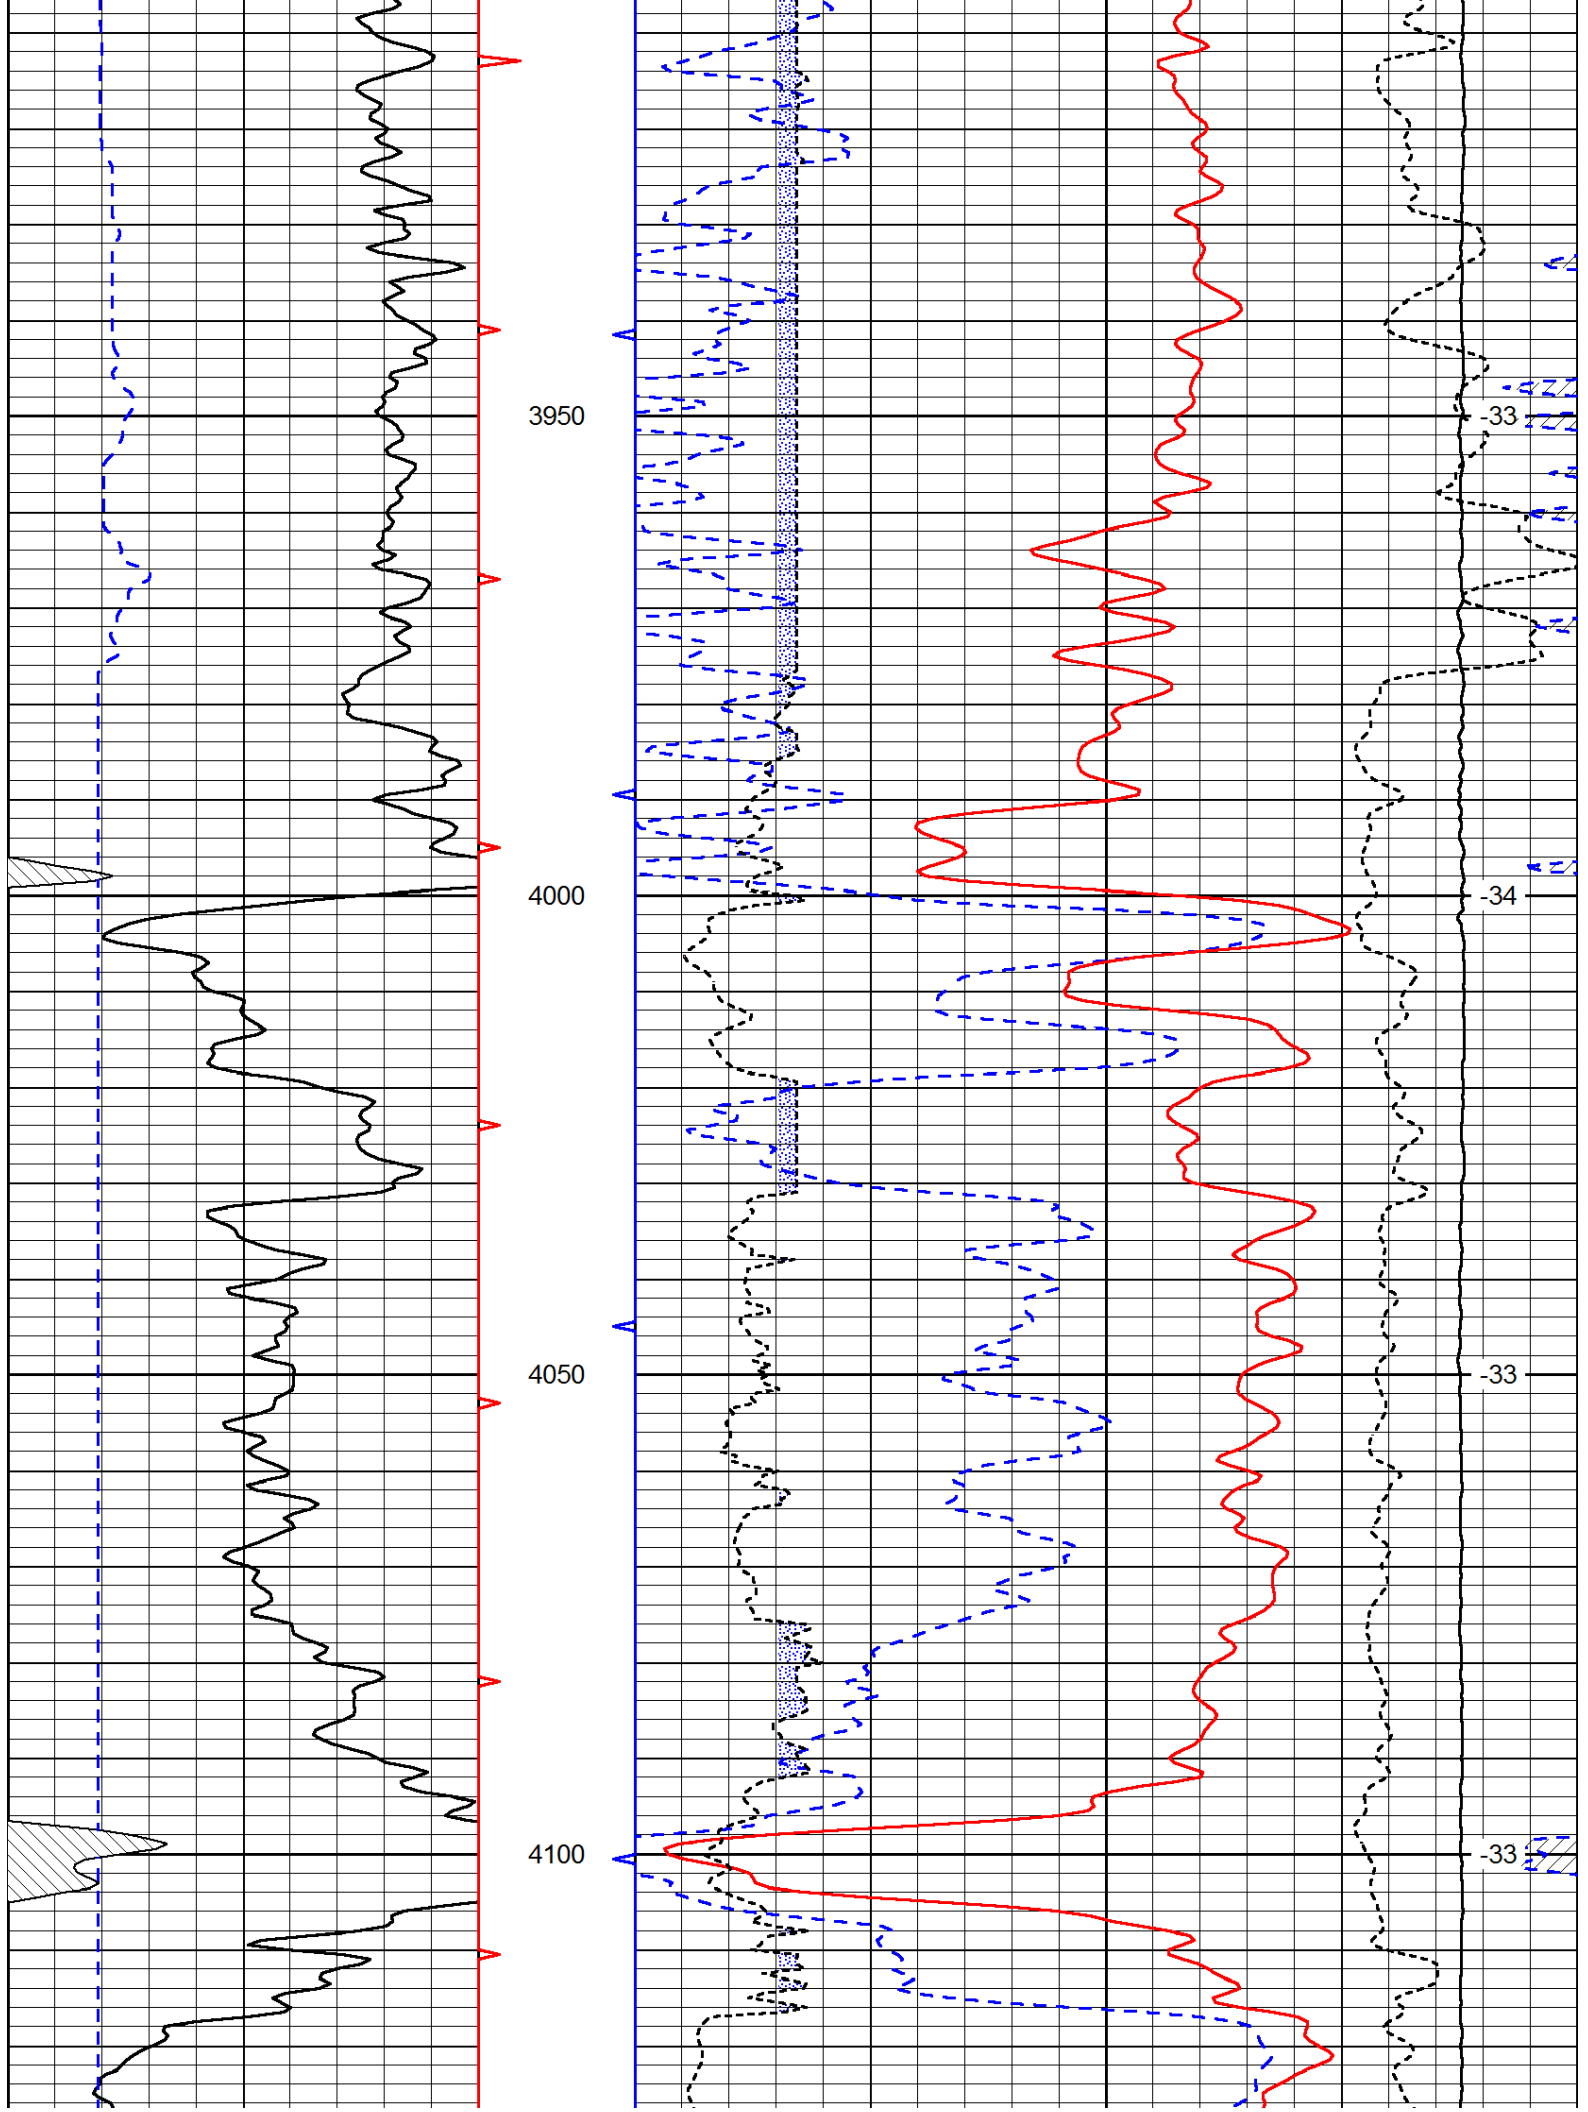
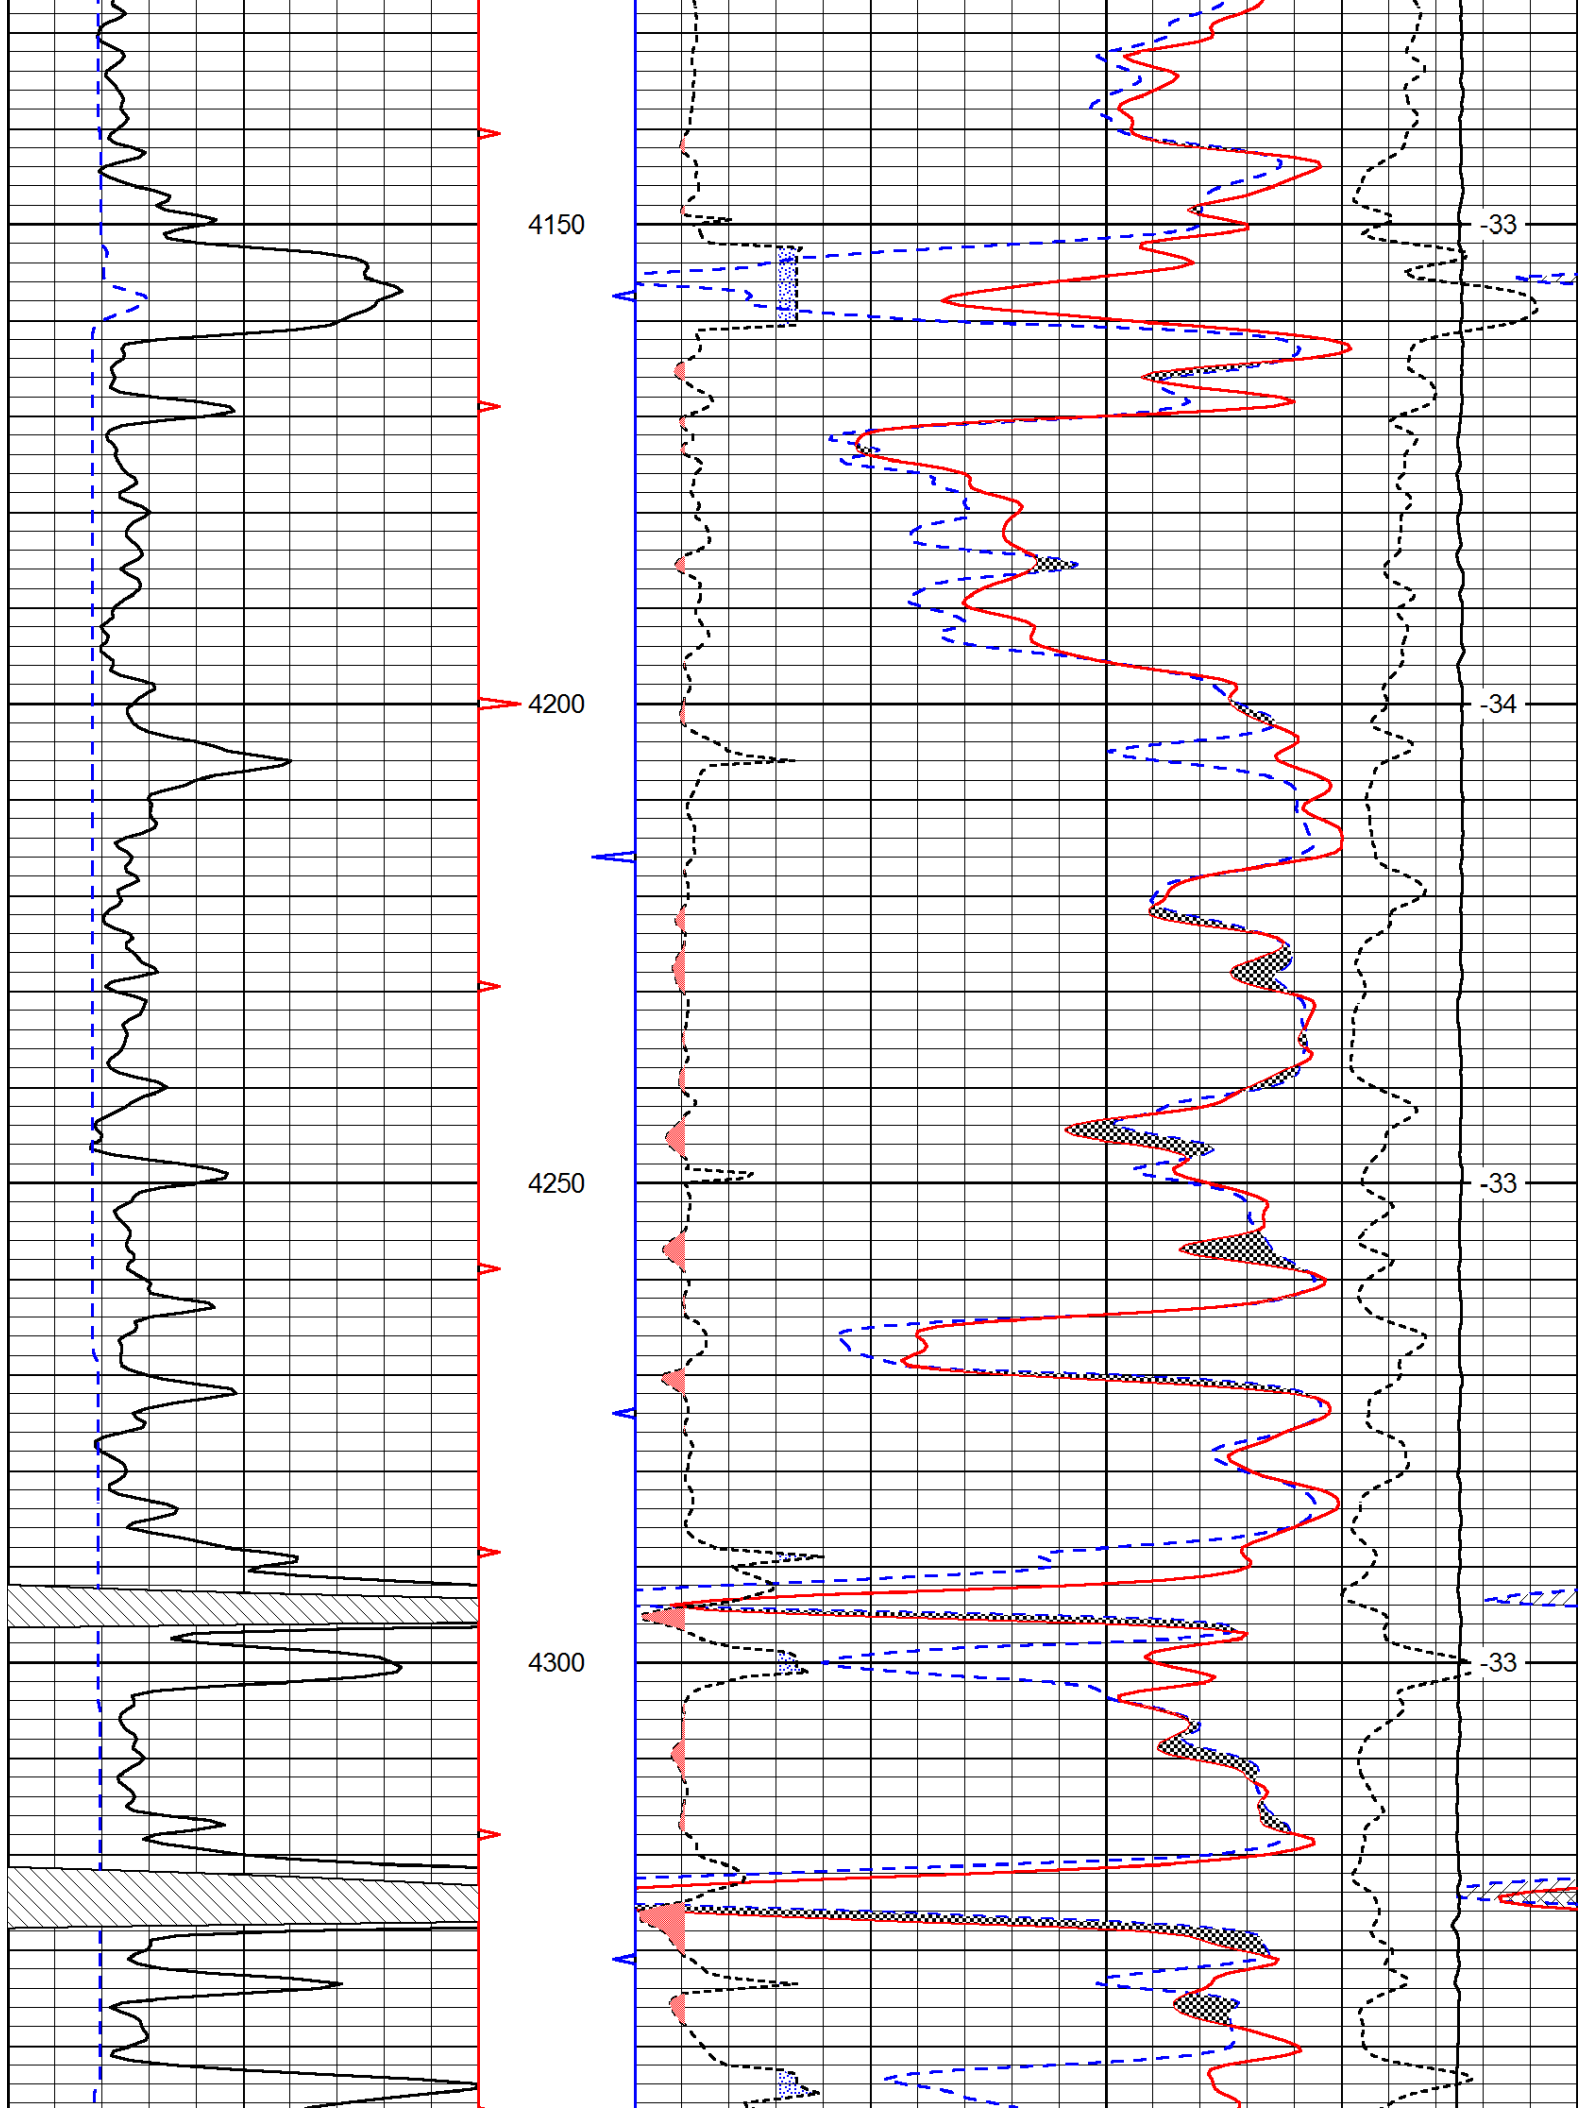
Database File: c:\warrior\data\val\_talbott #8-9\val\_talbott\_8-9hd.db  
Dataset Pathname: dil\vastkml  
Presentation Format: cndlspec  
Dataset Creation: Sat May 31 13:43:32 2014  
Charted by: Depth in Feet scaled 1:240

| 0 | Gamma Ray | 150 | 30 | Compensated Neutron (Limestone) | | -10 |
| 6 | Caliper (GAPI) | 16 | 30 | Compensated Density (Limestone) | | -10 |
| | | | 2.625 | DGA | 3.425 | -0.25 |
| | | | 15000 | Line Tension | | 0 |
