## Pioneer Energy Services

Microresistivity  
Log

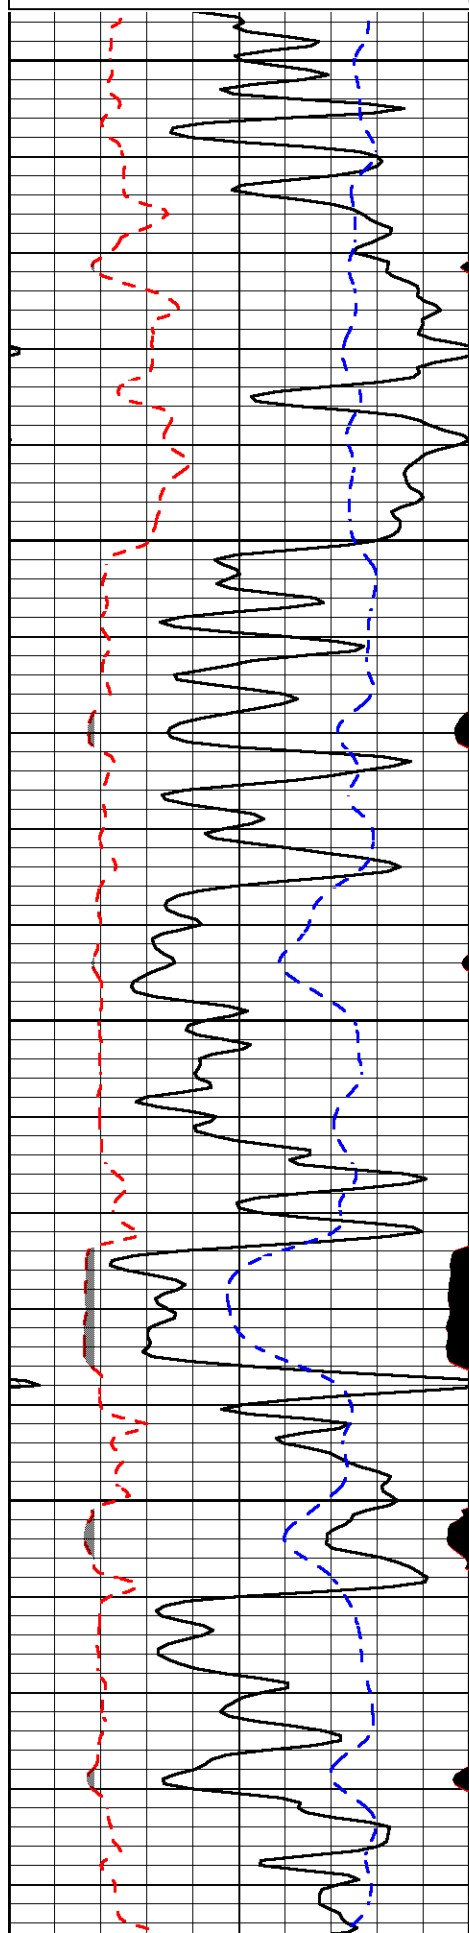
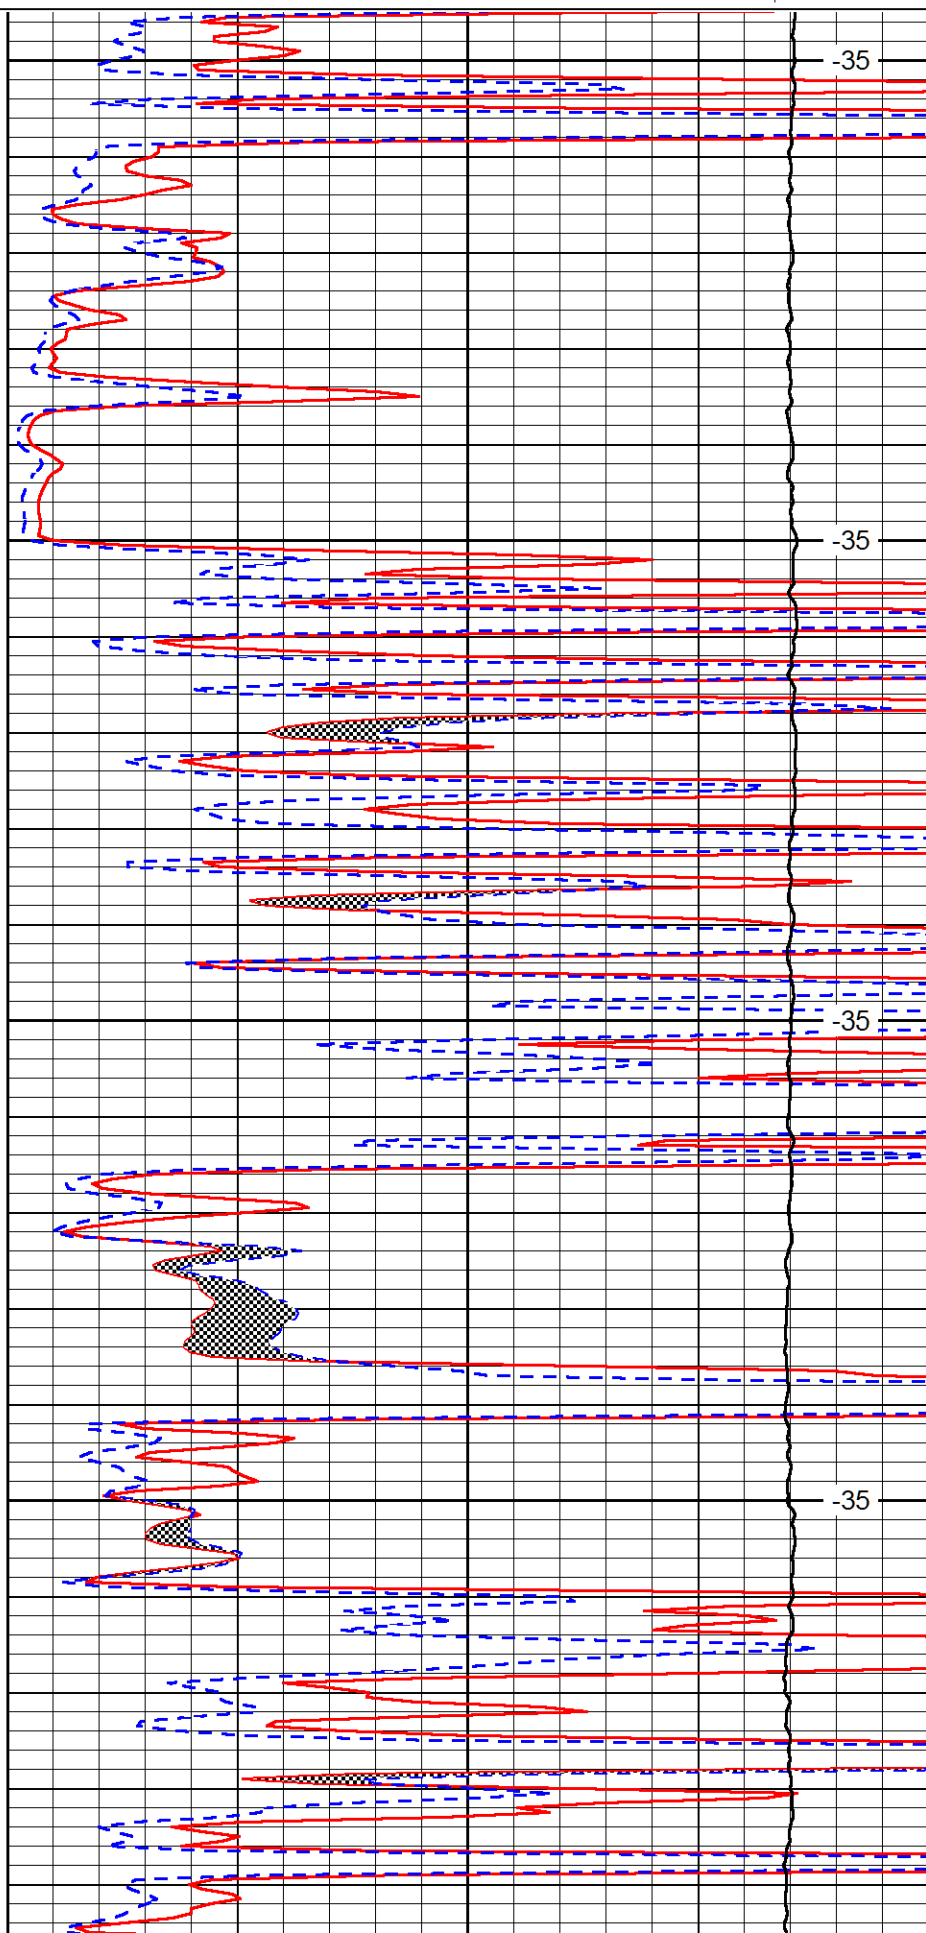
| 0 | Gamma Ray | 150 |
| 6 | MCAL (GAPI) | 16 |
| 2.875 | Mud Cake (GAPI) | 7.875 |
| -200 | SP (mV) | 0 |

| 0 | Micro Inverse 1 X 1 | 40 |
| 0 | Micro Normal 2" | 40 |
| 10000 | Line Weight | 0 |

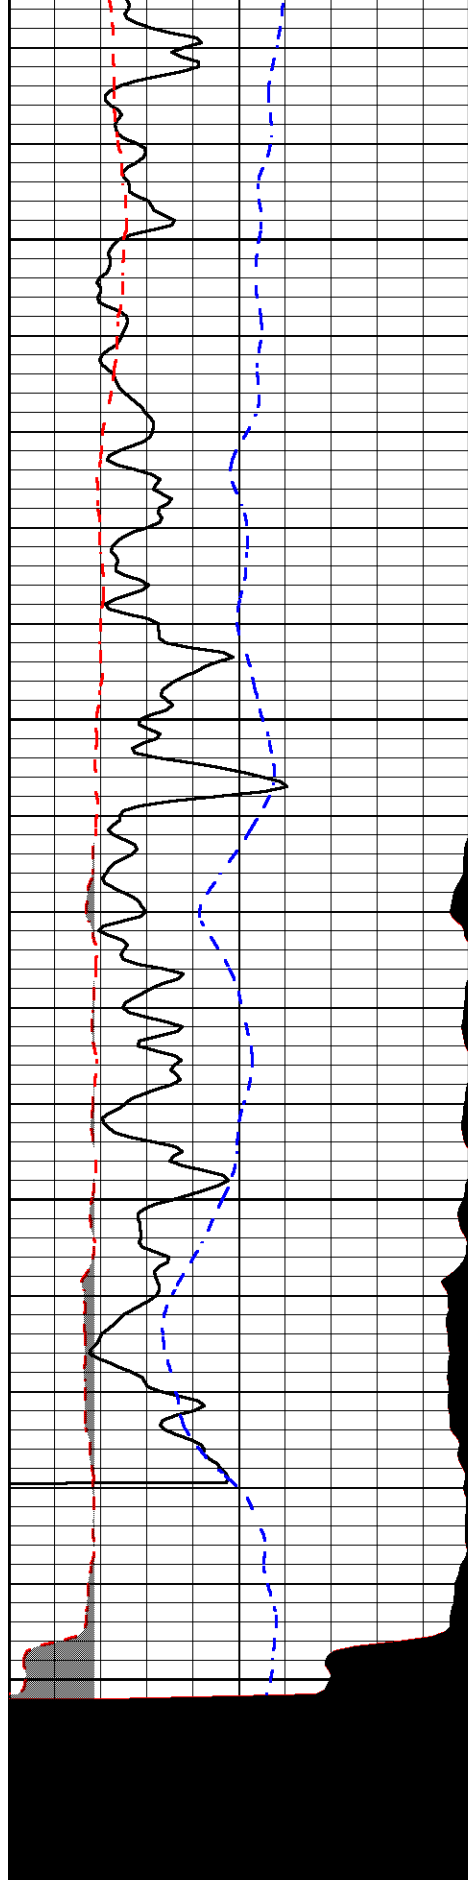
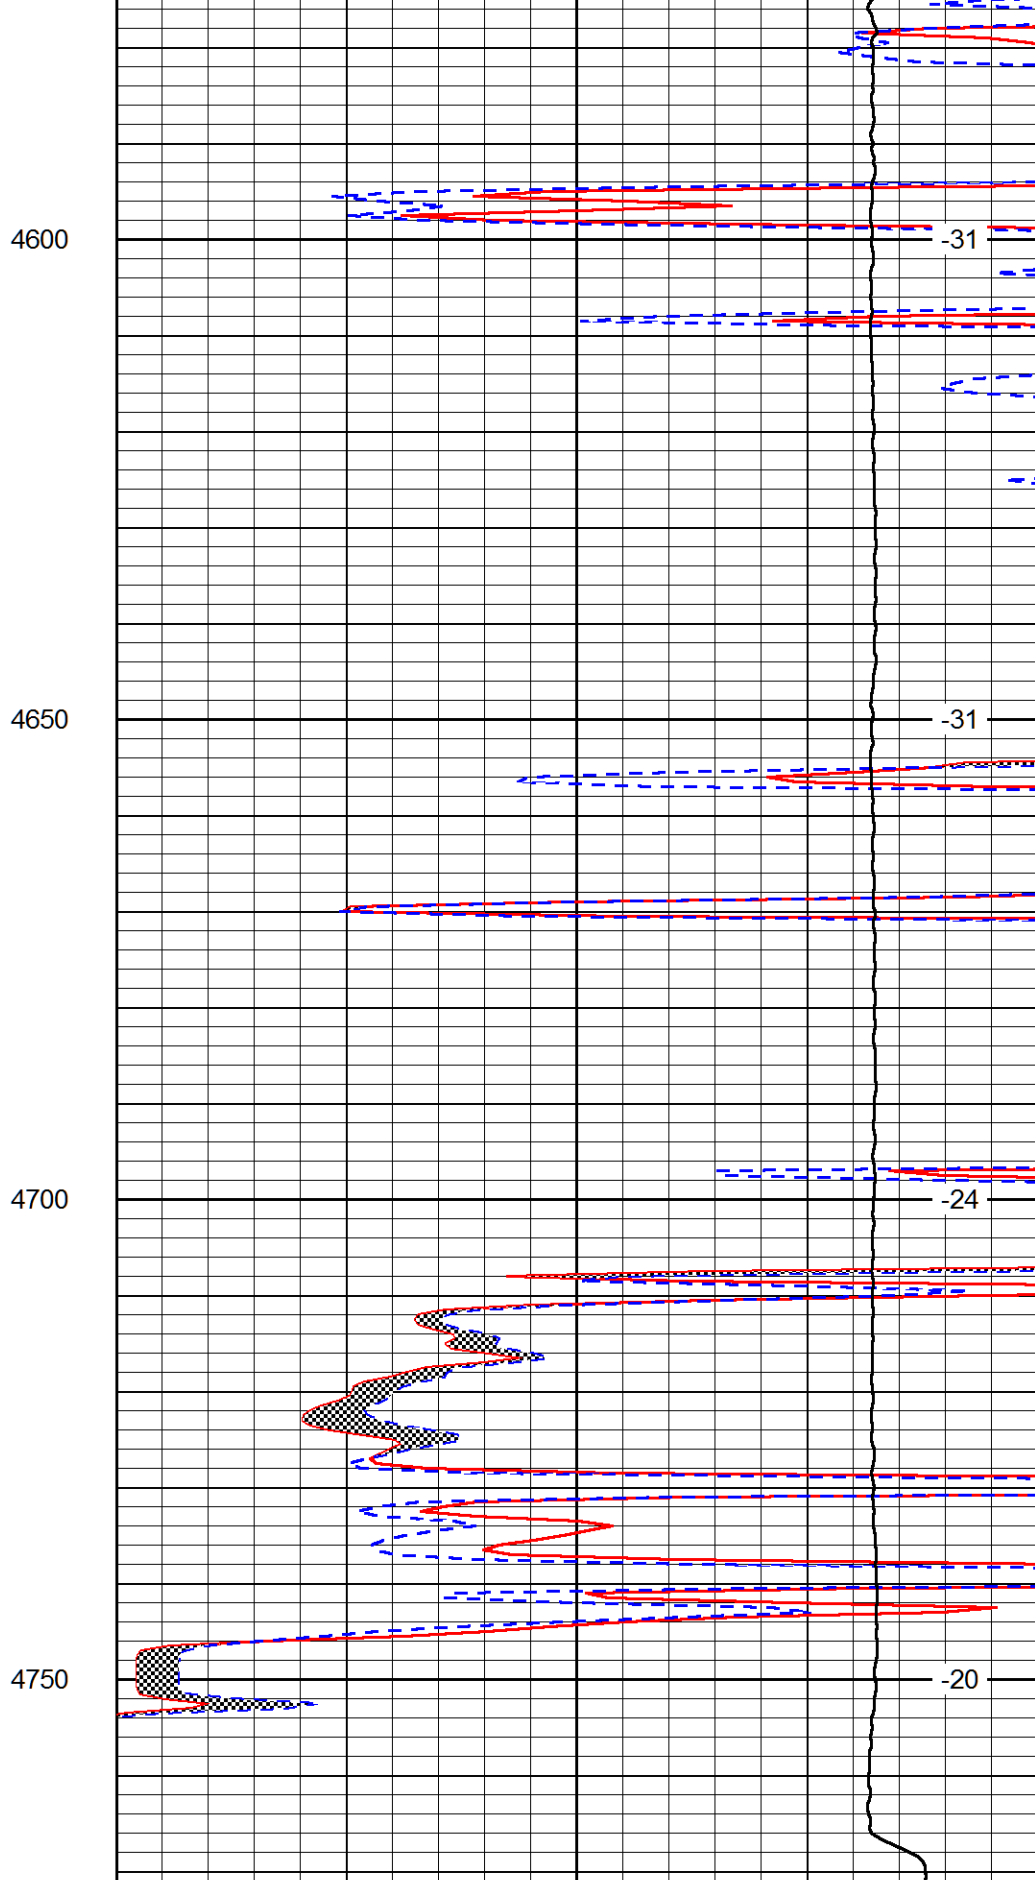
| 0 | Gamma Ray | 150 |
| 6 | MCAL (GAPI) | 16 |
| 2.875 | Mud Cake (GAPI) | 7.875 |
| -200 | SP (mV) | 0 |

| 0 | Micro Inverse 1 X 1 | 40 |
| 0 | Micro Normal 2" | 40 |
| 10000 | Line Weight | 0 |
