Pioneer Energy Services

# Dual Compensated Porosity Log

Dighton KS, 1 1/2 W S Into between buildings

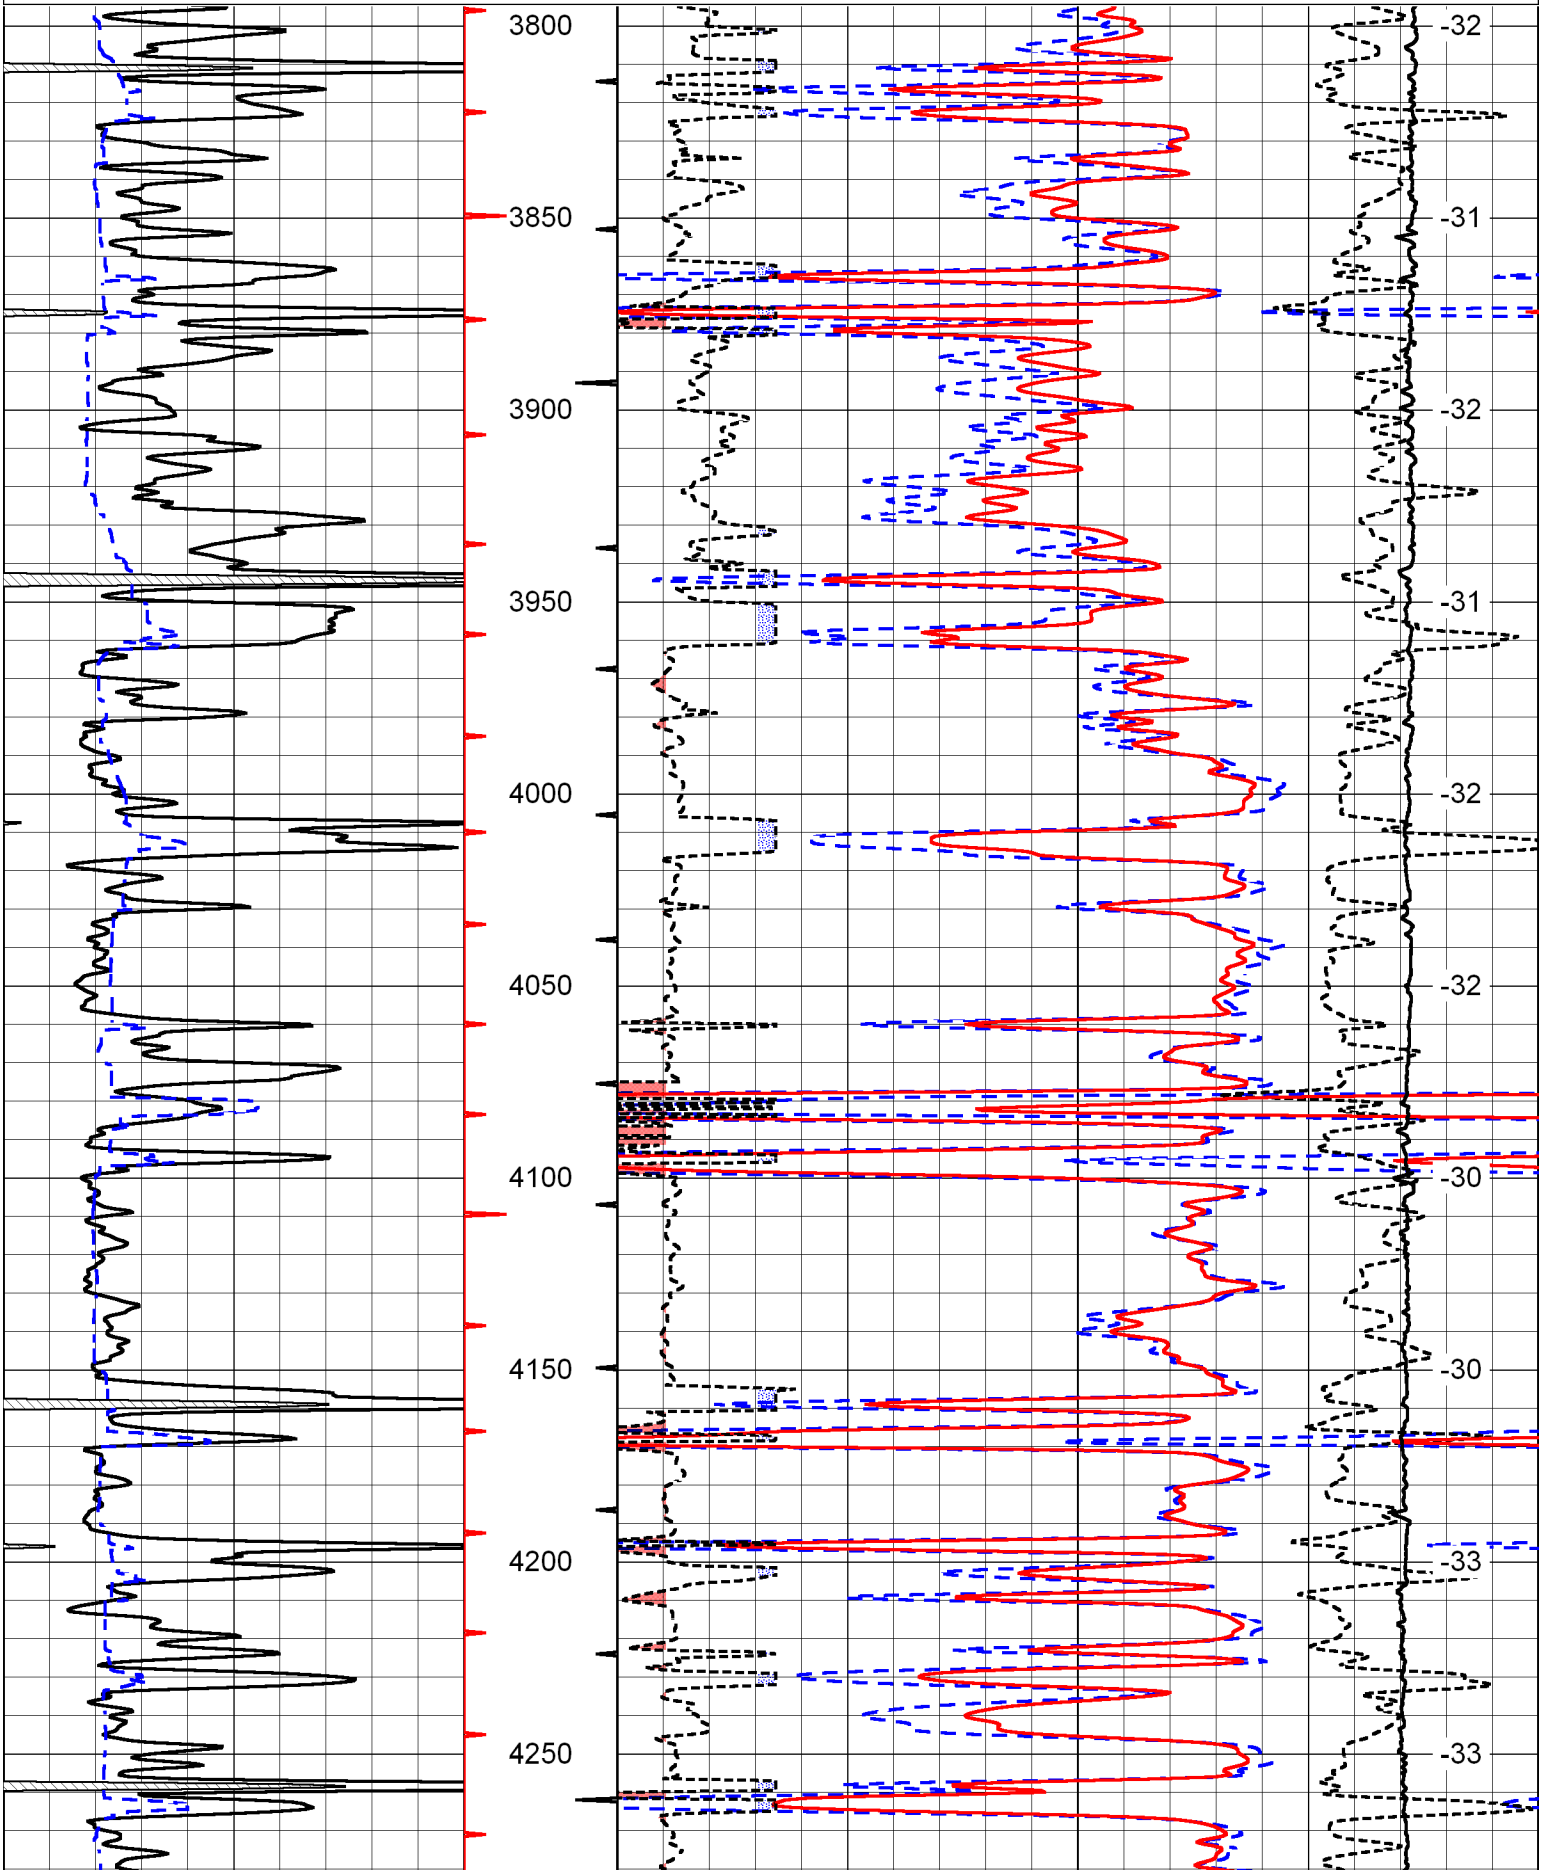
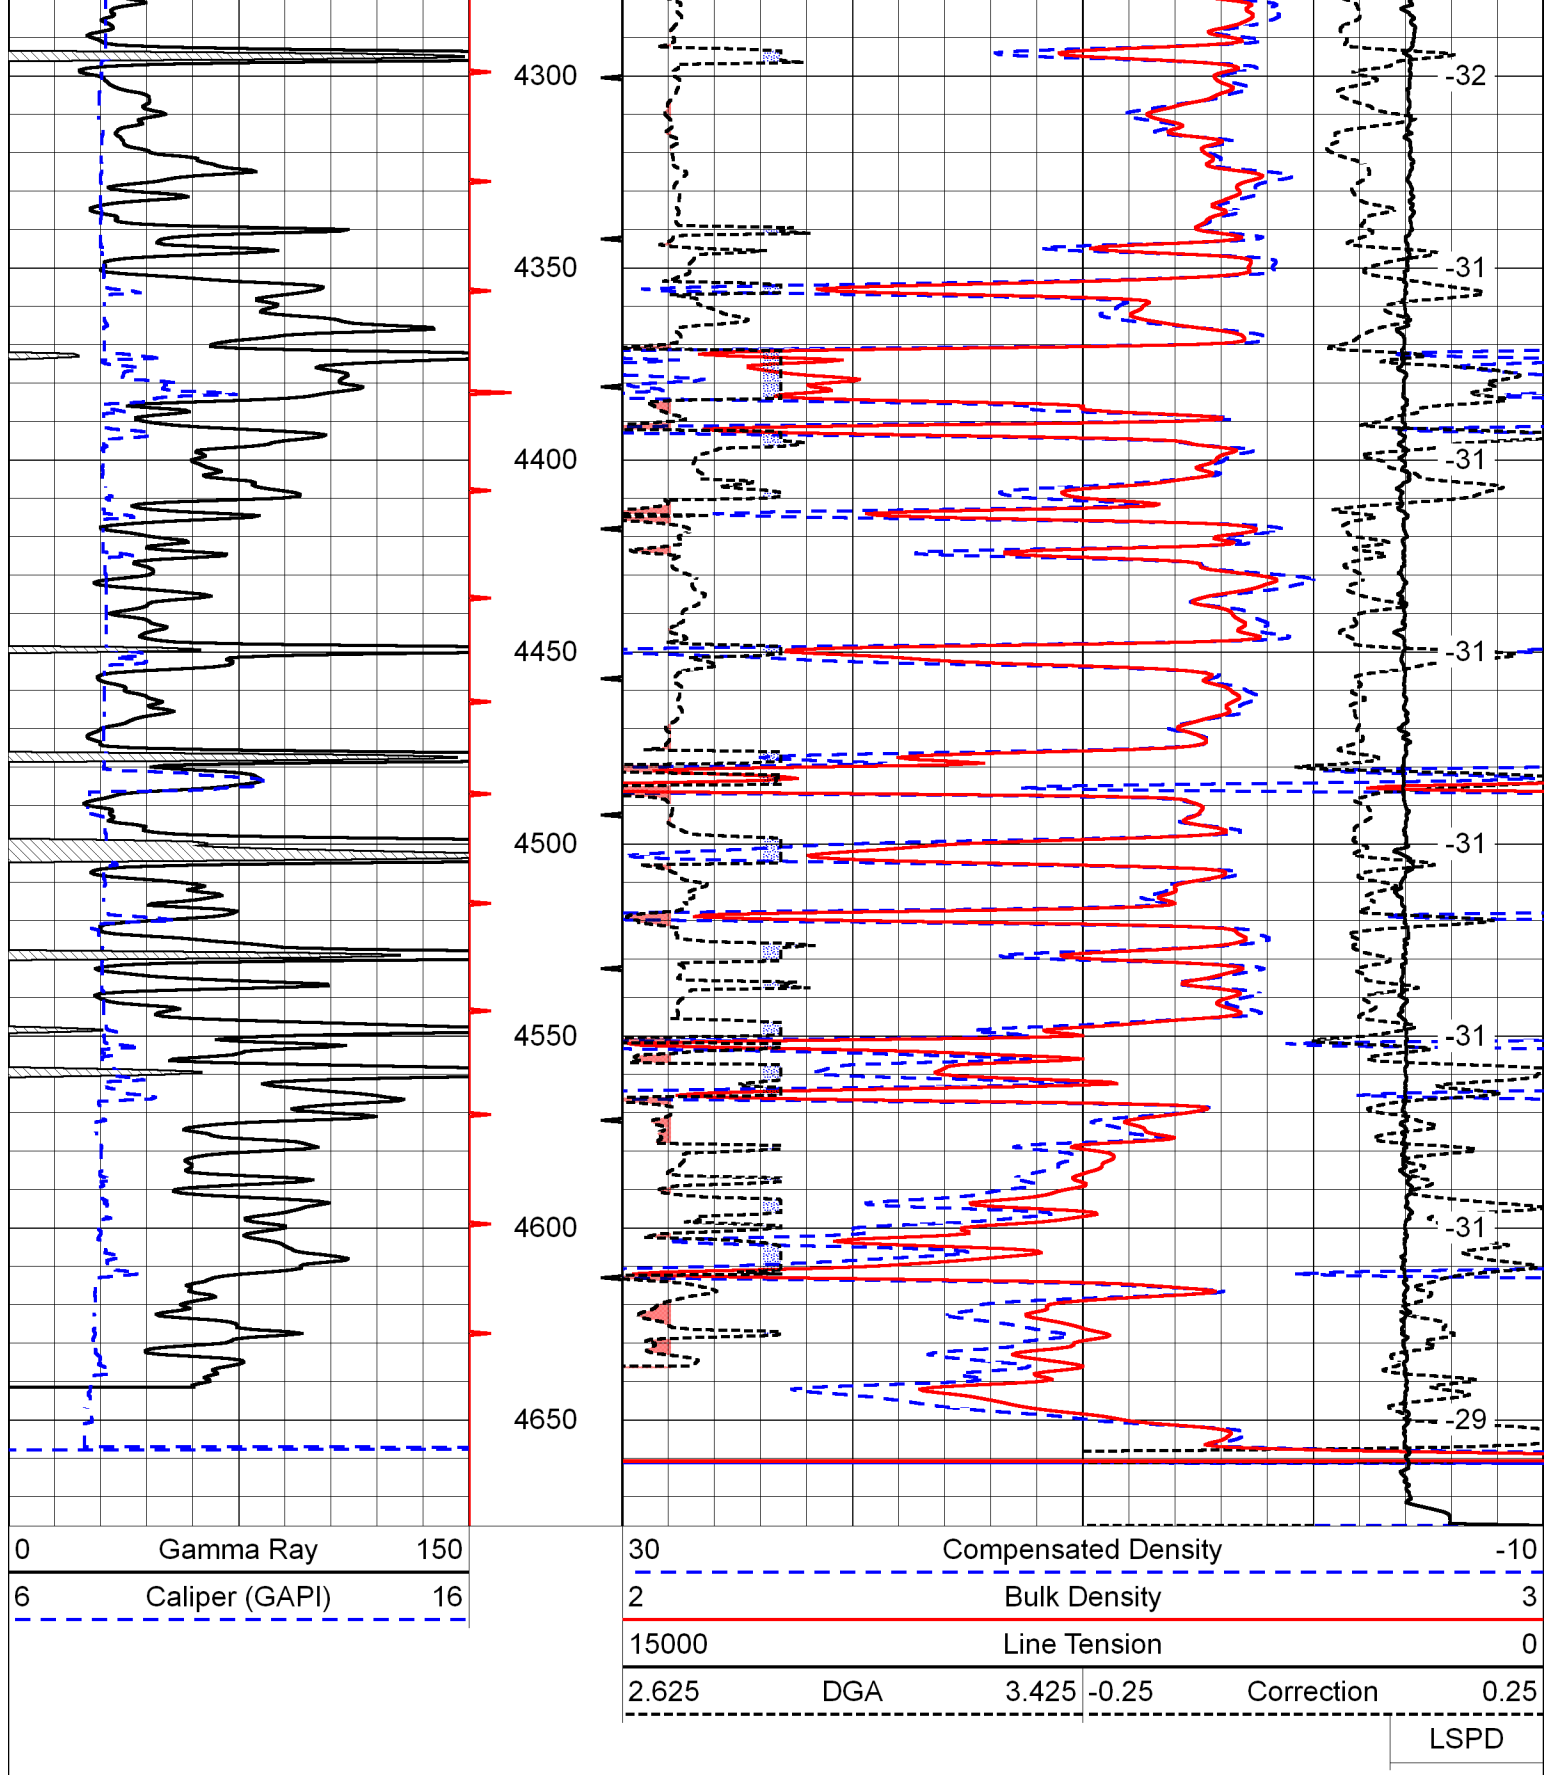
| Database File | larson_meeker #1 owwo\larshd3.db |
| Dataset Pathname | dil\larstk2 |
| Presentation Format | cdl |
| Dataset Creation | Tue Mar 03 15:41:50 2015 |
| Charted by | Depth in Feet scaled 1:600 |

| 0 | Gamma Ray | 150 |
| 6 | Caliper (GAPI) | 16 |

| 30 | | Compensated Density | | -10 | |
| 2 | | Bulk Density | | 3 | |
| 15000 | | Line Tension | | 0 | |
| 2.625 | DGA | 3.425 | -0.25 | Correction | 0.25 |

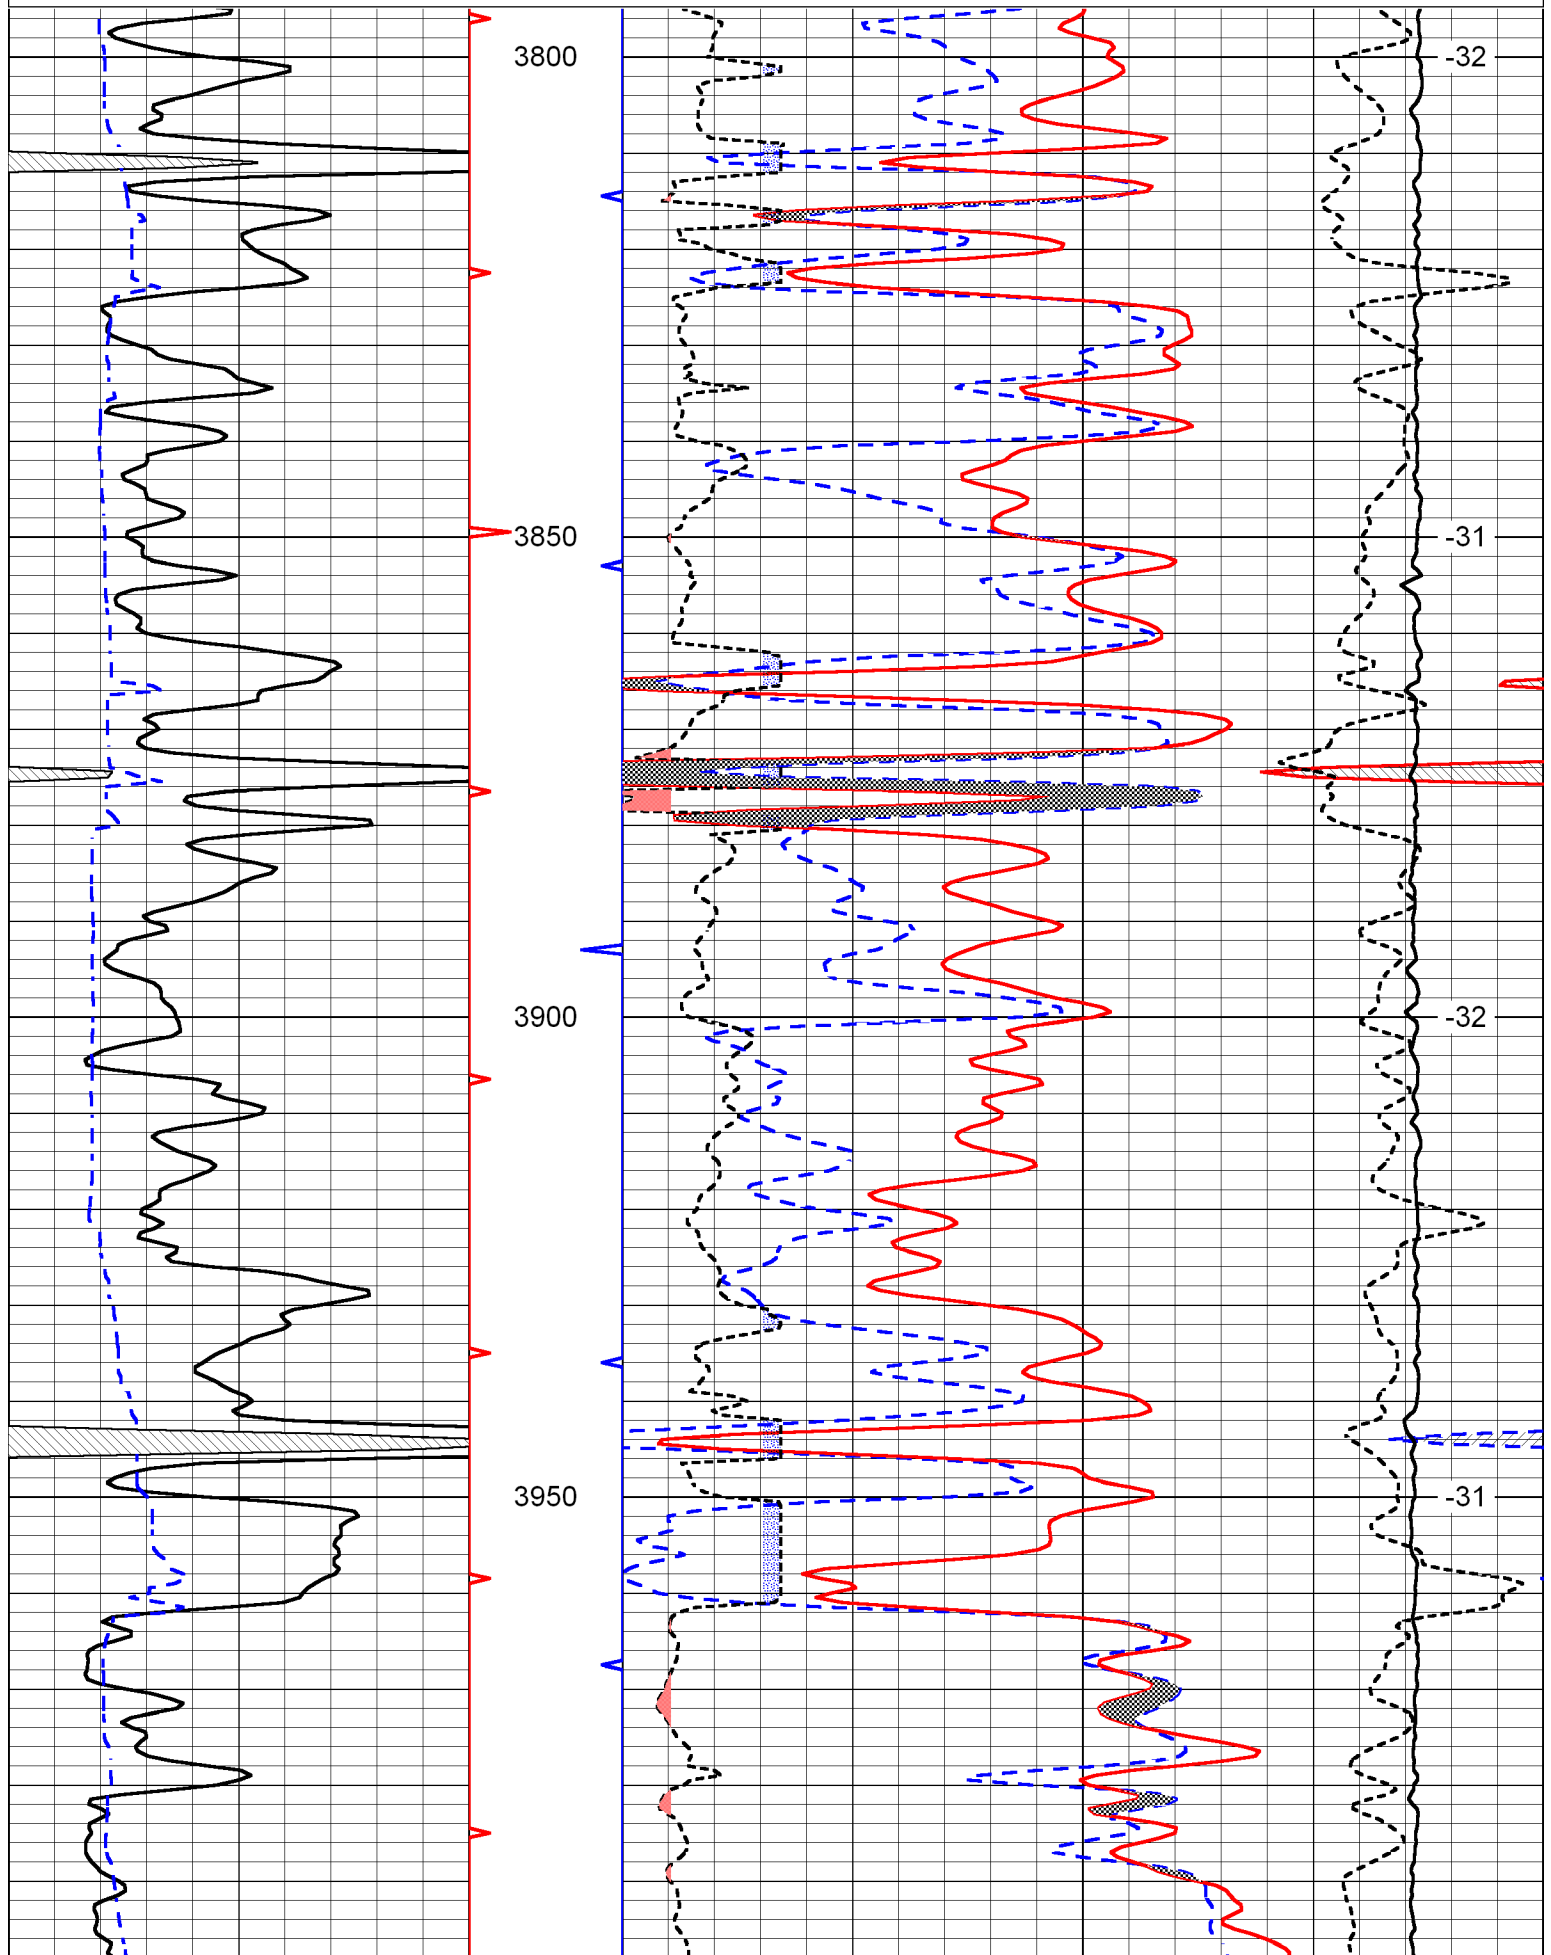
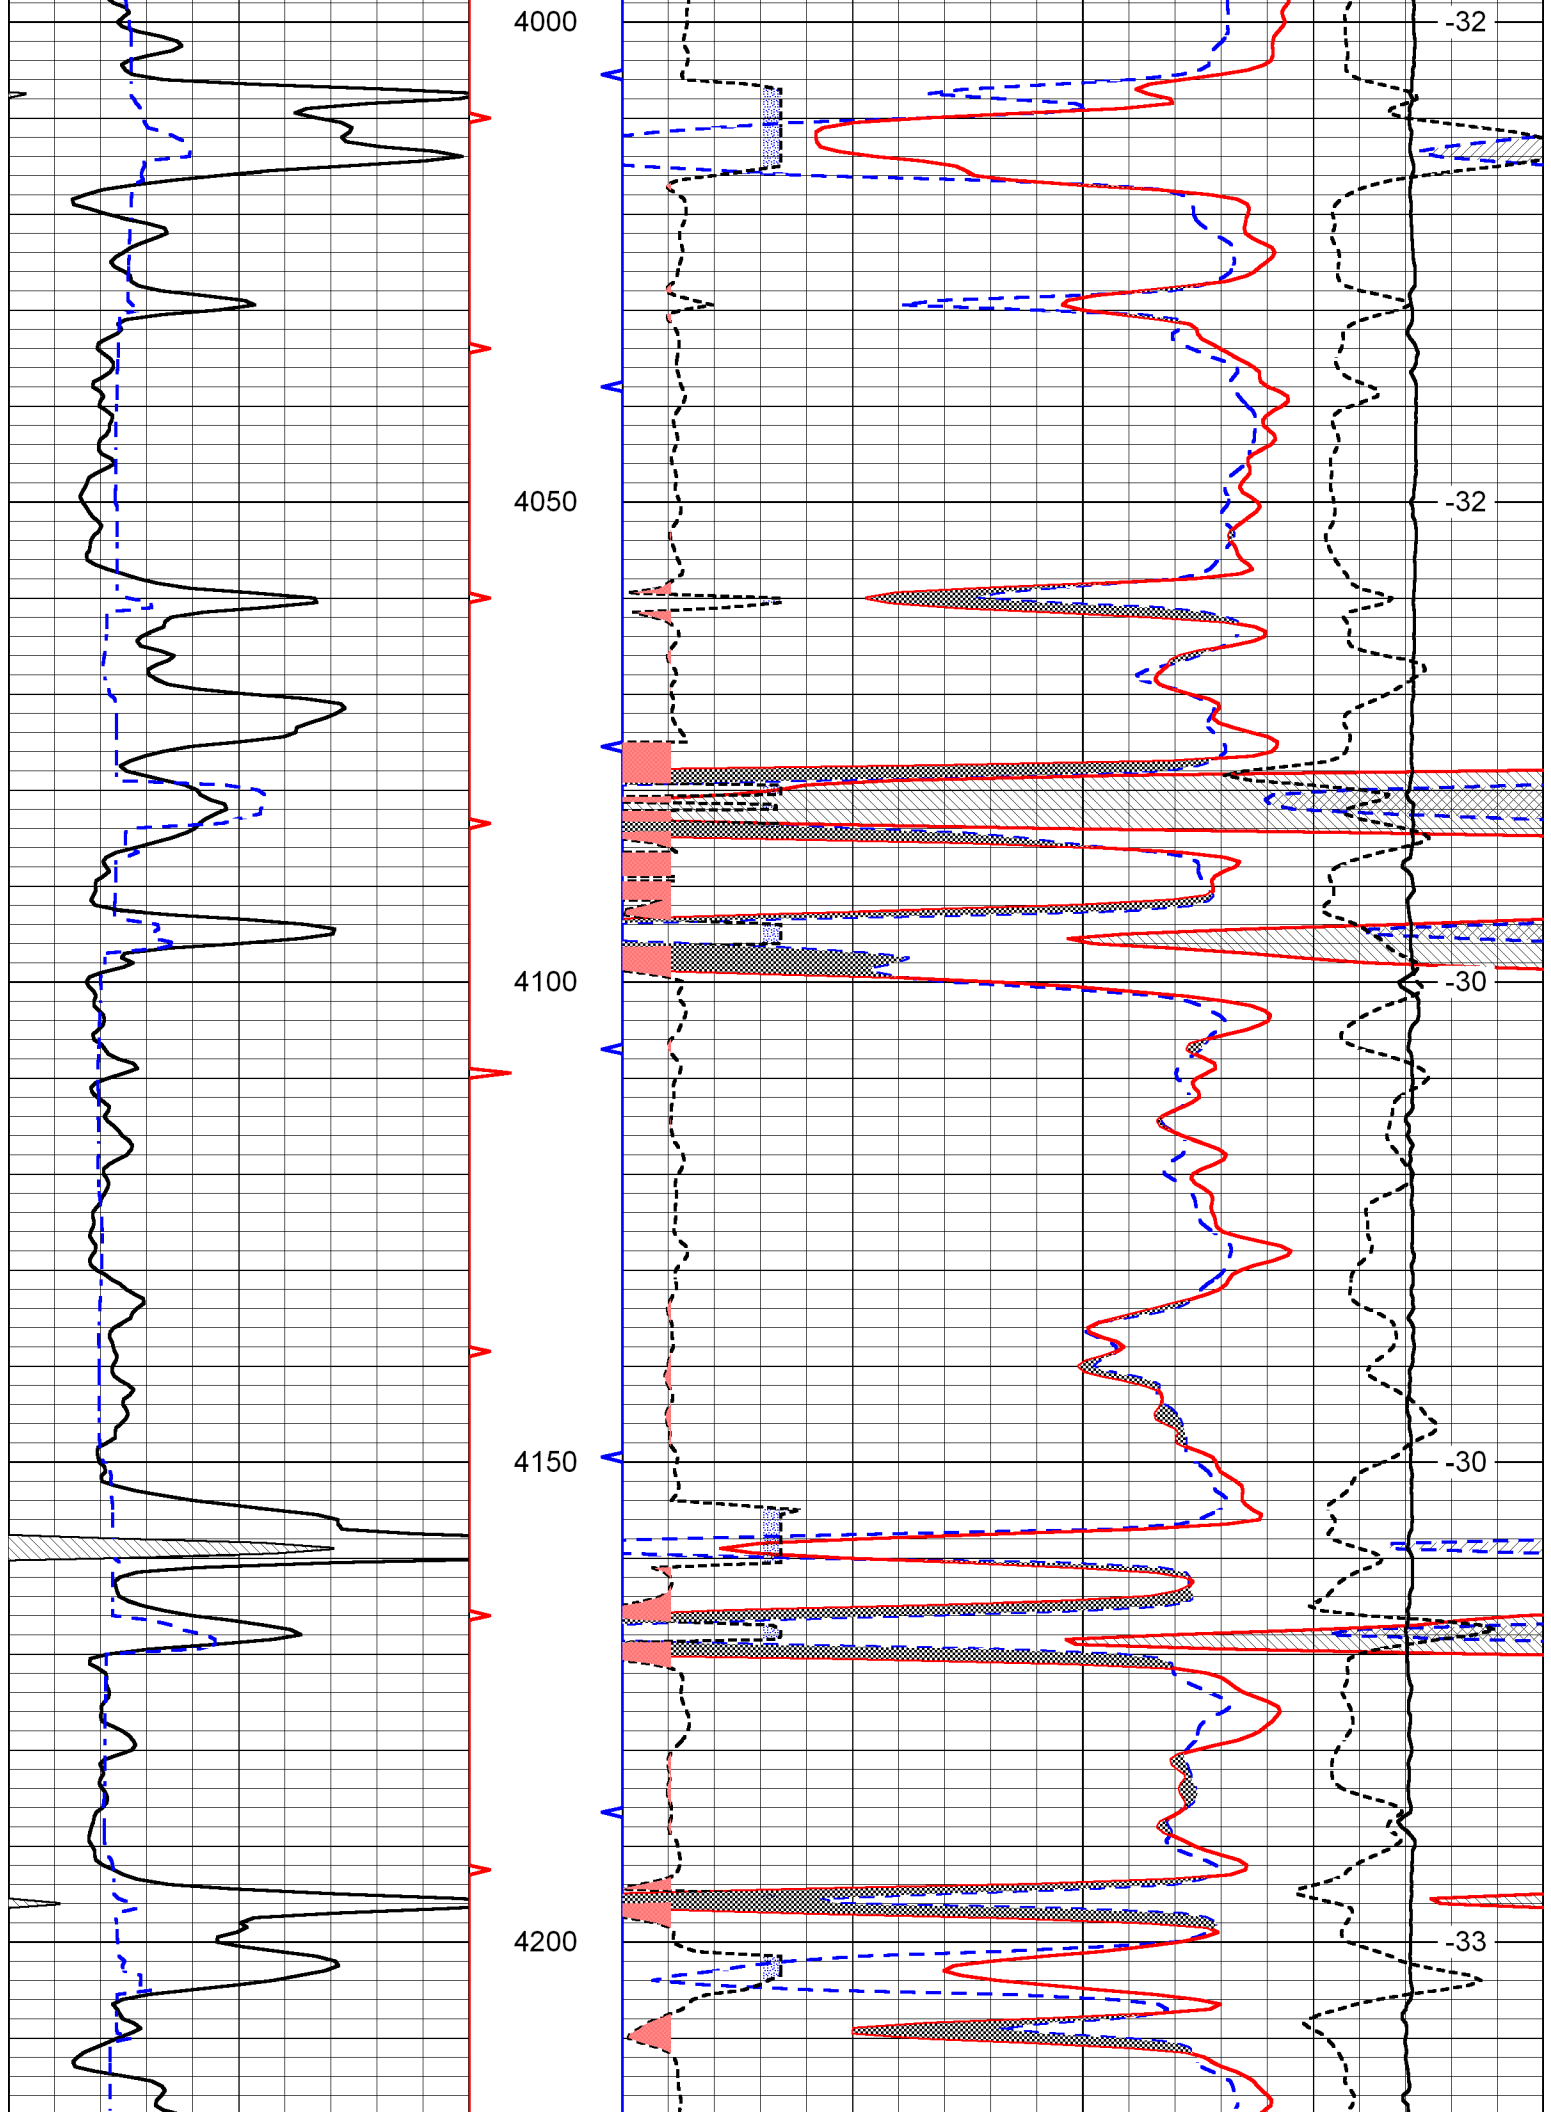
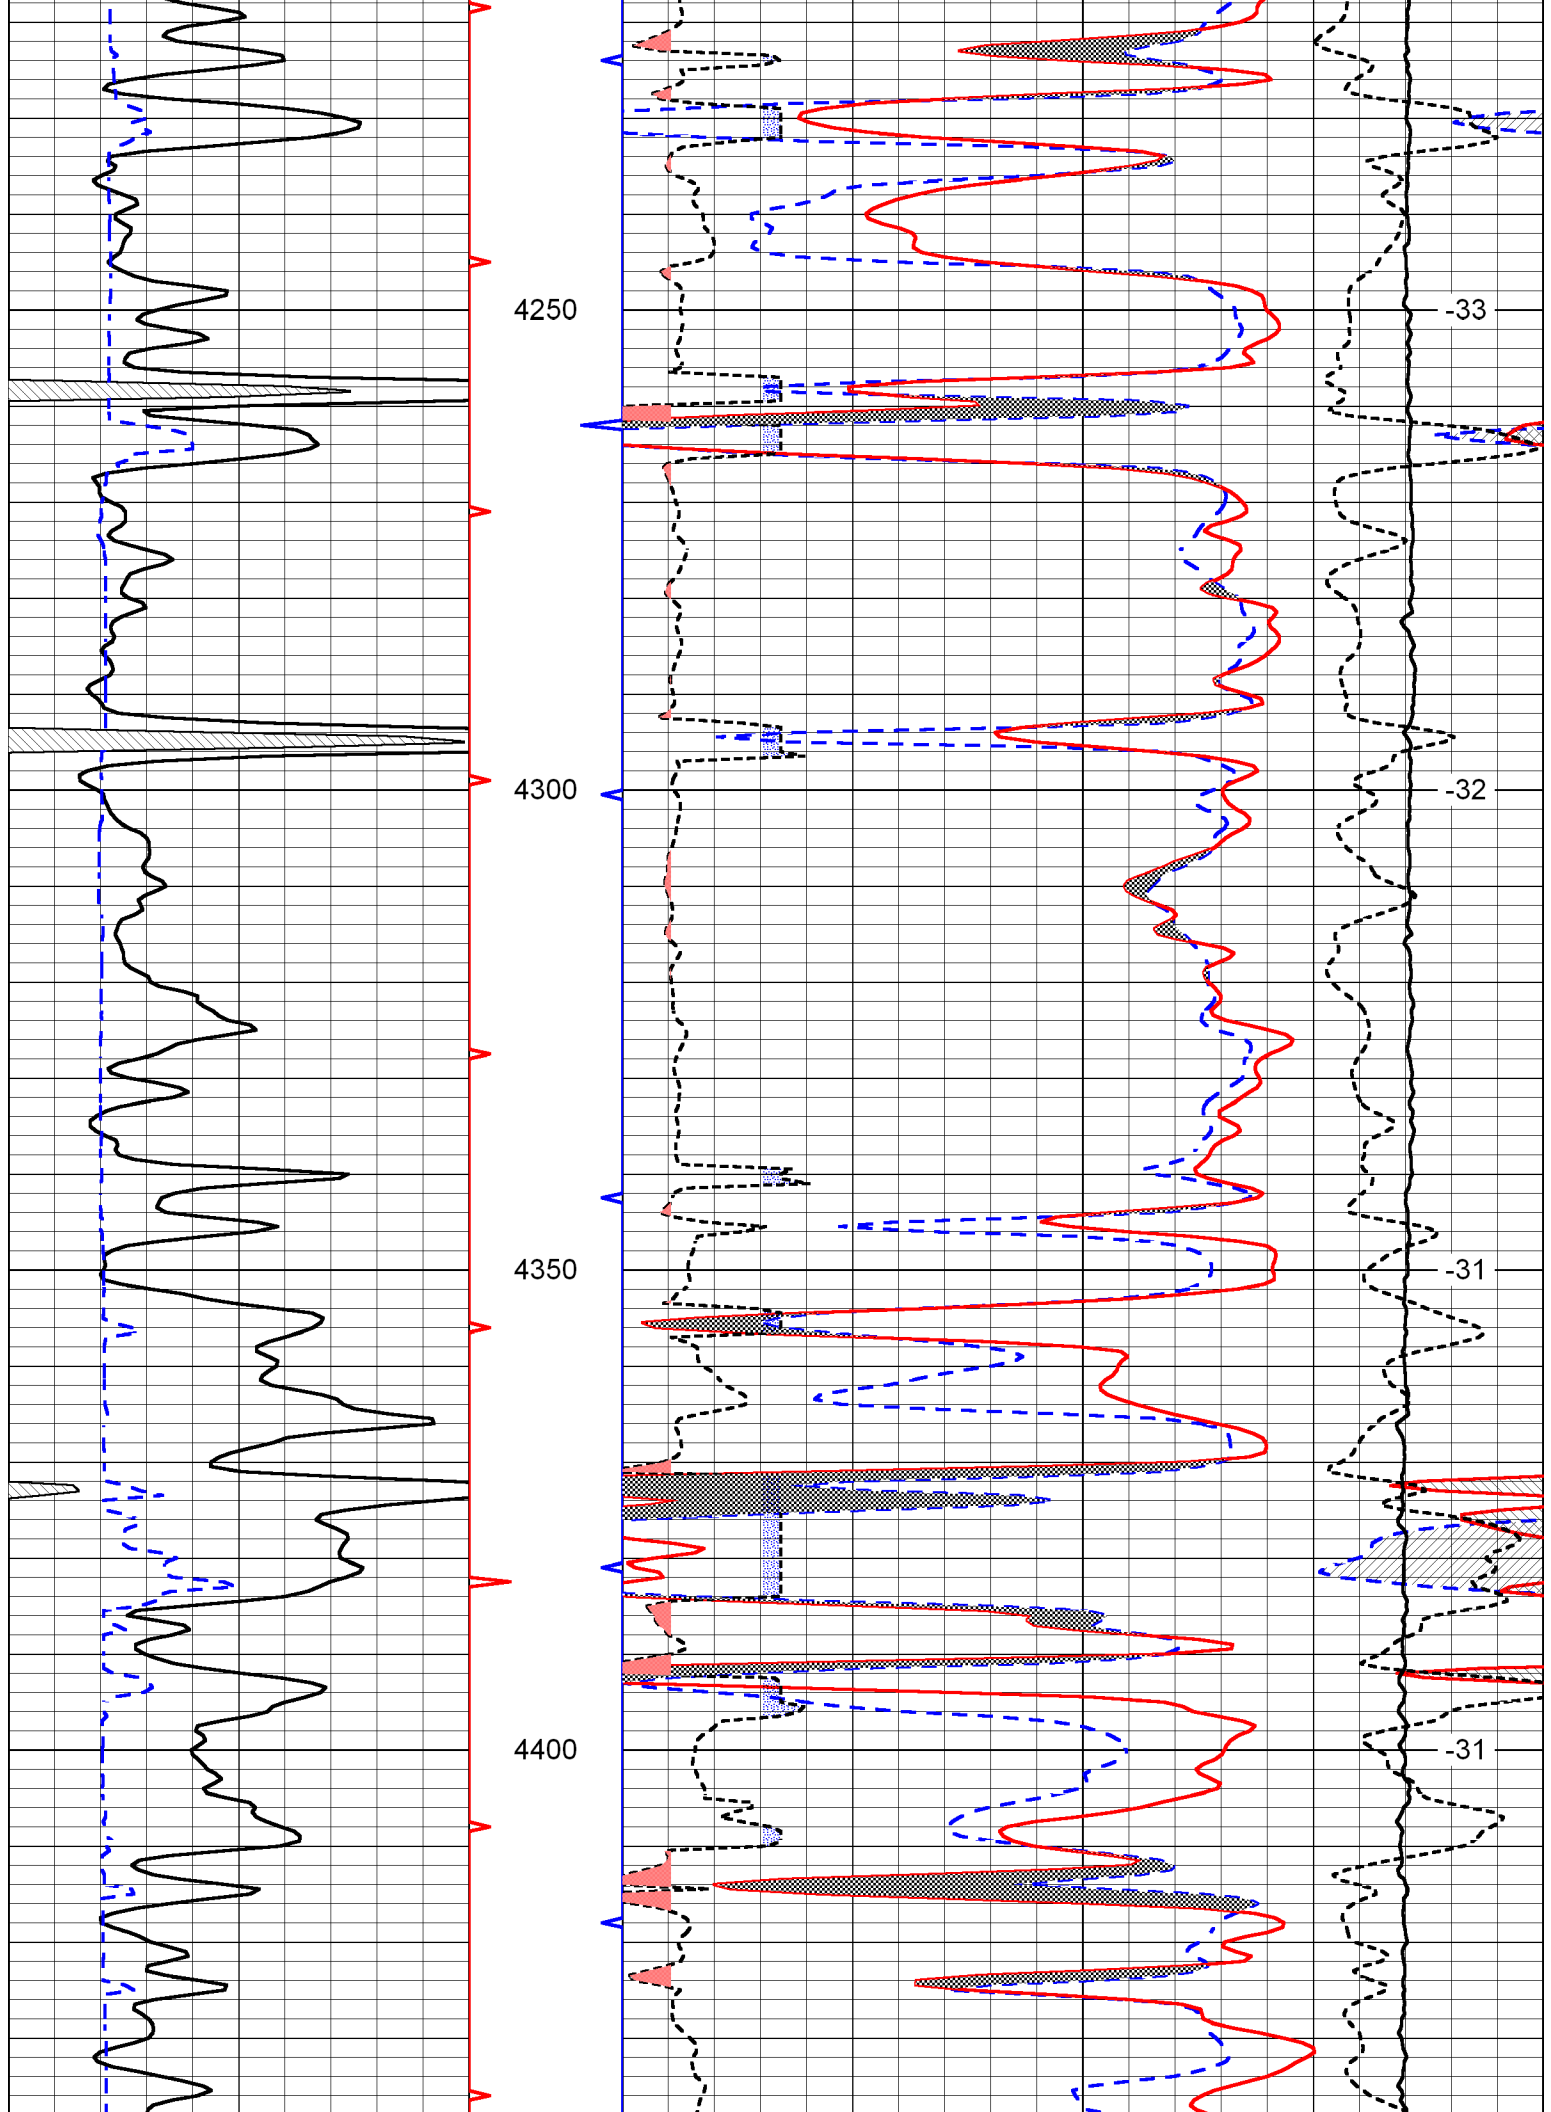
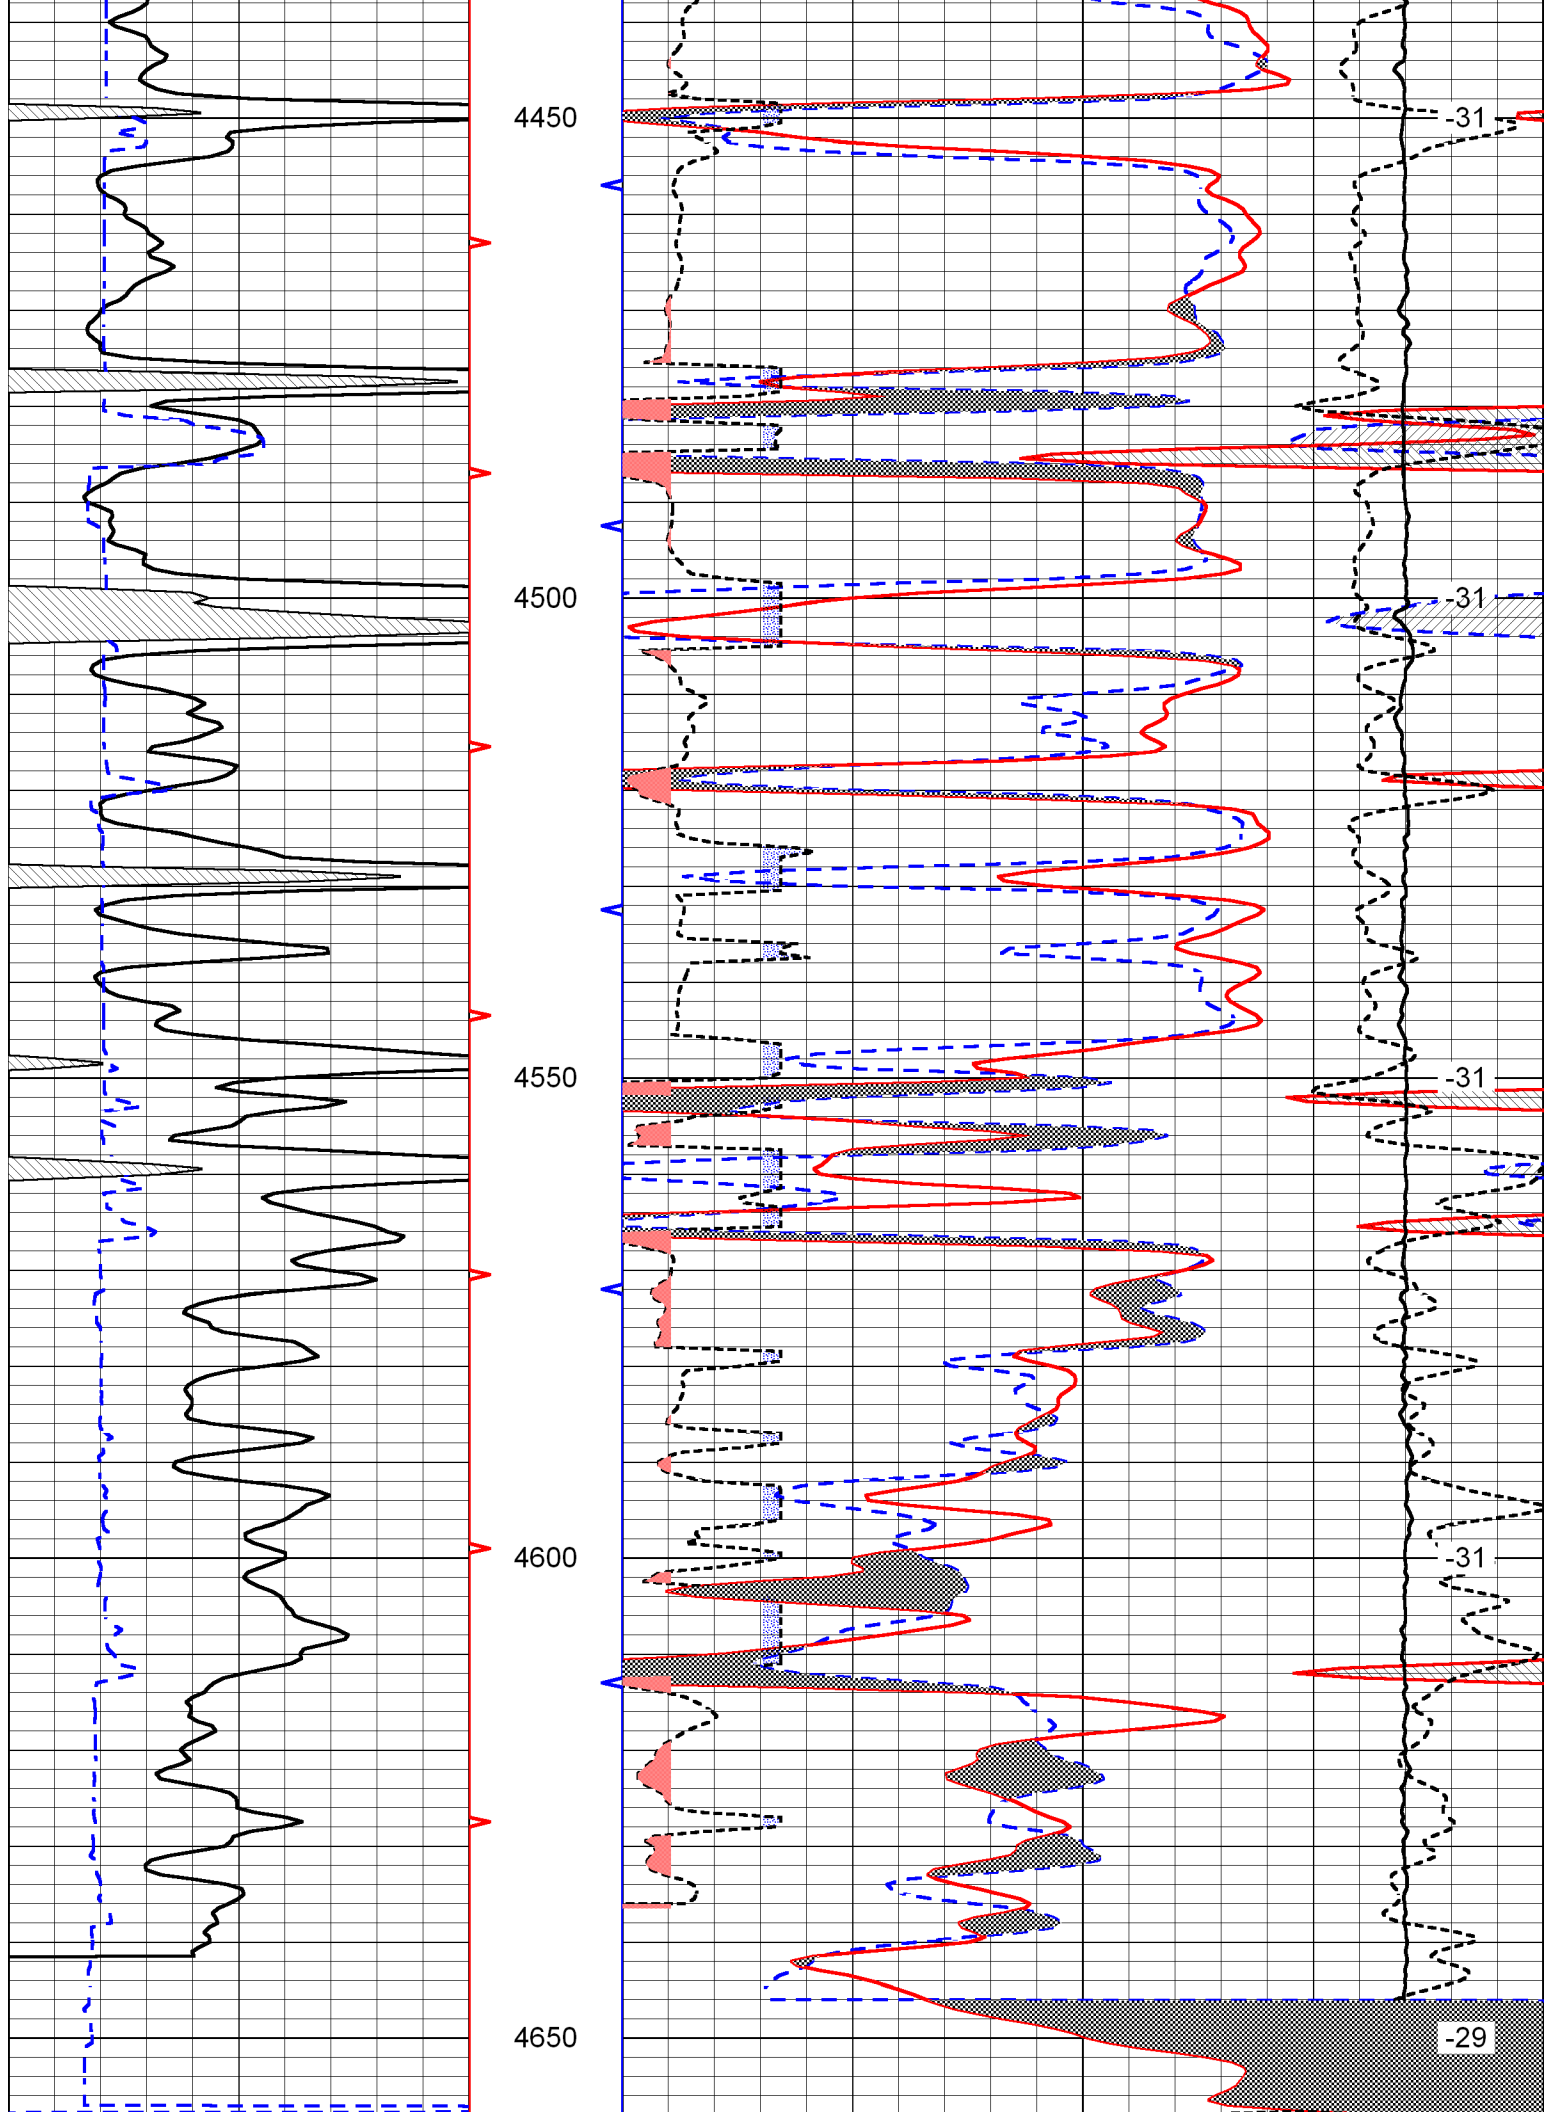
| Database File | larson_meeker #1 owwo\larshd3.db |
| Dataset Pathname | dil\larstk2 |
| Presentation Format | cnldspec |
| Dataset Creation | Tue Mar 03 15:41:50 2015 |
| Charted by | Depth in Feet scaled 1:240 |

| 0 | Gamma Ray | 150 | 30 | Compensated Neutron (Limestone) | -10 |
| 6 | Caliper (GAPI) | 16 | 30 | Compensated Density (Limestone) | -10 |

| 15000 | Line Tension | | | 0 |
| 2.625 | DGA | 3.425 | -0.25 | Correction 0.25 |
